Cite this article: Arora H, Kelly M, Worley A, Del Linz P, Fergusson A, Hooper PA, Dear JP. 2014 Compressive strength after blast of sandwich composite materials. *Phil. Trans. R. Soc. A* **372**: 20130212.
<http://dx.doi.org/10.1098/rsta.2013.0212>

Compressive strength after blast of sandwich composite materials

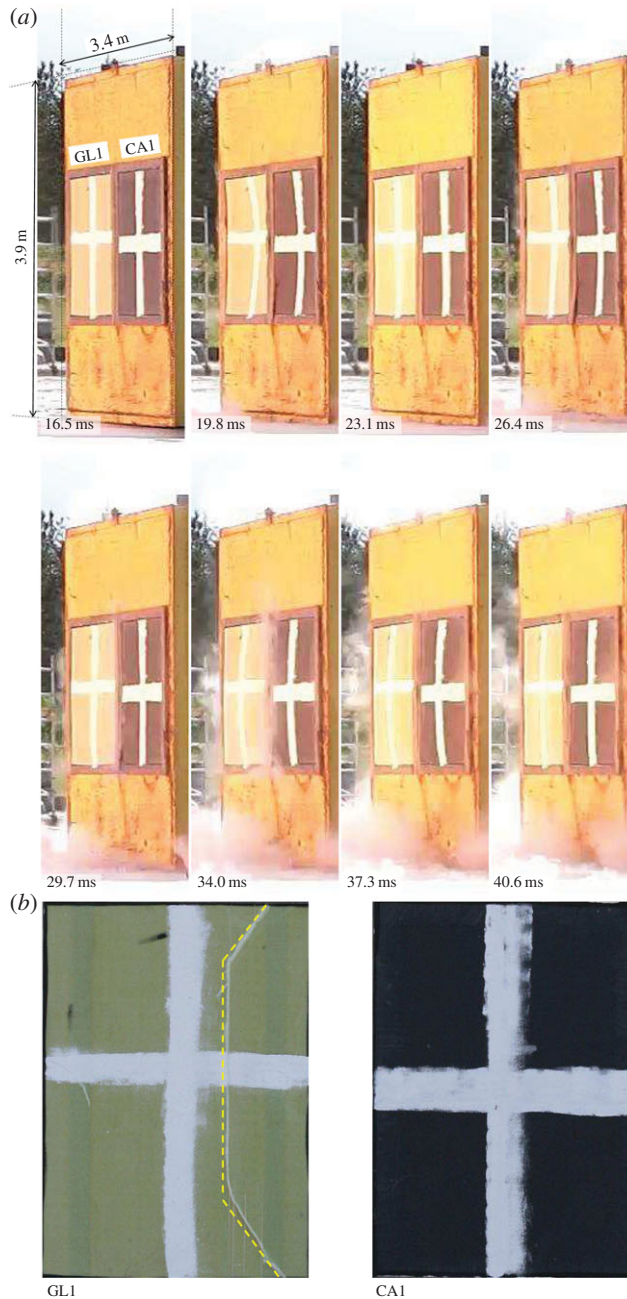
Figure 3 shows the effect of the blast on test samples GL1 and CA1. Front-face damage is seen to initiate in the top right corner of GL1 at 19.8 ms and propagate down the right-hand edge. The final front-face damage is shown at the bottom of figure 3, highlighting the relative visible damage sustained by each target. There was no visible skin damage in CA1.

Figure 3. (a) Images taken at regular intervals with the shockwave impinging on test samples GL1 and CA1 after 16.5 ms. (b) Final visible front-face damage. Time stamps are relative to detonation time at 0.0 ms. (online version in colour.)

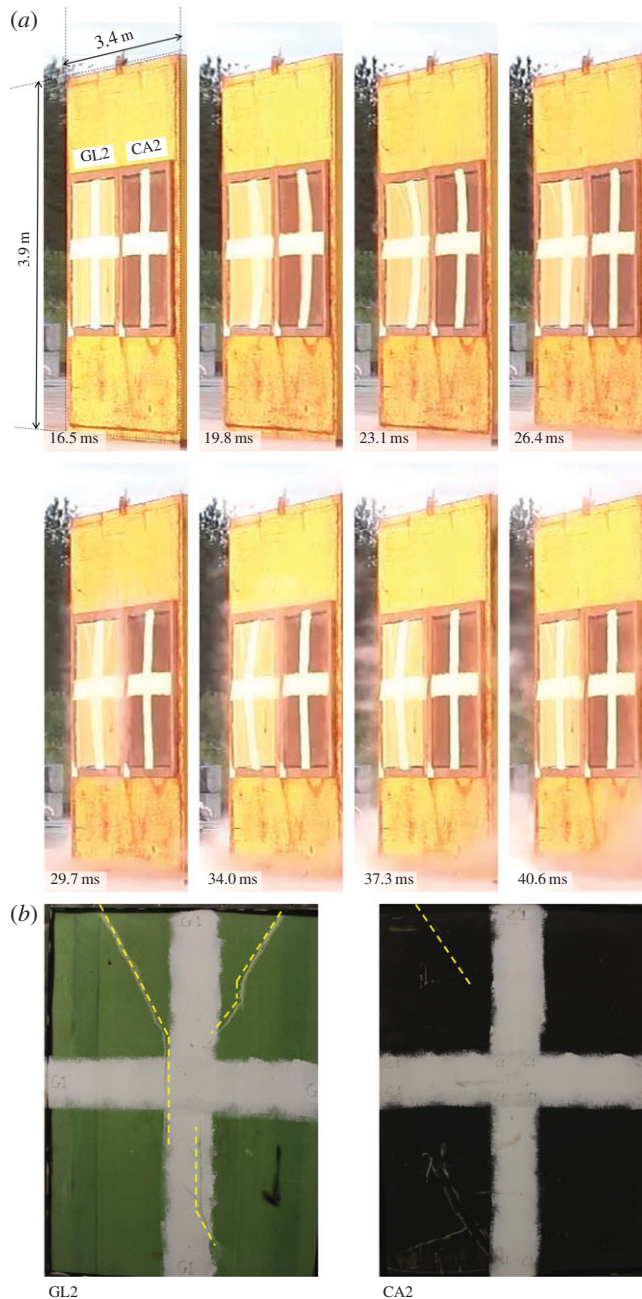
For the second pair of samples subjected to blast, figure 4 shows the external view of samples GL2 and CA2 for the duration of the loading cycle. Front-face damage is seen to initiate in the top left and right corners of GL2 between 19.8 and 23.1 ms. These cracks propagate down the sides of GL2. This time, in the CFRP panel, there is a small amount of skin failure visible, highlighted in the final front-face damage image at the bottom of figure 4.

Figure 4. (a) Images taken at regular intervals with the shockwave impinging on test samples GL2 and CA2 after 16.5 ms. (b) Final visible front-face damage of targets 1.6×1.3 m area. (Online version in colour.)

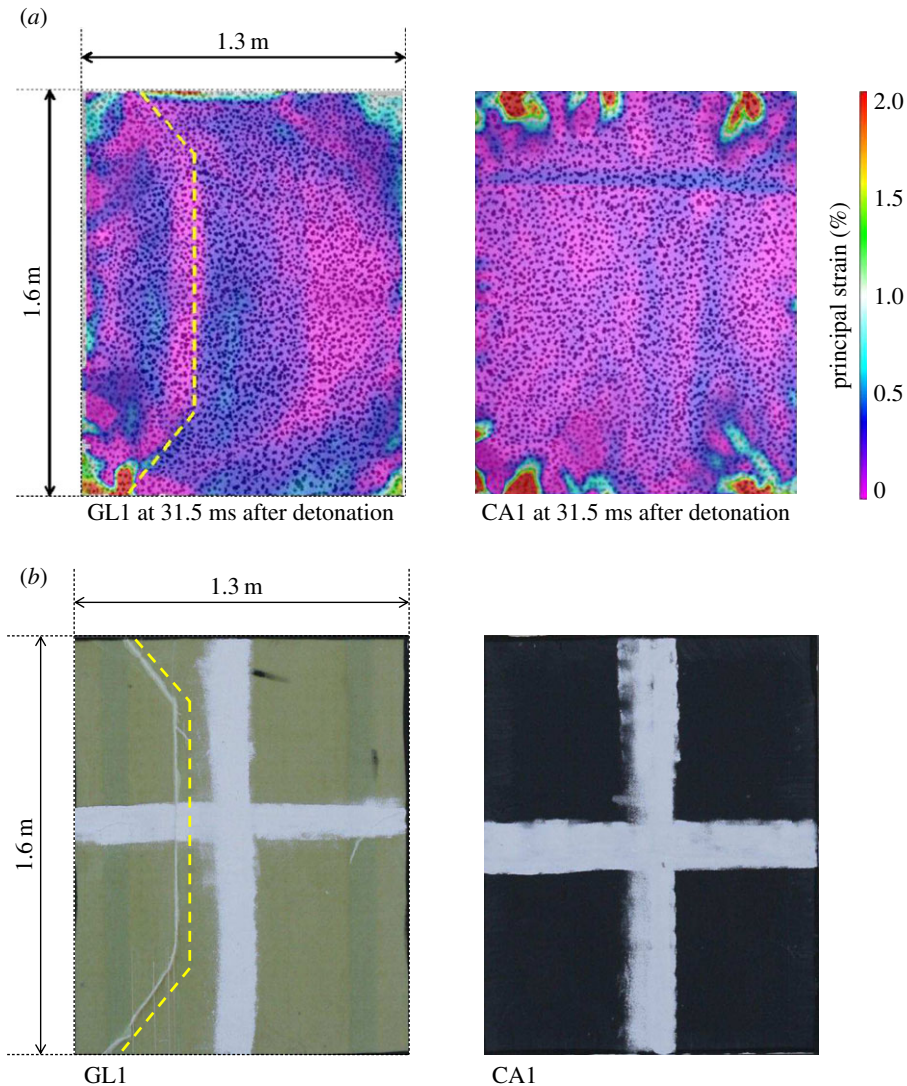
Clear indications of damage induced are shown in the DIC images. Sample snapshots of the maximum principal strain are given in figure 10*a*. For GL1, there is a region of material in compression of approximately -1% when GL1 is at its peak rebound displacement (out towards the origin of the charge). This region builds in strain owing to the lack of support

Figure 10. DIC analysis of both GL1 and CA1 showing (a) the maximum principal strains and (b) the mirrored images of the damaged front faces of each target. (Online version in colour.)

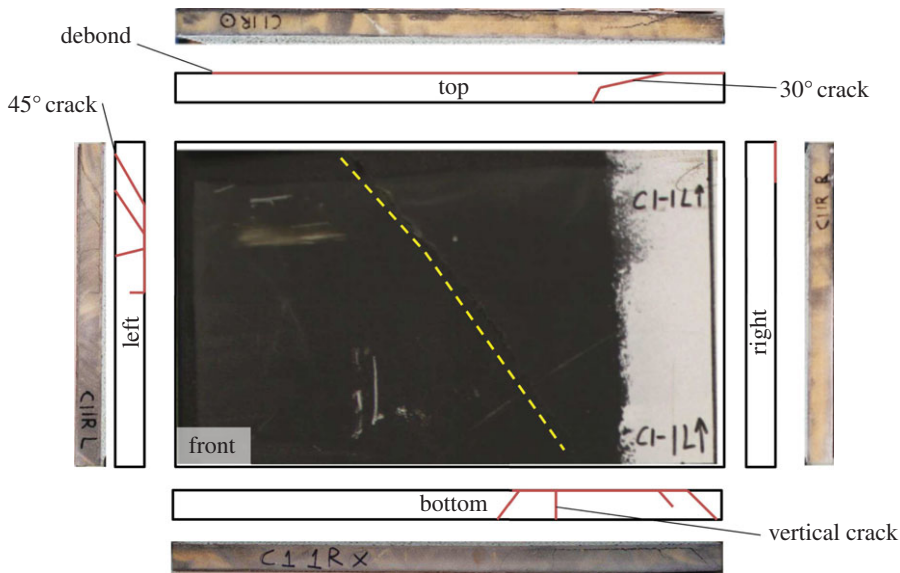
Figure 11. An example of the documentation process for visual inspection post-blast on CA1 subpanel 1R (650 × 400 mm in area), showing images and schematics of damage noted. Subpanel 1R is top right when viewed from the rear. (Online version in colour.)

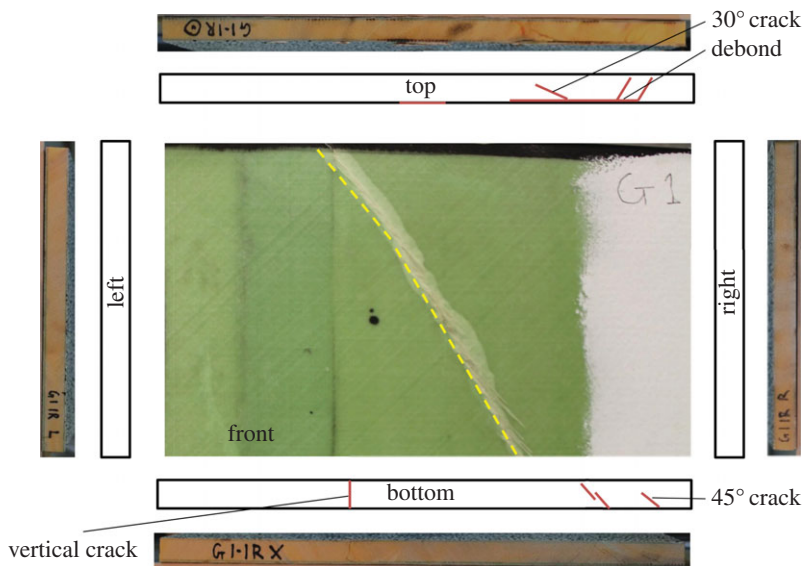
Figure 12. An example of the documentation process for visual inspection post-blast on GL1 subpanel 1R (650 × 400 mm in area), showing images and schematics of damage noted. Subpanel 1R is top right when viewed from the rear. (Online version in colour.)

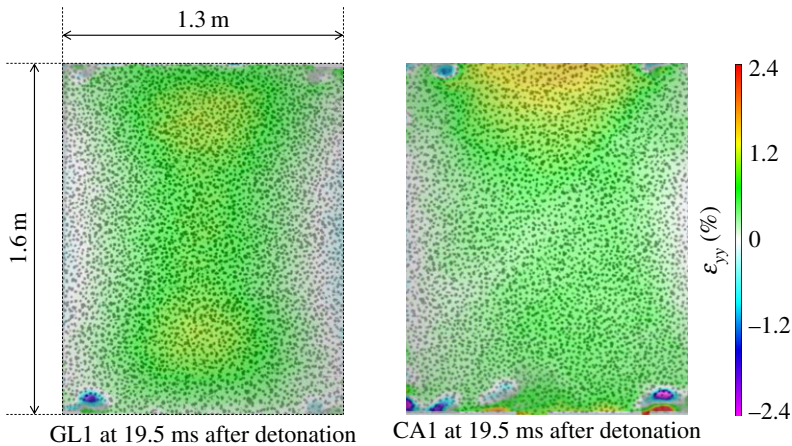
Signs of where the most damaged areas of each global panel occur were available in the DIC analysis. Figure 13 shows the strain in the y -direction in the image, denoted ε_{yy} , for GL1 and CA1. It is shown that the propensity for horizontal cracking along the shorter length (x -direction) is fairly uniform in GL1, whereas in CA1, ε_{yy} is much higher towards the top edge of the target. This goes some way to highlight why visual inspections show that the GFRP panels were more uniformly damaged throughout the target compared with the CFRP sandwich panels. Evidence

Figure 13. DIC analysis showing strain in the y -direction in GL1 and CA1 recorded during the blast taken at 19.5 ms after detonation. (Online version in colour.)

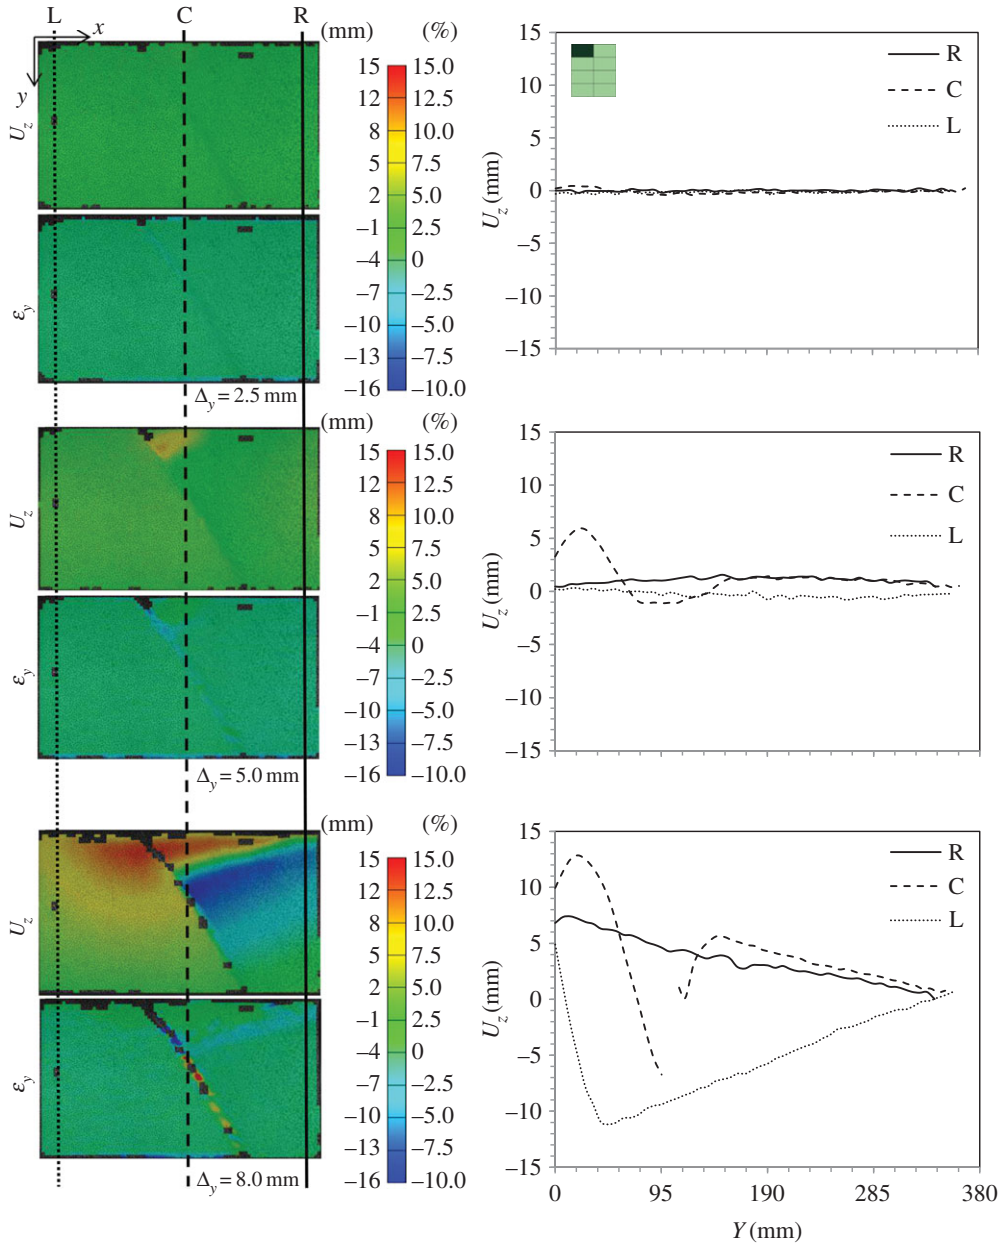
Figure 16. DIC analysis for subpanel 1L (top left when viewed from rear) in global blast panel GL1: out-of-plane displacement, U_z , and strain in the y -direction, ε_y ; and section plots showing the variation of U_z along the height of the panel at three locations along the length—right (R), centre (C) and left (L). Note the subpanel dimensions were 635×400 mm; however, a window height of 360 mm was imaged. (Online version in colour.)

Clearly visible from these images are residual cracks that were in place in the front glass sheet from blast testing. Also visible in these DIC images is the fact that wrinkling has taken place in the front skin, mainly due to discontinuity across the facesheet as a result of the skin cracking. This is an interesting feature, as it shows that the two facesheets still maintain some connection through the foam, so not all out-of-plane displacement is away from the centreline.

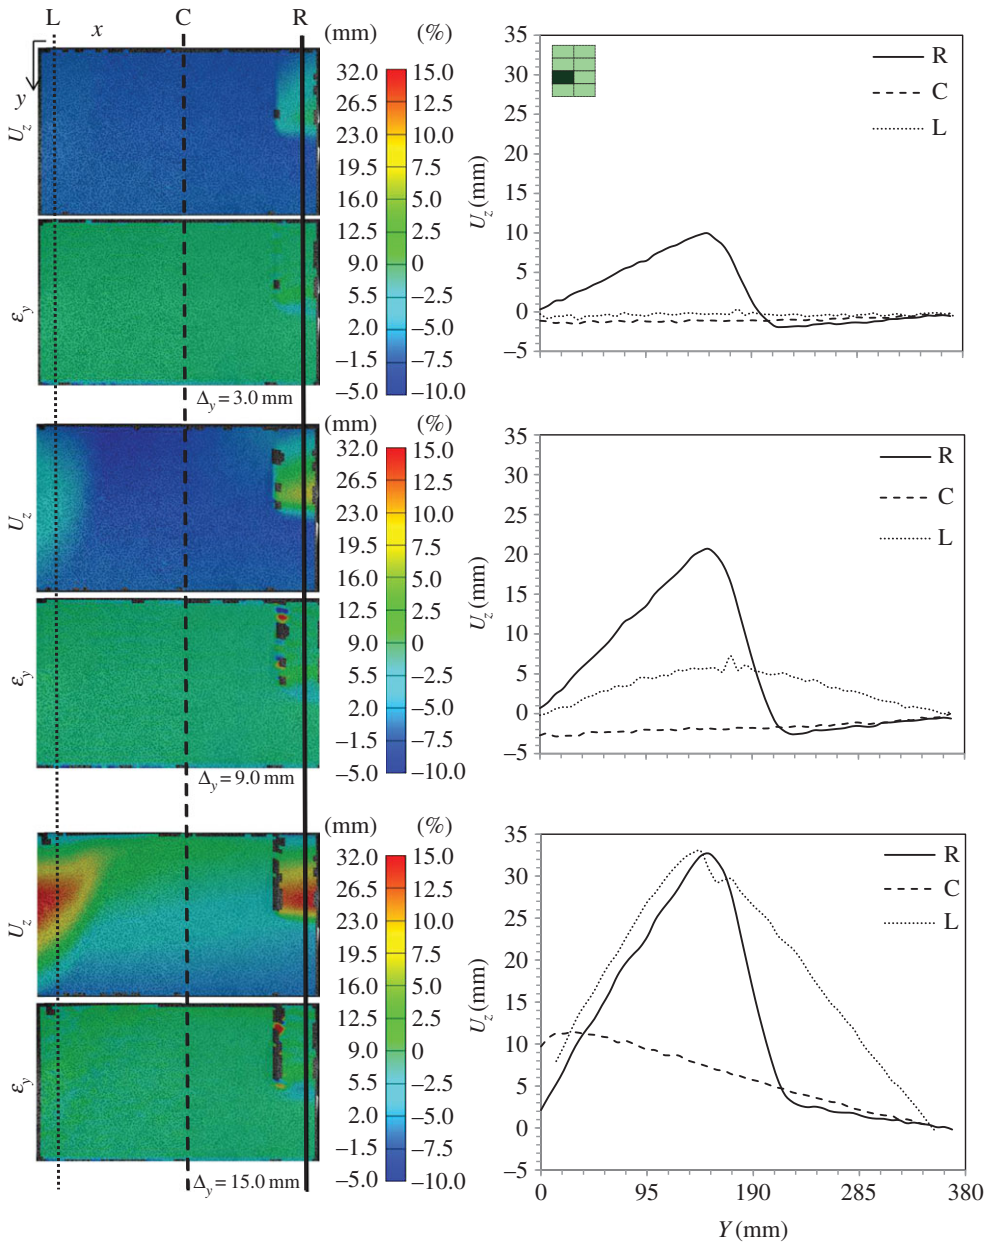
Figure 17. DIC analysis for subpanel 3L in global blast panel GL1: out-of-plane displacement, U_z , and strain in the y -direction, ϵ_y , and section plots showing the variation of U_z along the height of the panel at three locations along the length—right (R), centre (C) and left (L). (Online version in colour.)

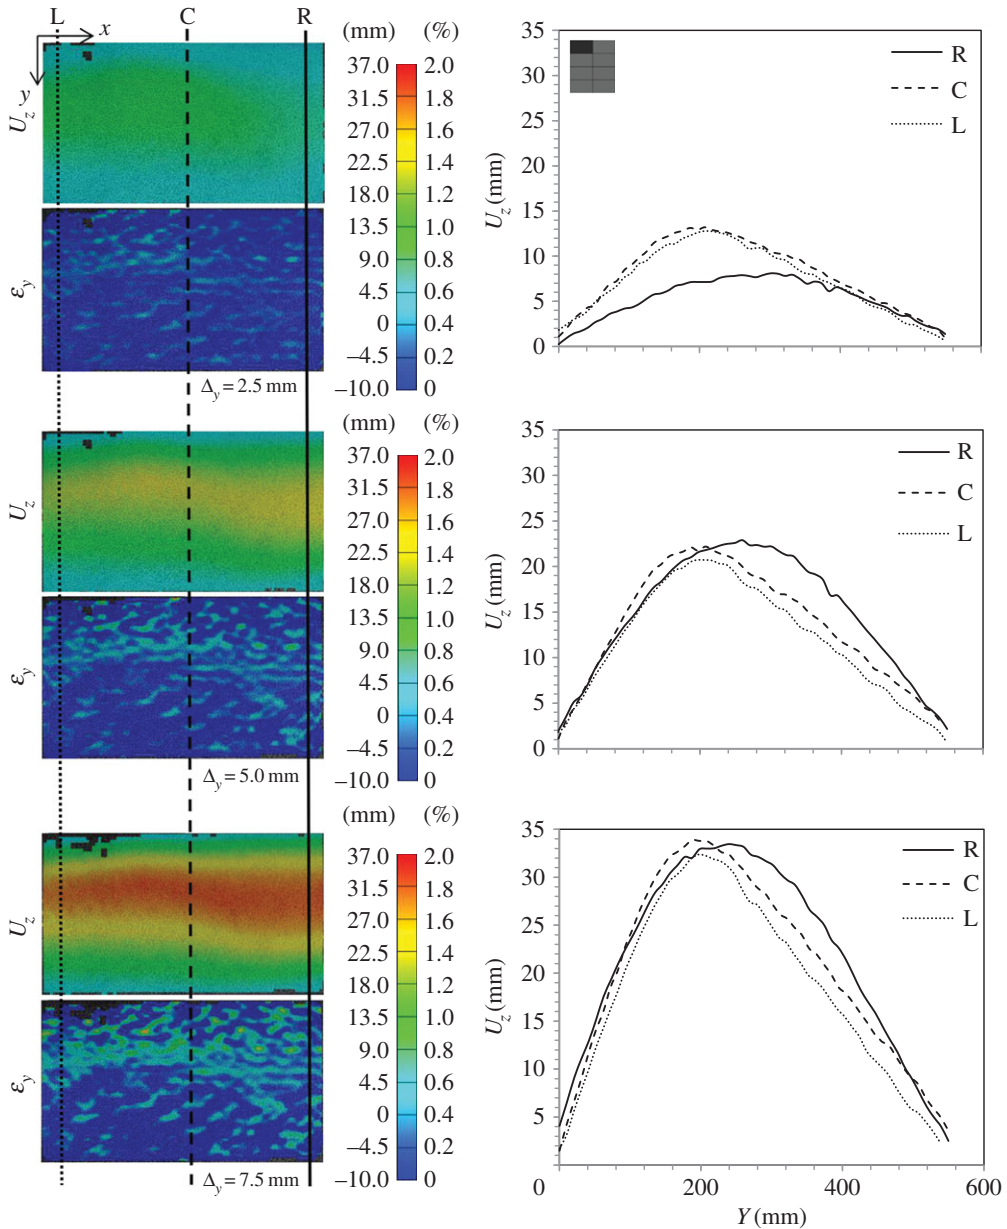
Figure 20. DIC analysis for subpanel 1L in global blast panel CA1: out-of-plane displacement, U_z , and strain in the y -direction, ε_y ; and section plots showing the variation of U_z along the height of the panel at three locations along the length—right (R), centre (C) and left (L). (Online version in colour.)

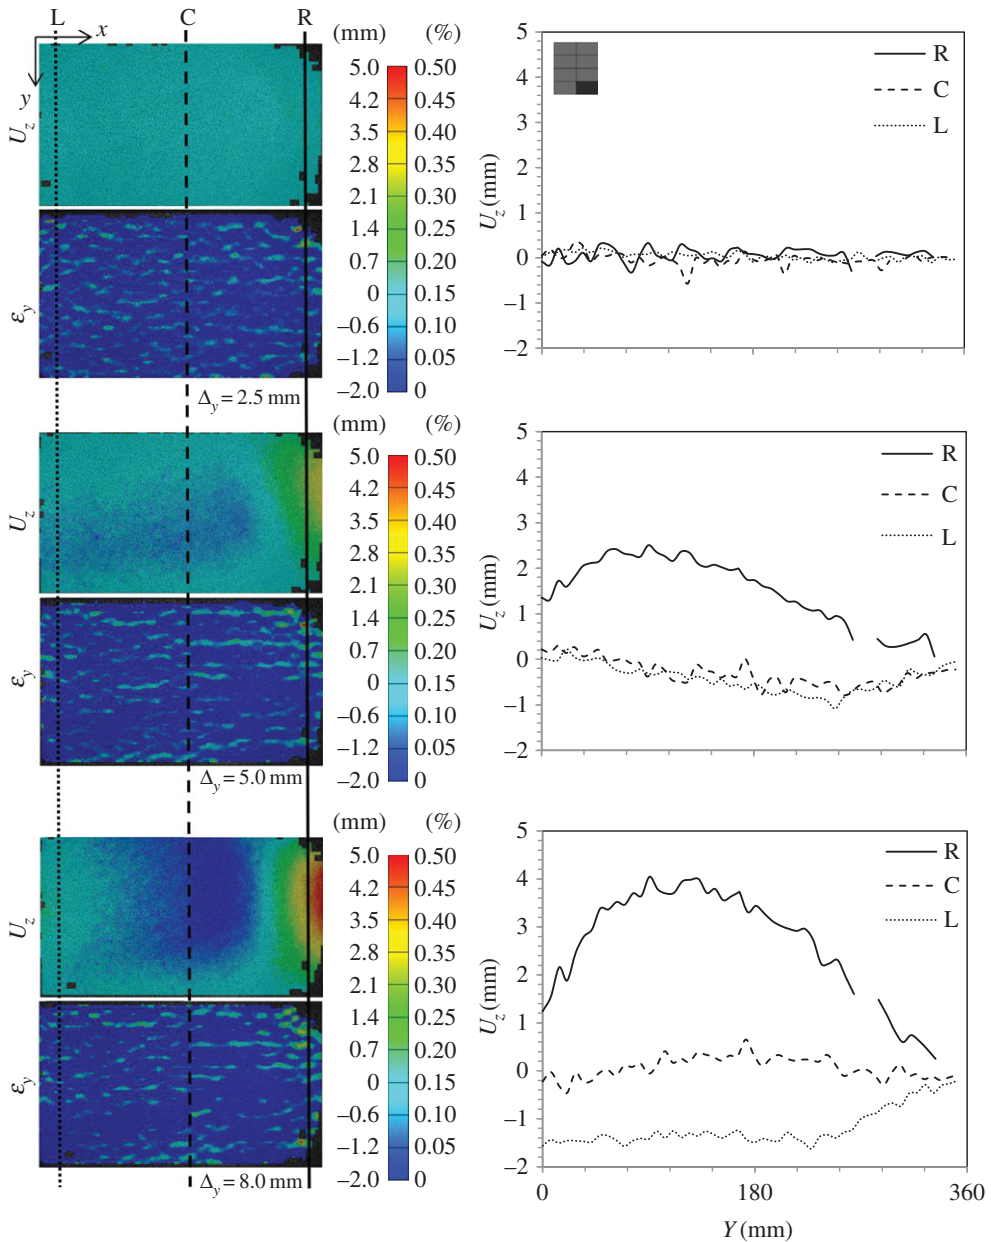
Figure 21. DIC analysis for subpanel 4R in global blast panel CA1: out-of-plane displacement, U_z , and strain in the y -direction, ϵ_y ; and section plots showing the variation of U_z along the height of the panel at three locations along the length—right (R), centre (C) and left (L). (Online version in colour.)
