Analysis of a Centreline Failure of a Lead Alloy Anode used in the Copper Electro-Winning Process

A. Elrefaey, Y. Gu, J.D. James, C. Kneen, I. Crabbe, J. Sienz

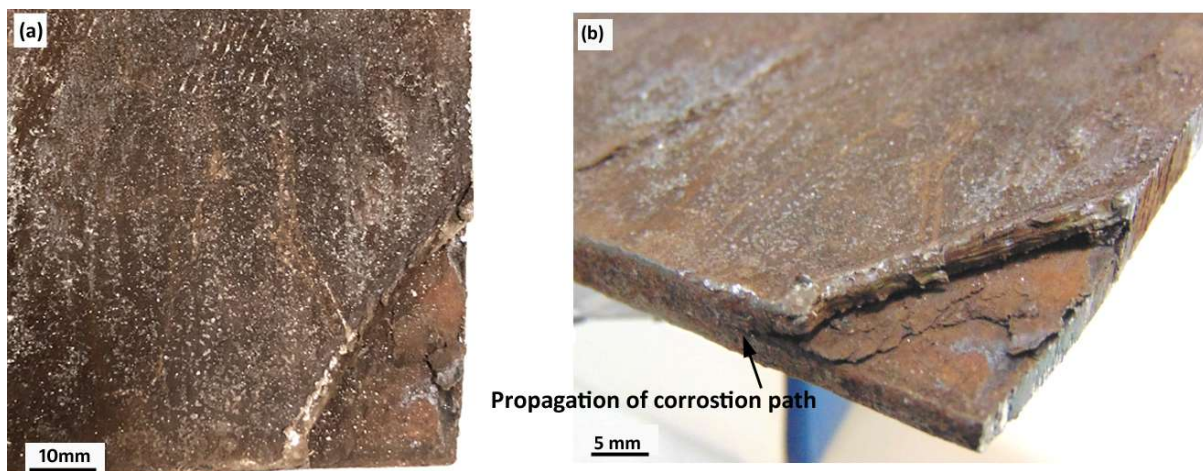
The limits for lead anode composition as given by anode manufacturer contains Ca (0.05 - 0.075), Sn (1.4-1.6), and traces of other impurities. The failed anode sample was received as shown in Fig. 2. The sample was in sheet form, 140 x 70 mm and 6 mm thick. There was general corrosion to the surface and some deep pitting corrosion to both sides. Additionally, the sample had split at almost the centre of the sheet as clearly shown in Fig. 2. The thickness of received sample has a clear indication that the sample has not in service for long time.

Fig. 2 Sample cut from failed anode (a) viewed perpendicular to anode surface; (b) illustration of the centreline failure path. The full thickness of the anode is 6mm.

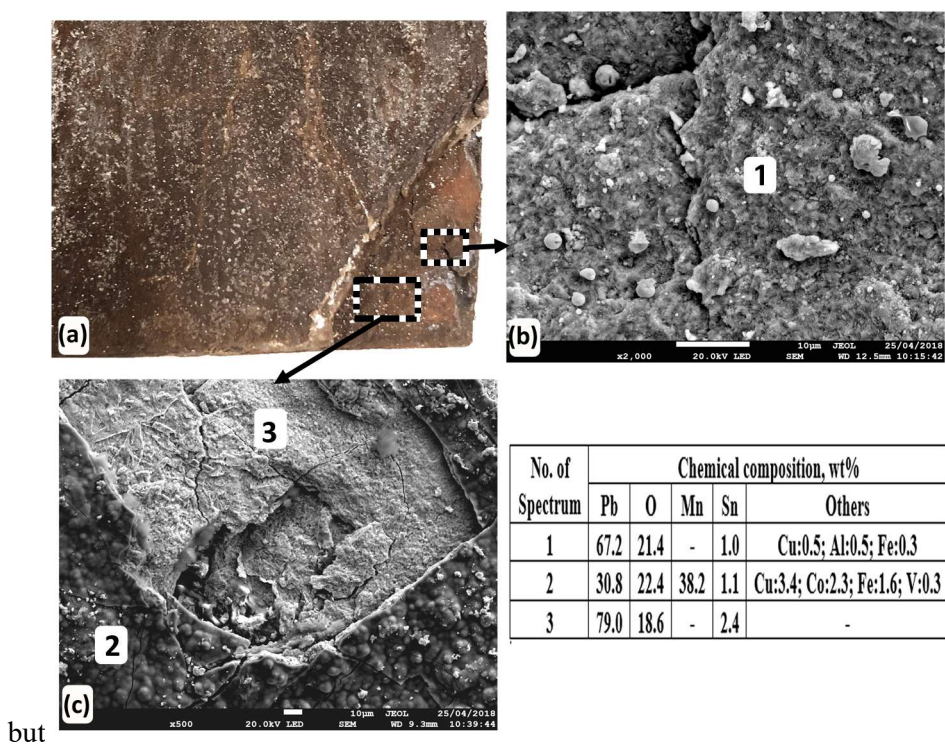
Fig. 3 shows the SEM image and EDS analysis of the pit and general areas at the fracture surface, indicated by dashed areas. It is clear that the pit area (spectrum 1) mainly consists of lead and oxygen. Carbon is present but difficult to accurately detect because it is light metal and its signal may arise from the contamination deposited during analysis[16]. Sulphur is also existing but difficult to identify since the peak of sulphur overlaps with the peak of Pb[17]. Therefore, lead oxides, lead sulphate, and lead carbonate are the possible existing phases. Meanwhile, the general area of the same surface, outside of pit area, showed a different structure. Manganese was detected by high percentage (spectrum 2) in addition to all elements present at the pit area. Taking into account the change in surface morphology outside the pit area, as shown in Fig. 3(c), there is a replacement of the lead oxides by manganese dioxide. The manganese dioxide layer had in some cases broken down, revealing the surface underneath containing the lead oxides (spectrum 3).

Fig. 3 (a) Failed region of anode, (b), and (c) SEM views of the two specified areas

Manganese is usually found in the cell as a result of its natural presence in the ore containing copper. This element is frequently reported to be harmful for the copper electro-winning process and should be removed in so far as is practicable [19-20]. The formation of manganese dioxide on top of the lead dioxide passivates the lead anode and inhibits the oxygen evolution reaction [21]. Furthermore, the manganese dioxide is formed as thick scales, which can easily become detached. These scales are damaging to the anode, could potentially cause an electrical short, and also increase the likelihood of cathode contamination. The above is demonstrated by the unattached manganese dioxide layer as shown in Fig. 3c and is detrimental to the electro-winning process.

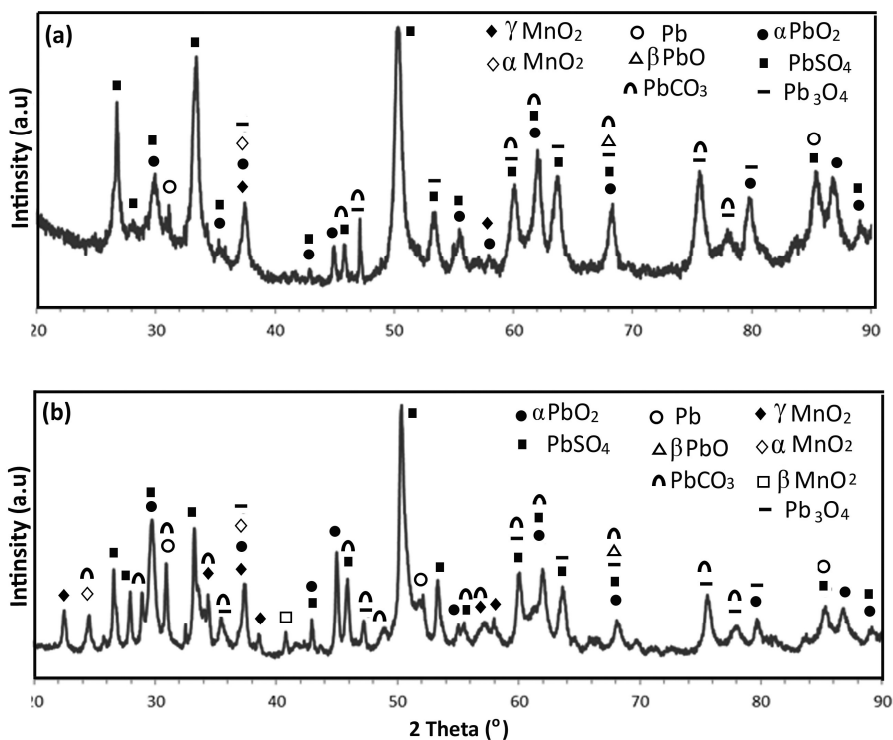
The XRD analysis gives information on which compounds or phase do exist at the different areas of fracture surface. Fig. 4 shows the peak pattern of the anode at the pitting area (a) and normal fracture surface area (b). The pattern showed a typical high crystallite material since the peaks are quite sharp. The formed phases have separated but closely allied crystallographic characteristics. Hence, it is quite hard to distinguish owing to the partially overlapping peaks. Through the matching with the data base, different corroded compounds were detected and confirmed. Pit area showed several peaks of phases such as Pb, α PbO₂, Pb₃O₄, PbSO₄, PbCO₃, and hardly peaks of β PbO₂, γ MnO₂, α MnO₂. While the normal surface of fracture area showed similar peaks to the one detected in the pit area but the manganese dioxide peaks were more prominent. It is worth mention that MnO₂ showed abundant structural flexibility and existed in several crystallographic polymorphs such as α -, β -, and γ -MnO₂ [18]. The normal fracture surface area detected more peaks of the γ -MnO₂. This result in agreement with our finding by EDS analysis.

Figure 4: XRD patterns at pitting area (a) and normal fracture surface (b)

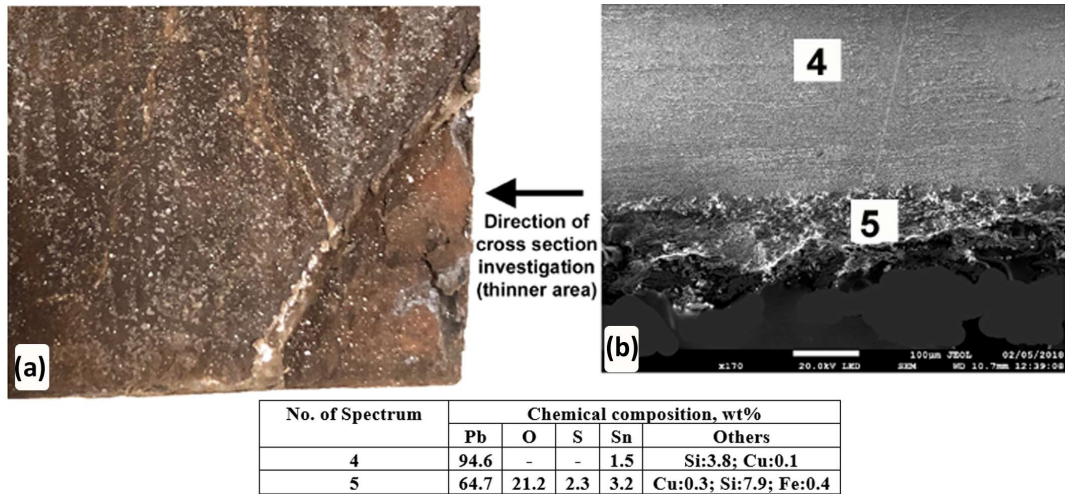
Fig. 5 depicts the polished cross section investigation at the fracture surface towards the thinner area and the corresponding EDS analyses. Corrosion products containing lead, silicon, tin, iron, sulphur and copper oxides were accumulated at the edge of the sample, while the main content of the anode base material is lead, with few other elements. Investigation of the thicker area showed the formation of similar kinds of oxides.

Fig. 5 Propagation of corrosion products at the centre of anode with EDS analyses

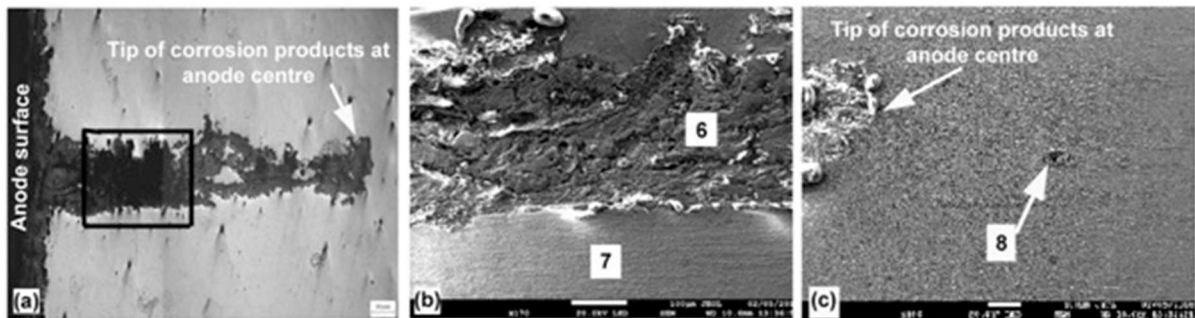
Fig. 6 illustrates the propagation of corrosion products at the centre of the lead anode before fracture. The macrostructure view corresponds to this crack path as previously seen in Fig. 2b. Corrosion products are composed of lead, silicon, and tin oxides (points 6, 7 and 8 in Fig. 5). Slightly ahead of the tip of the corrosion, traces of corrosion products were also detected (point 8). This indicates that the anode centre is the preferable location of the corrosion path. No corrosion products were detected in the rest of the sample.

Fig. 6 Propagation of corrosion products at the centre of anode with EDS point analyses; (a) optical microstructure showing the corrosion products at the centre of anode; (b) SEM of the rectangular area in Fig. 5(a); (c) traces of corrosion products at the extension of corrosion tip.

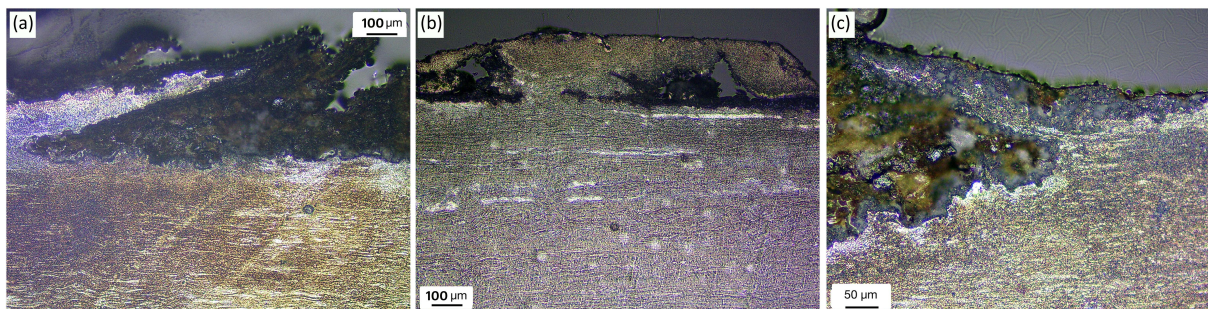
It is noted that at the edge of the failed samples' cross section, there are obvious lifted surface layers as shown in Fig. 7. In these areas corrosion attack is taking place through the layer of the rolling structure, which results in the removal of layers of metal. This kind of corrosion attack is known as exfoliation corrosion and has previously been observed in aluminium alloys [22-25].

Fig. 7 Examples of lifted material areas at the edge of failed sample.

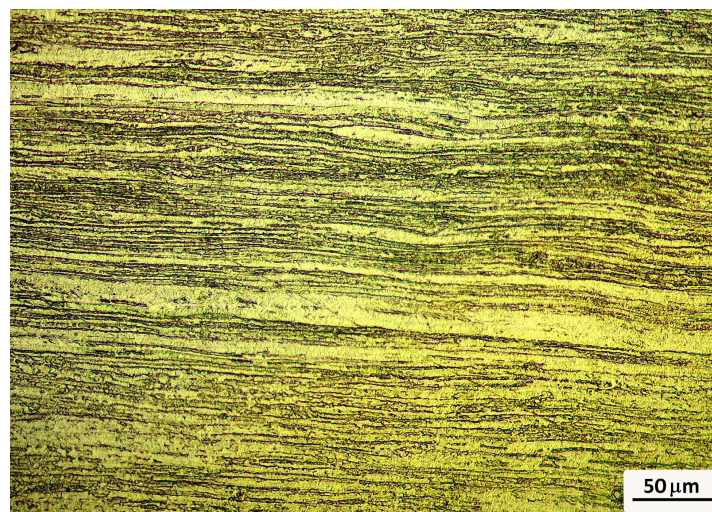
The microstructure that is most susceptible to this type of attack is the layered or elongated grain structure. It is reported that the grain aspect ratio of the material is one of the main variables to be considered in respect of exfoliation corrosion [22,24-26]. The higher the grain aspect ratio, the greater the susceptibility to exfoliation attack. It was observed that the most aggressive attack was initiated at the centre of the plate [27]; this corresponds to the centre of the lead anode where the grains are more elongated, as previously observed in Fig. 6. More elongated grains are associated with a long and tortuous corrosion path, as well as slow development and consequently maximum value of the corrosion product force [28]. Fig. 8 shows the severe elongation of grains at the anode centre.

Fig. 8 Microstructure of anode at the centre.

Although, as mentioned previously, anodes are rolled during their manufacturing process to improve their mechanical strength and corrosion resistance, the rolling processes of the plate increase the deformation and grain thinning toward the centre of the plate, which makes its microstructure more susceptible to exfoliation corrosion. Strains build up slowly in the grains with a high aspect ratio, and when the strains exceed the fracture strength of the materials, the grains start to break open and exfoliation starts [29].

Extensive rolling of the anode is probably the main reason for the susceptibility of the material to exfoliation corrosion. To counter this, it would be possible to lower the aspect ratio of the grains by reducing the thickness of the initial slab that is the starting point for rolling, thereby avoiding significantly stretched grains in the final product. It is however noted that SnCaPb anodes are deliberately rolled with a reduction in excess of 70% for specific performance related reasons [30-31]. Where contaminants are able to be kept to low levels the benefits resultant from high rolling reductions can be realised, where manganese or other contaminants are expected to be present, lower rolling reductions could be considered.
