Influence of uniaxial deformation on surface morphology and corrosion performance of chromium-based coatings for packaging steel

Jordan Whiteside¹, Dr Arnoud C.A. de Vooy², Dr Elizabeth Sackett¹ and Prof Hamilton Neil McMurray¹.

¹ Swansea University, Swansea, United Kingdom, ²TATA Steel Europe, Ijmuiden, The Netherlands

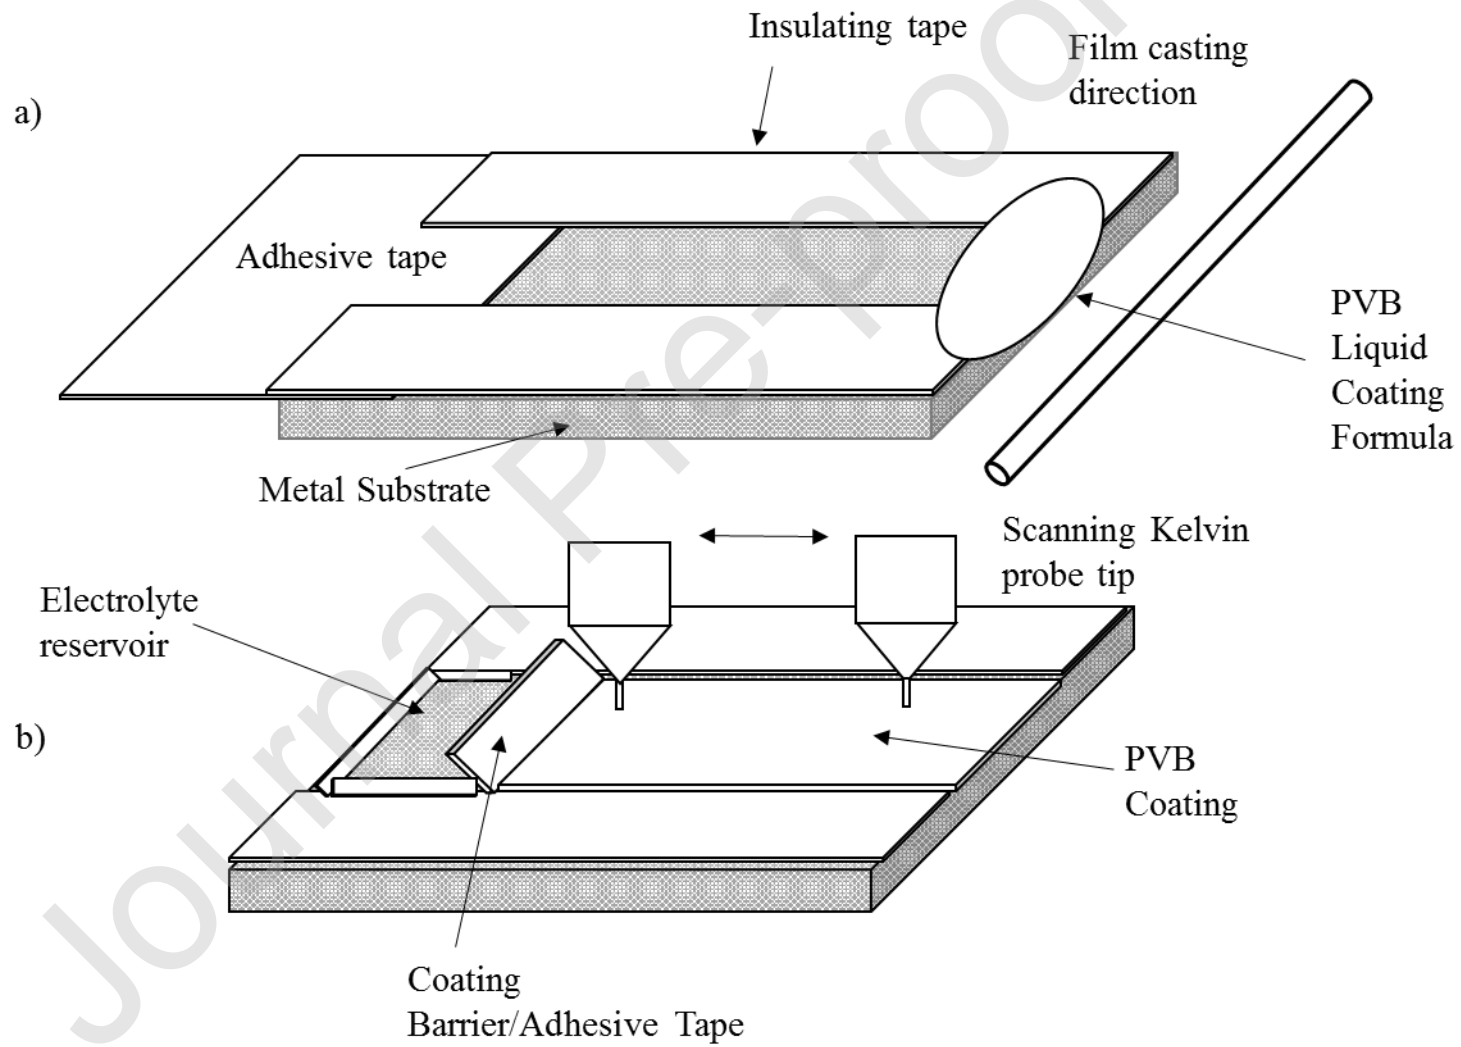
Figure 1 Representation of a) PVB bar coating and b) the final Stratmann cell with the defect and electrolyte well created.

For cathodic disbondment experiments the preparation of the samples followed a well-established methodology [1-2,16-21]. Fig.1. displays a representation of the sample preparation. Strained tensile specimens of the coated steels were cut into 30x20mm samples using a sheet metal guillotine. The samples were sectioned from the region measured by the extensometer (Fig.3). All samples were degreased before any experimentation. Adhesive clear tape, measuring 12mm x 20mm was placed over one edge

of the sample, followed by two strips of PVC tape with a thickness of 50 μ m, placed adjacently to either side of the clear tape. Exposed on the sample was a central 10mm strip of the uncovered surface. PVB solution was used as the model organic coating during the cathodic delamination study. Using a glass rod, the samples were bar coated with a 15% w/w PVB and ethanol solution. The PVB coating thickness was determined by the PVC tape adhered to either side of the 10mm exposed surface. The well for the cell was created by cutting down the sides of the border between the PVC tape and clear tape with a scalpel, leaving an uncut section of 0.5mm to the edge of the 10mm exposed area. The cut area was lifted from the surface and cut off, leaving a clear tape lip at the edge of the exposed area. The electrolyte well was sealed by coating silicone rubber, supplied by RS Components Ltd.

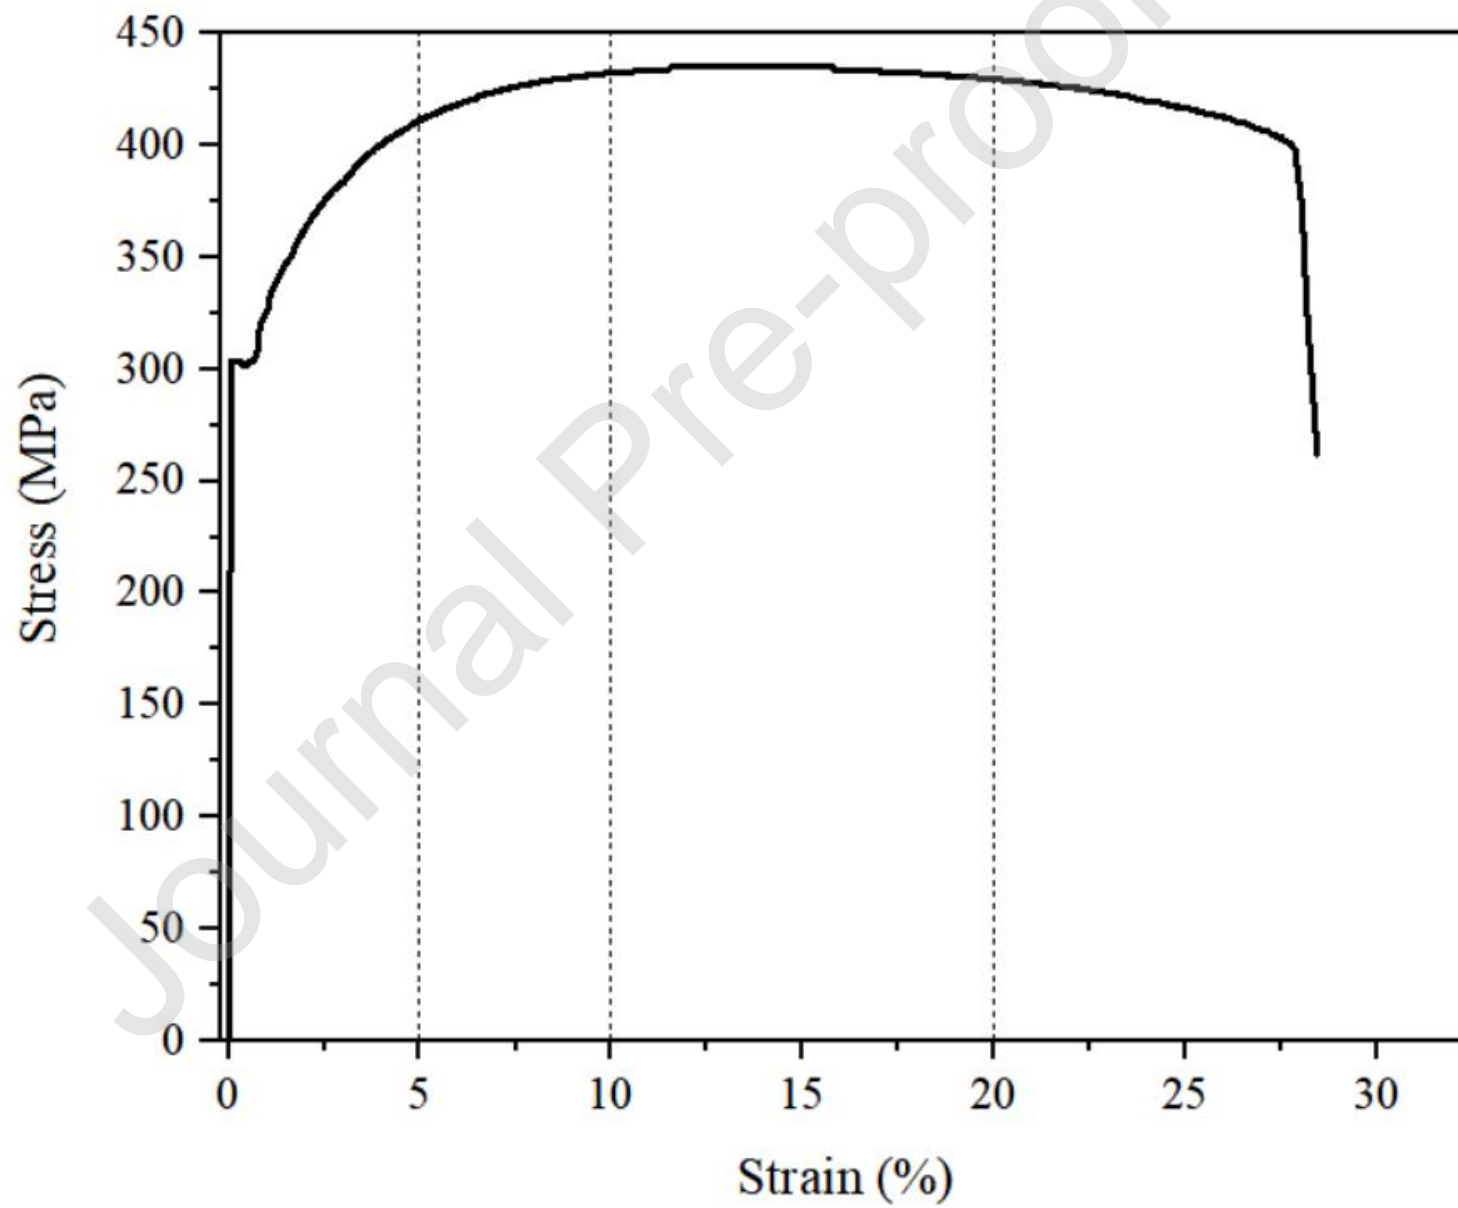
Figure 2 Typical Stress–strain curve of a tensile test for electro-chromium coated steel (ECCS)

The samples were uniaxially deformed to 5%, 10% and 20% strain using a Hounsfield/Tinius Olsen tensile tester and extensometer. A typical stress-strain curve of a Cr(III) coated steel samples, shown in Fig.2, identifies the elongation points of the strain values chosen. The tensile samples were dog-bone shaped and had a gauge area of 60 x

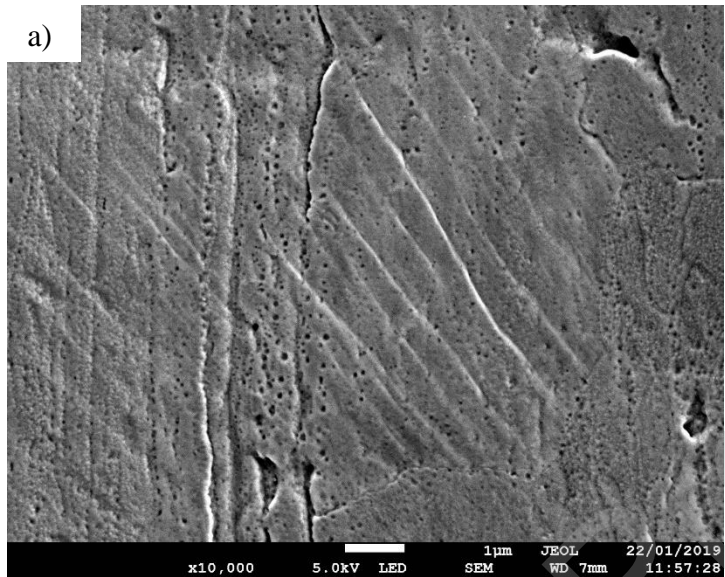
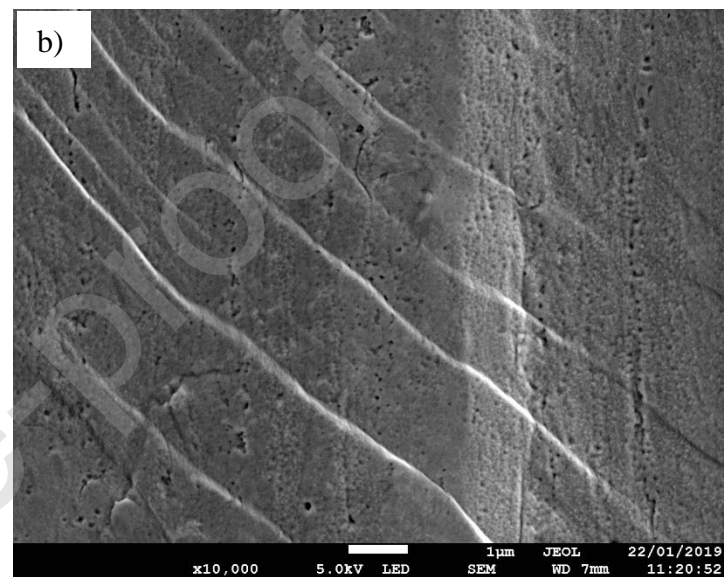
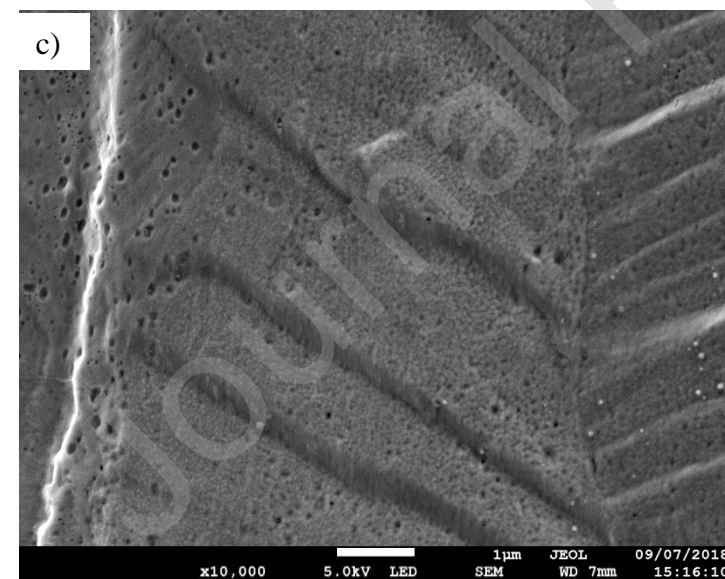
Fig.4 shows the surface morphology of ECCS post elongation at various percentage strains. Bands on the surface, forming at 45 degrees to the applied tension in the y-axis, intensify with increased strain. These surface features have been reported by X. Zhang, where they are identified as Lüders bands or localized areas of plastic deformation in the underlying steel substrate caused by discontinuous yielding [8]. No visual cracking is identified from

these band formations for ECCS samples. However the underlying substrate may still be exposed due to the formation of the slip bands cutting through the Cr layer. Defects seen on the surface are caused by the plating process and the penetration of features from the underlying steel. Elongation is not considered the cause for the discussed defects, due to the surface of 0% strain demonstrating similar imperfections. It may be assumed that these scratches are defects in the underlying steel, penetrating through the tin coating. ECCS does not show any cracks where the Lüders bands push through the surface. As ECCS is usually epitaxial to the substrate it may be assumed that they deform as one with the underlying steel. It is proposed that if no Cr is spread out over the surface during the process of straining, then it is expected no iron will be exposed at the features as long the steps in the y axis of the steel are smaller than the thickness of the Cr layer.

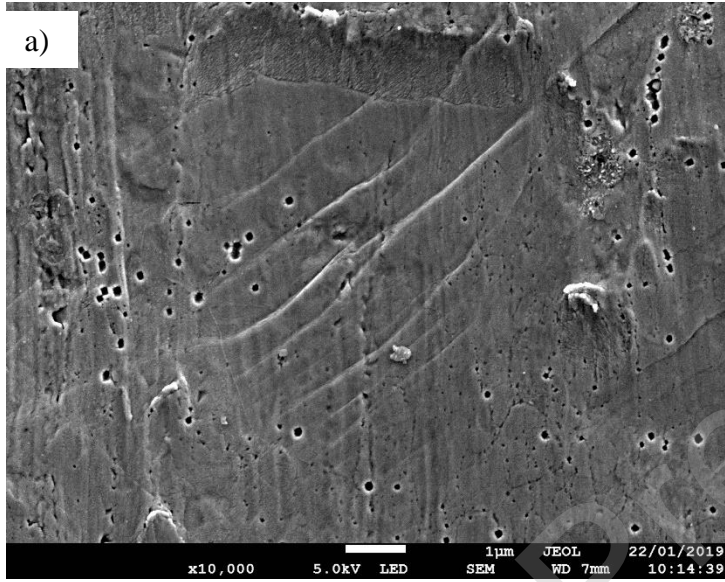
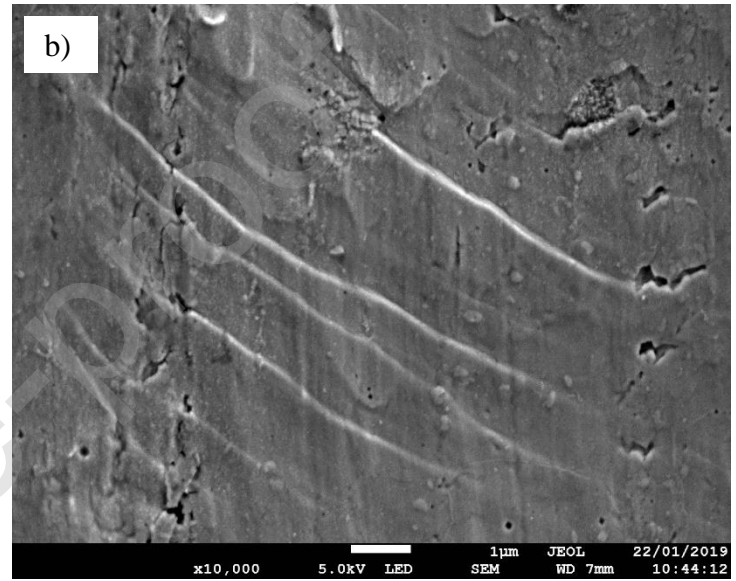
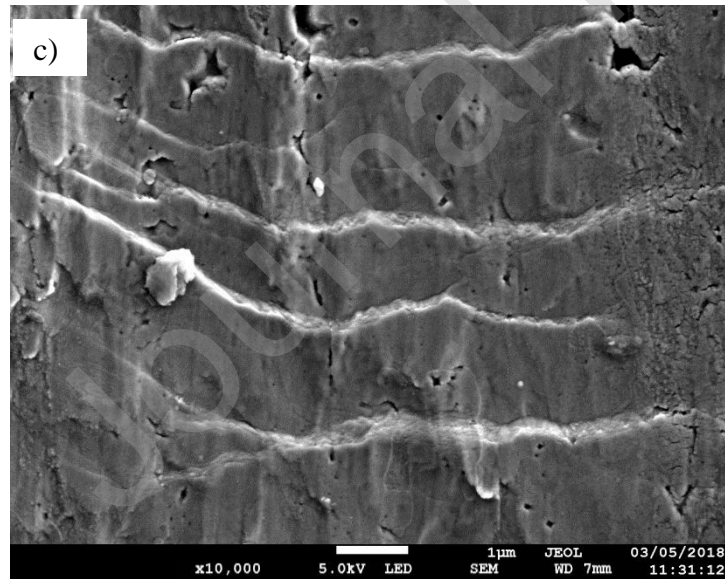
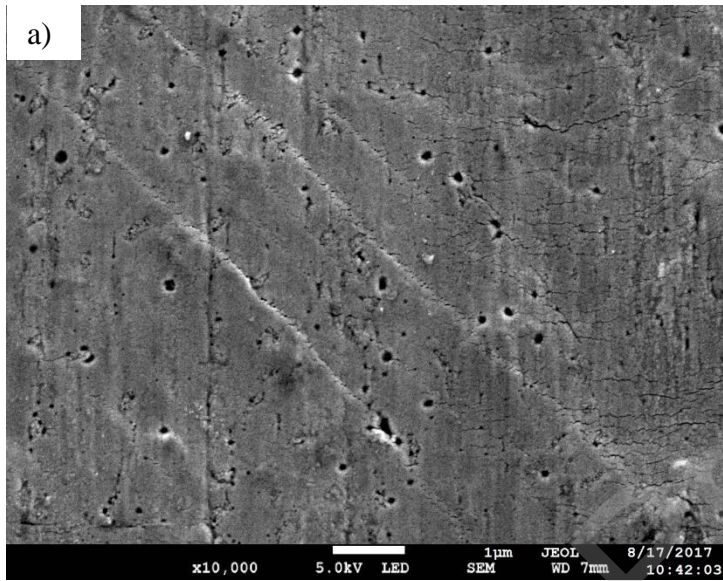
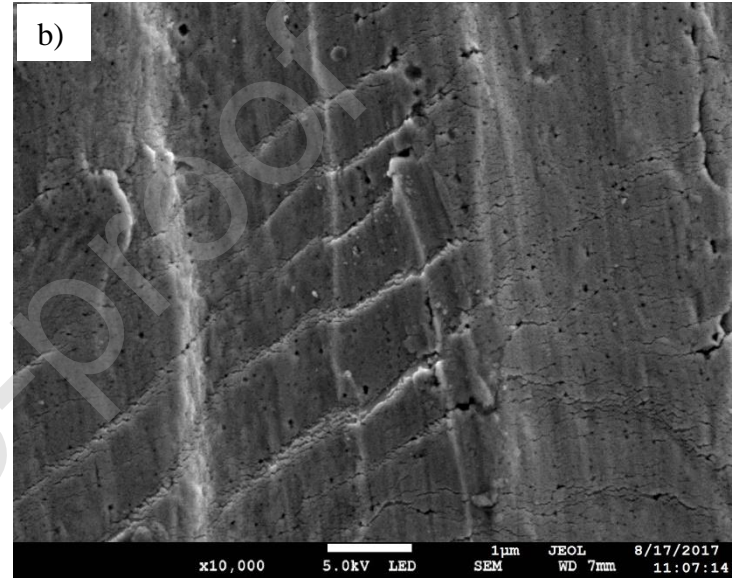
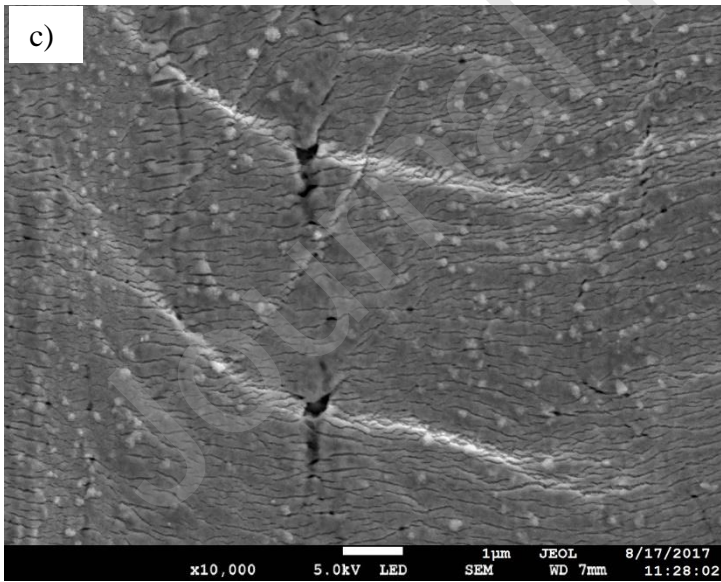
The SEM images in Fig.5-6 illustrate that the more deformation which is applied to the Cr(III) layer, for both the low (4mg/m^2) and high (19mg/m^2) Cr(III) oxide Cr(III) coatings, the more cracking appeared on the surface. Cracking on the outer surface of the samples appeared in bands, 45 degrees to the direction of force applied. The high Cr(III) oxide coating in comparison to the low Cr(III) oxide coating showed a higher value of interlinking smaller cracks, from the 45-degree bands. This feature could be attributed to the higher Cr(III) oxide content of 19mg/m^2 , resulting in a higher degree of brittle cracking. Cracking of the coating however does not suggest the exposure of the underlying steel to a corrosive electrolyte due to the thickness of the oxide layer applied.

For low and high Cr(III) oxide coatings cracking formations are seen on the 5% strain samples. At 10% strain, little change is seen when compared to 5% strain for the low oxide coating. However for the high Cr(III) oxide coating visible cracks appear, due to the increased roughness caused by an increase in deformation. The amount of cracking increases between 10% and 20% for both samples; however, the cracks on the surface of the high Cr(III) oxide coating show regions of interlinking. A high density of tiny cracks are seen to cover the whole coating surface of the high oxide sample strained to 20%. The cracking is not only confined at the Lüders bands, but also is present in the areas between the features

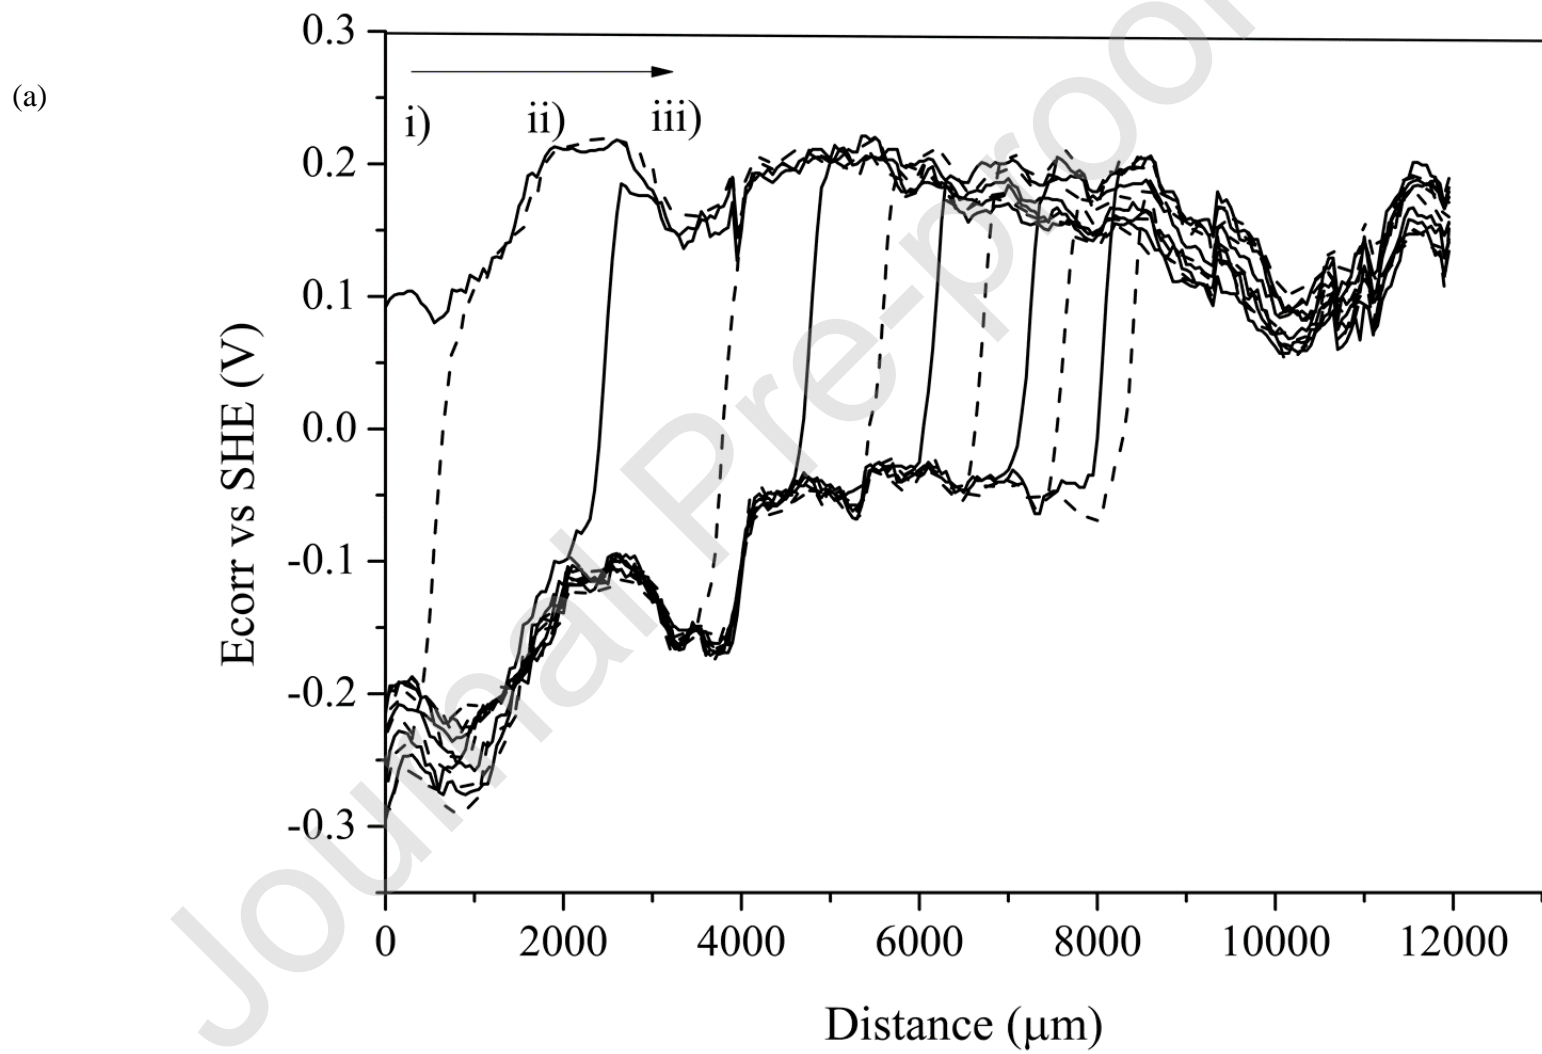
Figure 7 (a) SKP derived E_{corr} vs distance (x) profiles for pure iron overcoated with a $30\ \mu\text{m}$ PVB film, held in air at 95% R.H., initiated using $0.86\ \text{mol.dm}^3$ NaCl (aq.) applied to a penetrative coating defect. Time key i.) 0 mins ii.) 60 mins iii) 120 mins and 1-hour intervals thereafter. **(b)** Plot of delamination distance (x_{del}) vs time obtained for a pure iron sample overcoated with a $30\ \mu\text{m}$ PVB film, initiated using a $0.86\ \text{mol.dm}^3$ NaCl electrolyte.

Initial experiments were completed on pure iron to acquire a threshold of resistance to delamination in the absence of the electroplated chromium coatings. From the point of initiation of the experiment, the PVB overcoat began to delaminate, resulting in the $E_{\text{corr}}(x)$ profiles shown in Fig.7(a). The intact coating values for E_{corr} remained high and uniform at values between 0.05V and 0.22V vs SHE for 24 hours. Measured values are similar to studies previously completed [19]. At the point where the metal and electrolyte meet due to delamination, the E_{corr} value drops to -0.25V vs SHE after initiation. The recorded value is expected and in the region of active anodic iron at -0.44V vs SHE [15,19].

A plot of x_{del} vs $(t_{\text{del}} - t_i)$ for iron E_{corr} profiles were compiled and shown in Fig 7(b). The plot shows a parabolic curve identifying migration controlled disbondment kinetics [21].

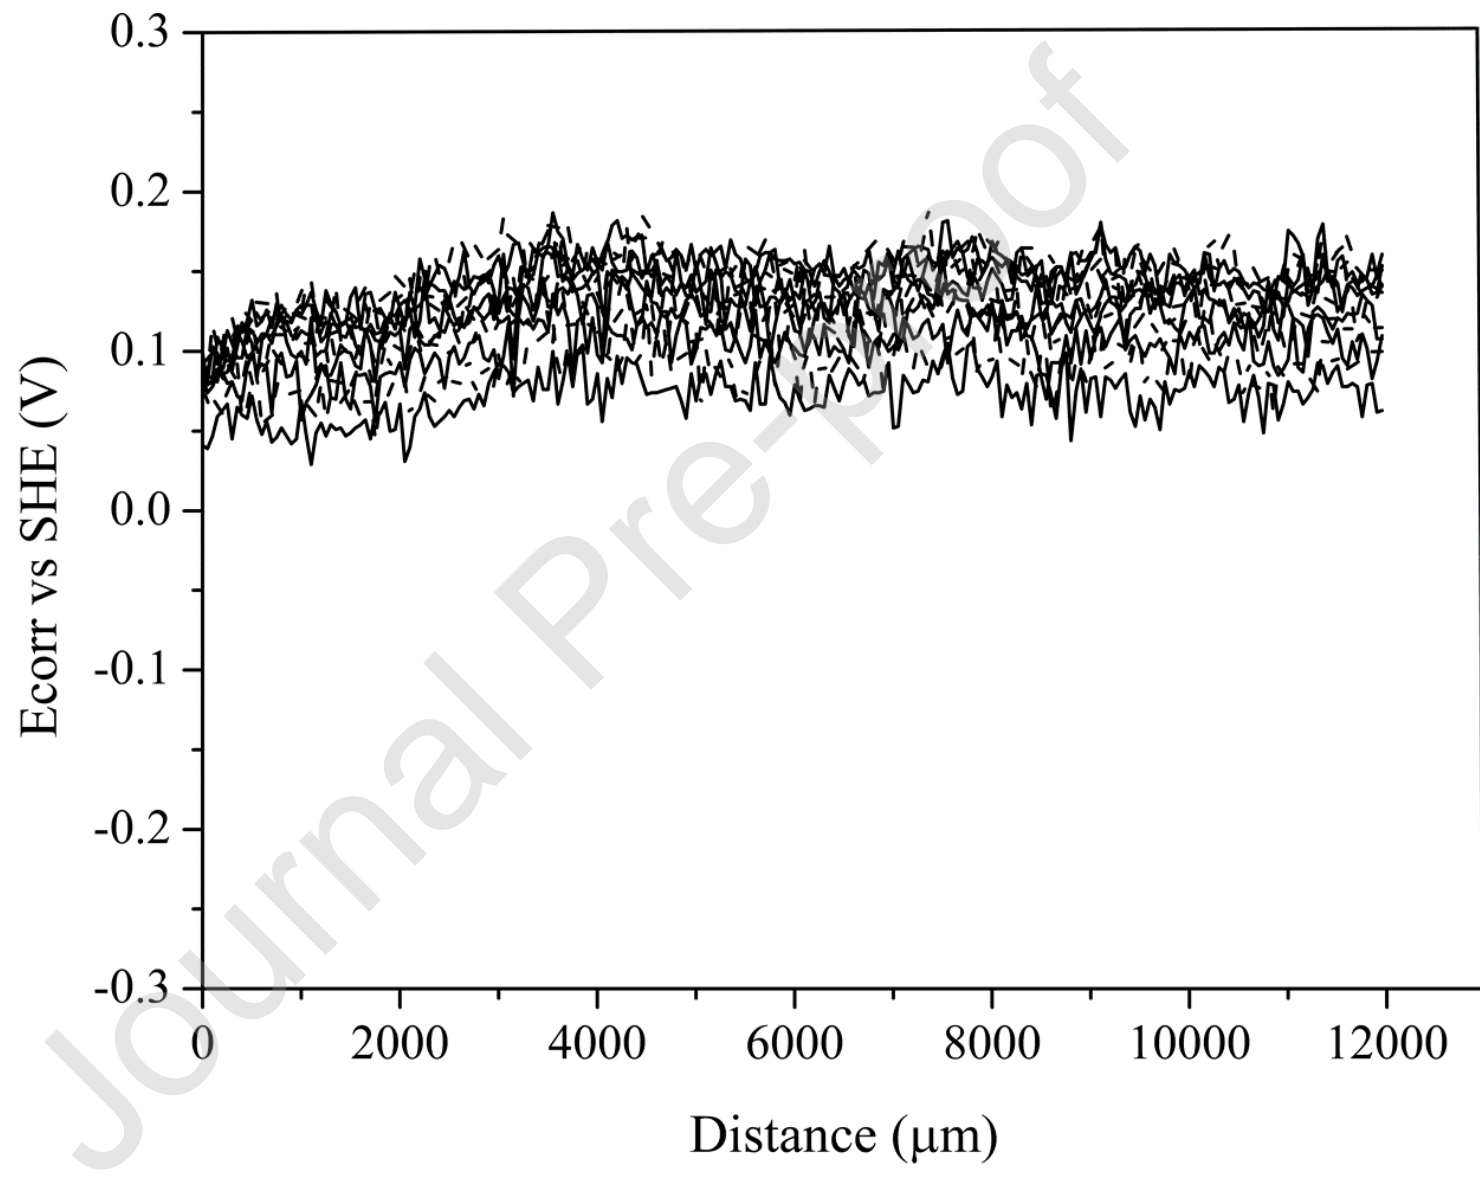
Figure 9 SKP derived E_{corr} vs distance (μm) profiles for high Cr(III) oxide (19mg/m²) Cr(III) coating overcoated with a 30 μm PVB film, held in air at 95% R.H., initiated using 0.86 mol.dm³ NaCl applied to a penetrative coating defect. Starting at 5040 mins, 2-hour intervals thereafter.

Cathodic delamination was observed for both the low ($4\text{mg}/\text{m}^2$) and high ($19\text{mg}/\text{m}^2$) Cr(III) oxide Cr(III) coating samples, however, at different values of elongation. The high Cr(III) oxide coating at 0% and 5% elongation observed the same E_{corr} potential plateau shown for all the ECCS samples, indicating no cathodic delamination over 96 hours. Fig.9 shows the $E_{\text{corr}}(x)$ profiles for 10% strain, high Cr(III) oxide coating, which are displayed from initiation time, followed by 4-hour gaps, over 24 hours of delamination. The data shows that the $E_{\text{corr}}(x)$ profiles are separated by a constant distance over the length of the

delamination experiment, suggesting linear kinetics controlled by electron transfer [21]. Electron transfer controlled delamination of a PVB overcoat on Cr(III) coatings have been shown by Wint [1]. Wint suggested delamination initiated on Cr(III) based coatings due to pinholes observed on scanning electron microscope images. The pinholes were suggested to expose the underlying steel, acting as defects in the coating. The high Cr(III) oxide coating showed no delamination when no deformation was applied. Therefore the only defects in the coating are the cracks formed post-deformation. Fig. 10 shows plots of delamination area vs time for 10% and 20% strain, high Cr(III) oxide coating. An increase in the delamination distance from 850 μm to 1050 μm occurs at a higher strain percentage. Differences between the intact and delaminated potential values are not present between the two deformed samples.

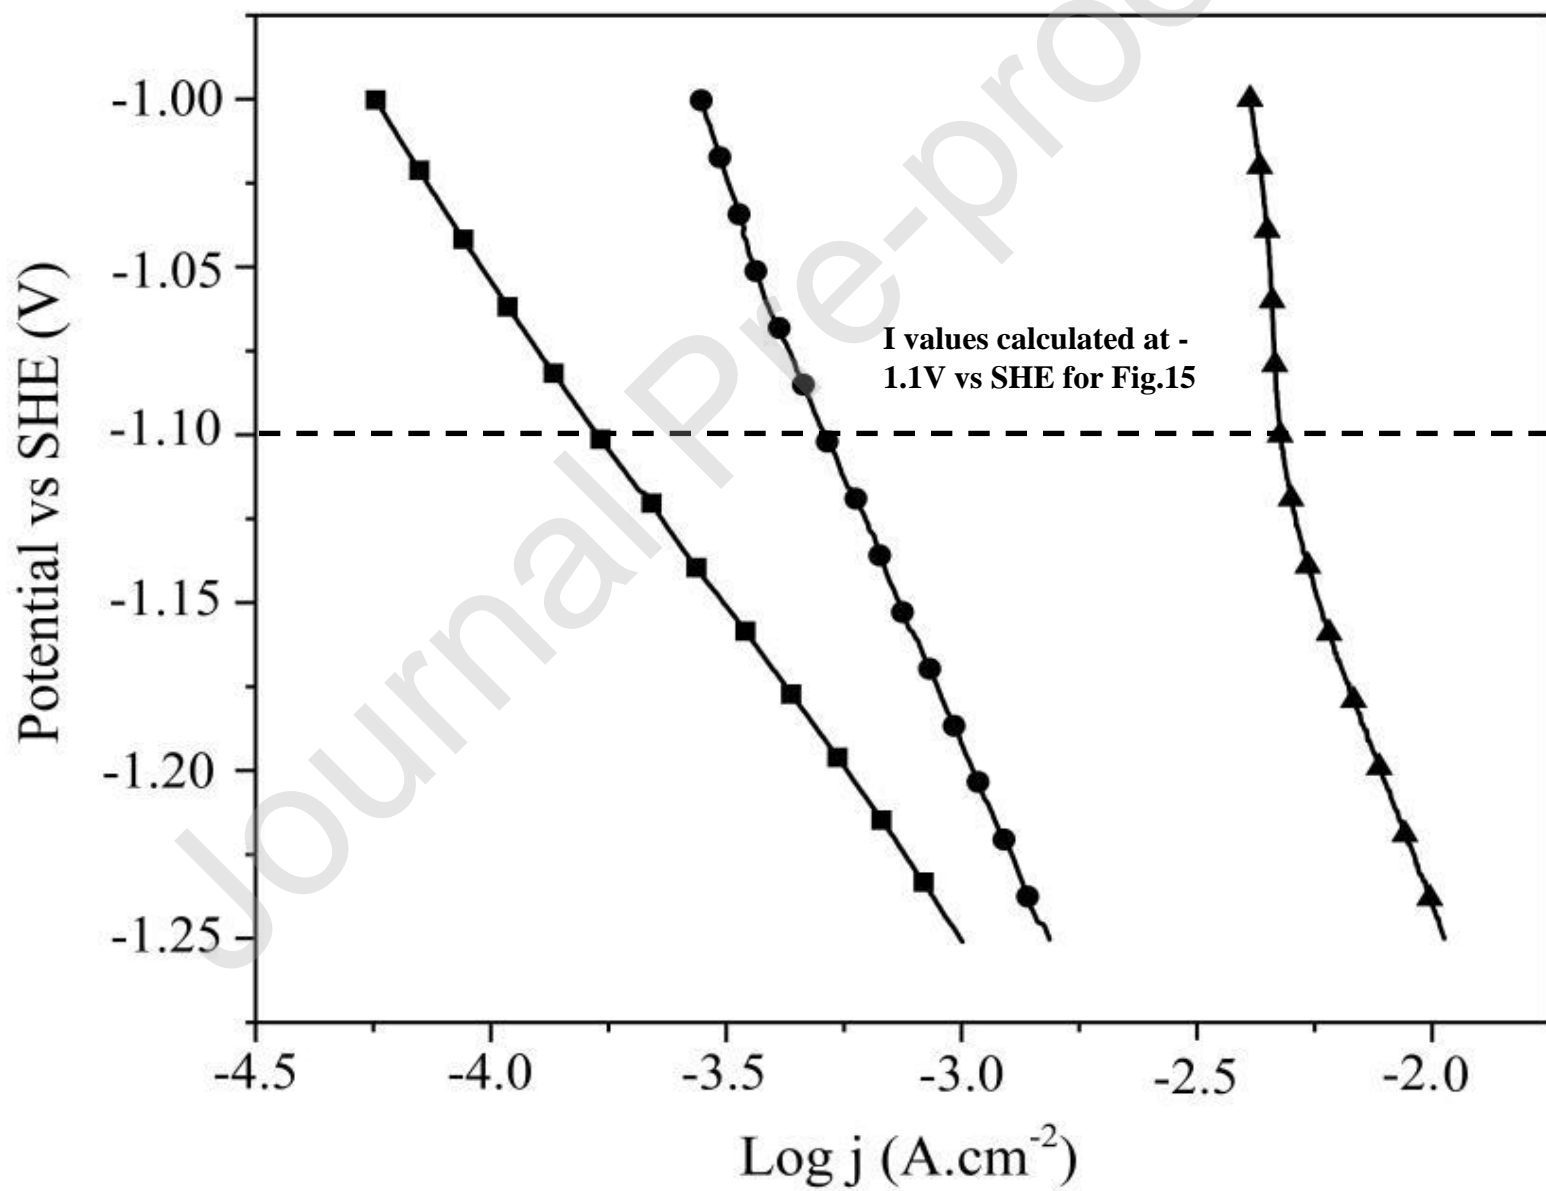
Figure. 14 Tafel plots of pure iron (▲) and low Cr(III) oxide (4mg/m²) Cr(III) coating, uniaxial strain 0% (■) and 20% (●) in a deaerated 0.5M Na₂SO₄ buffered to pH 9.3. Potential sweep rate 3.3×10^{-4} Vs⁻¹.

Tafel slopes for the hydrogen evolution reaction for Fe and low (4mg/m^2) Cr(III) oxide coating, with 0% and 20% applied uniaxial strain are shown in Fig 14. The Tafel slopes values are shown in Table 4. for all samples. A mechanistic hydrogen evolution reaction occurs in the following steps [25]:

The Tafel slope result for Fe in a sodium sulphate solution, buffered to pH 9.3, was -146 mv/dec. Studies by María R. Gennero de Chialvo and Abel C. Chialvo [29] recorded a similar result of -133.2 mv/dec in alkaline conditions.
