Corrosion fatigue and damage tolerance in the nickel-based superalloy RR1000 subjected to SO₂ environments

Martin Bache¹

¹Institute of Structural Materials, Faculty of Science and Engineering, Bay Campus, Swansea University, Swansea, UK

²Rolls-Royce plc, Derby, UK

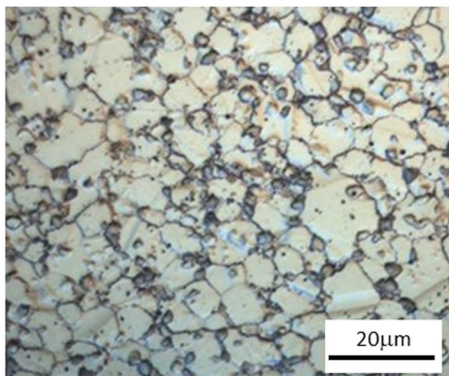
FIGURE 1 Fine-grained microstructure in RR1000. Near-equiaxed γ grains (light regions) with γ' particles decorating the grain boundaries [Colour figure can be viewed at wileyonlinelibrary.com]

The current investigation focussed on the nickel-based superalloy RR1000 in fine-grained microstructural form. Plain cylindrical and corner crack test specimens were machined from a RR1000 forging. Proprietary thermomechanical processing and heat treatment had generated a standard fine-grained microstructure with an average grain size of 8 μm plus trimodal distribution of γ' strengthening particles (i.e., coarse primary γ' particles decorating the grain boundaries, with finer scale secondary γ' and tertiary γ' precipitates evenly distributed inside the grains). The grain size was measured using a standard line intercept method applied to multiple two-dimensional (2D) digital images (ASTM E112-10). The typical γ/γ' microstructure is illustrated in Figure 1; however, much greater detail on RR1000 thermomechanical processing and microstructural evolution, including resolution of the secondary and tertiary γ' particles, has been previously published by Mitchell et al.¹²

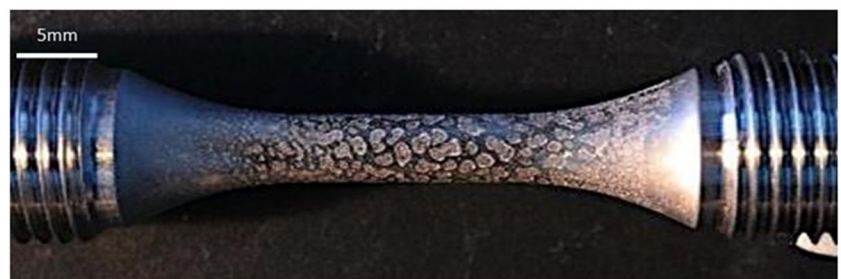
FIGURE 2 Example of a shot peened and salted LCF specimen prior to fatigue testing [Colour figure can be viewed at wileyonlinelibrary.com]

Alternatively, additional specimens were subjected to hot corrosion under zero applied stress prior to fatigue testing. All classes of “pre-corroded” specimen were initially heated to 100°C and sprayed with a sodium chloride salt solution (98% Na₂SO₄ + 2% NaCl dissolved in 45-ml methanol and 55 ml of water), resulting in a salt flux of 0.15 mg/cm². The typical appearance of such salted specimens after returning to room temperature is illustrated in Figure 2. Different hot corrosion sequences were then applied to selected salted specimens to provide the three classifications of specimen described in Table 1.

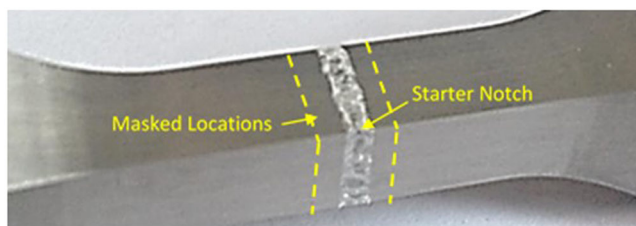
FIGURE 3 Pre-salted corner crack specimen employed for hot corrosion fatigue crack growth testing in a SO_2 gas environment [Colour figure can be viewed at wileyonlinelibrary.com]

Fatigue crack growth measurements, conducted to ASTM E647, employed 7×7 mm square section specimens containing a starter slit machined by a diamond wheel at the mid length position along one edge. The growth of the part through quarter circular crack was monitored using a pulsed DC potential drop monitoring system. Full background on the corner crack test technique, DCPD calibrations, and associated stress analysis can be found in previous publications.^{13,14} Largely influenced by the resolution of the digital voltmeter utilized for DCPD monitoring, instantaneous crack length was measured to an accuracy of $3 \mu\text{m}$.

Stage II Paris crack growth was measured using relatively fast “cyclic” waveforms (i.e., 5-Hz sine and 15 cycles per minute trapezoid). All corner crack propagation tests were performed under $R = 0.1$ at 700°C . Data are compared from as machined specimens tested under standard laboratory air and a hard vacuum ($<10^{-5}$ mbar) condition. A set of specimens was also subjected to pretest salting and exposure to the same flow of SO_2 during crack growth as described for the LCF assessment. An example of a pre-salted specimen is illustrated in Figure 3. To avoid freely initiated cracking during the hot corrosion testing, the specimen was masked during the application of the salt spray excluding a 2-mm-wide region, which encompassed the starter slit and predicted plane of cracking.

The same corner crack geometry was employed for fatigue crack growth threshold testing. A constant K_{max} /increasing R ratio technique was selected utilizing a 5-Hz sine waveform. The precise ΔK_{th} values were established as per ASTM E647 at a growth rate of 10^{-10} m/cycle, although selected experiments continued to even slower growth rates. The constant K_{max} technique¹⁵ was deliberately adopted to provide a lower bound measurement of ΔK_{th} (given the inverse relationship between threshold value and R ratio) utilizing a minimum number of available specimens. From the engineering perspective, this also presents a conservative approach.

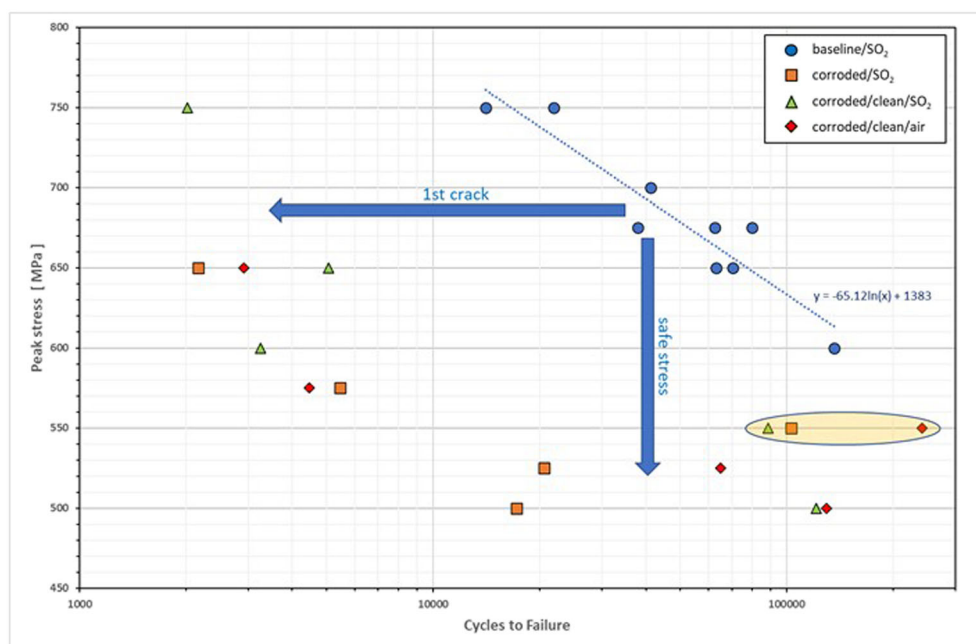
FIGURE 4 Low cycle fatigue behavior [Colour figure can be viewed at wileyonlinelibrary.com]

The LCF response of peened and salted specimens tested at 700°C in the SO_2 gas environment is plotted in Figure 4. A best fit trend line has been superimposed through this “baseline” dataset to help compare to the relative performance of pre-corroded specimens. The baseline data span lives of 10^4 to 10^5 cycles.

Compared with the baseline response, all pre-corroded specimens demonstrated a reduction in fatigue life irrespective of corrosion scenario. This can be considered either in terms of “life to first crack” or “safe stress” design and component lifing philosophies. In the first instance, for a given applied stress condition, the life of pre-corroded specimens is reduced by approximately one order of magnitude. For the latter, a reduction in stress of approximately 150 MPa induced an equivalent life to the baseline data. These relative shifts in performance are emphasized by the two schematic arrows superimposed on the SN graph.

The number of individual specimens available to define the SN curves for either dataset was limited. A degree of scatter was highlighted among the combined pre-corroded specimen data, noting that the classical inverse relationship between applied stress and cyclic life was not consistent. It appears that pre-corroded specimens performed in a similar manner irrespective of cleaning between the exposure treatments and whether the exposures incorporated a SO_2 or air environment.

Three anomalous data points are highlighted in Figure 4. These relate to three separate tests performed at a common normalized stress level of 550 MPa, where a relatively strong response was measured compared with the general SN curve for the combined pre-corroded specimen datasets. A common feature was noted during inspection of these three specimens prior to fatigue loading. The gauge sections had retained a continuous protective oxide layer across the surface, thus protecting the substrate from sulphide attack and corrosion pitting. An example is illustrated in Figure 12 and compared with the typical surface appearance displayed by the majority of corroded samples. The precise reason for such variation in corrosion response is unknown, particularly as the fatigue specimens were pre-corroded in batches, not

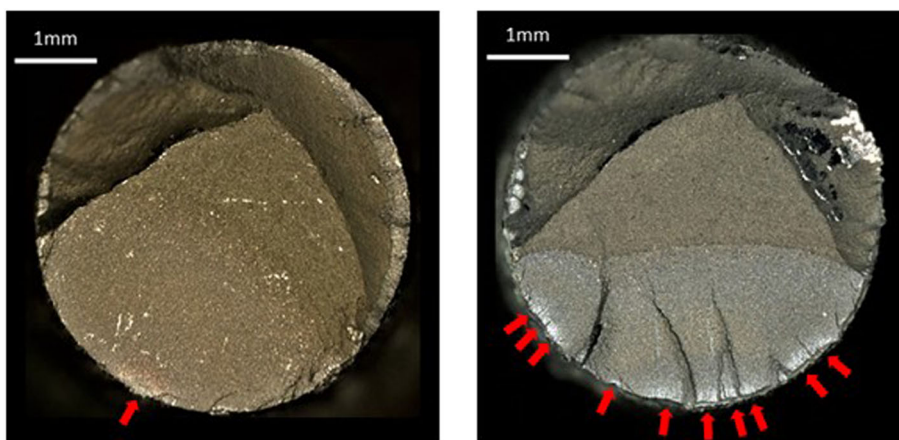
FIGURE 5 Typical fracture surfaces generated in (left) baseline specimen, $\sigma = 650$ MPa, $N_f = 63,271$ and (right) pre-corroded specimen ($\sigma = 650$ MPa, $N_f = 2,168$). Both tested in the SO_2 gas environment [Colour figure can be viewed at wileyonlinelibrary.com]

Inspection of the specimen fracture surfaces indicated that all specimens initiated multiple cracks from distributed surface corrosion pits. The example from a baseline specimen in Figure 5 illustrates that limited crack growth occurred from numerous individual shallow pits around the periphery of the gauge section, now exposed as a lustrous outer ring. Ultimately, crack growth dominated from a single pit (arrowed) on a distinct plane, forming a regular, elliptical final fatigue crack profile. The example from a pre-corroded specimen in the same figure displays an almost identical region of tensile overload to the baseline specimen. However, more extensive fracture has progressed from at least 10 pits distributed around the lower portion of the gauge circumference, with adjacent cracks on slightly different planes coalescing, forming steps on the fracture surface and an irregular final fatigue crack profile. This difference in pit to crack transition behavior was consistent for all baseline specimens compared with their pre-corroded counterparts. Notably, the two specimens illustrated in Figure 5 were tested at an identical stress condition ($\sigma_{\text{max}} = 650$ MPa). Significantly different fatigue lives were measured for these specimens, with the baseline specimen failing after $N_f = 63,271$ compared with $N_f = 2,168$ for the pre-corroded equivalent.

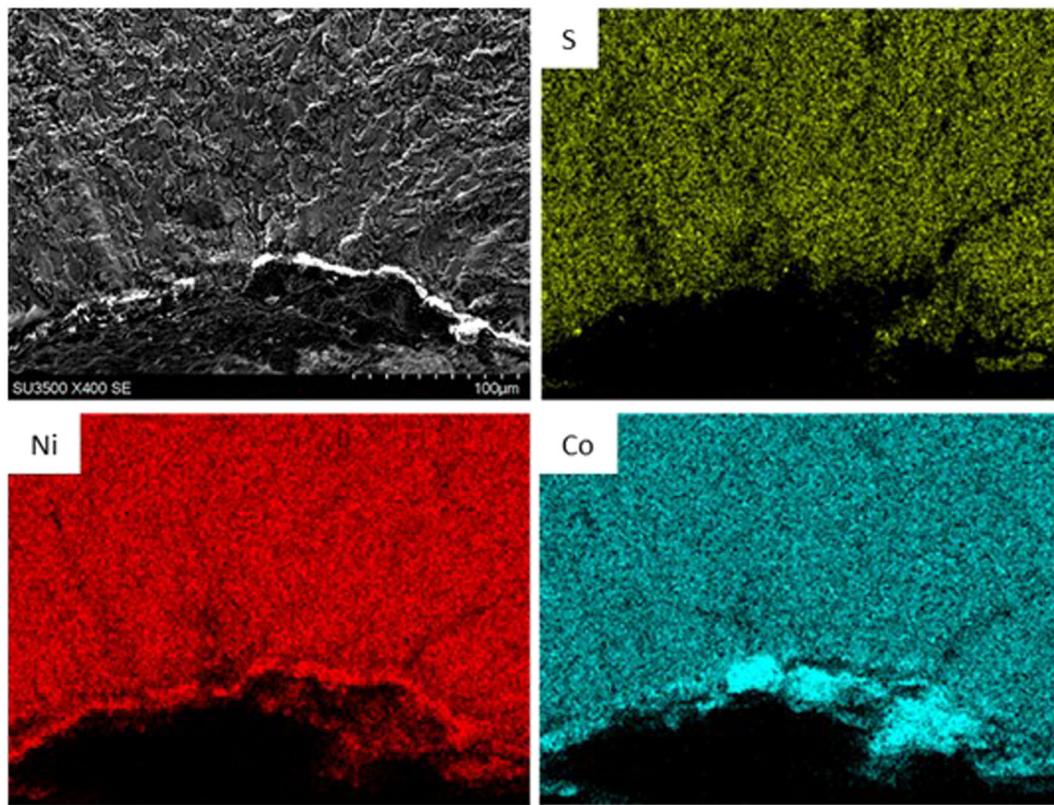
FIGURE 6 Fractography of crack initiation from a corrosion pit (top left) and corresponding EDS maps for sulphur, nickel, and cobalt (from a pre-corroded SYS specimen) [Colour figure can be viewed at wileyonlinelibrary.com]

The detailed form and metrics of corrosion pits were best defined from the various cleaned specimens where surface corrosion product had largely been removed (Figure 6). When performing EDS inspections of such pits, at least on this scale of magnification and directly from the fracture surface, it was pertinent to note the even distribution of remnant sulphur and a lack of concentration of this element around the base of the pit, in contrast to an apparent concentration of cobalt and nickel. The earliest stages of cracking appeared slightly faceted before a gradual transition to transgranular fracture.

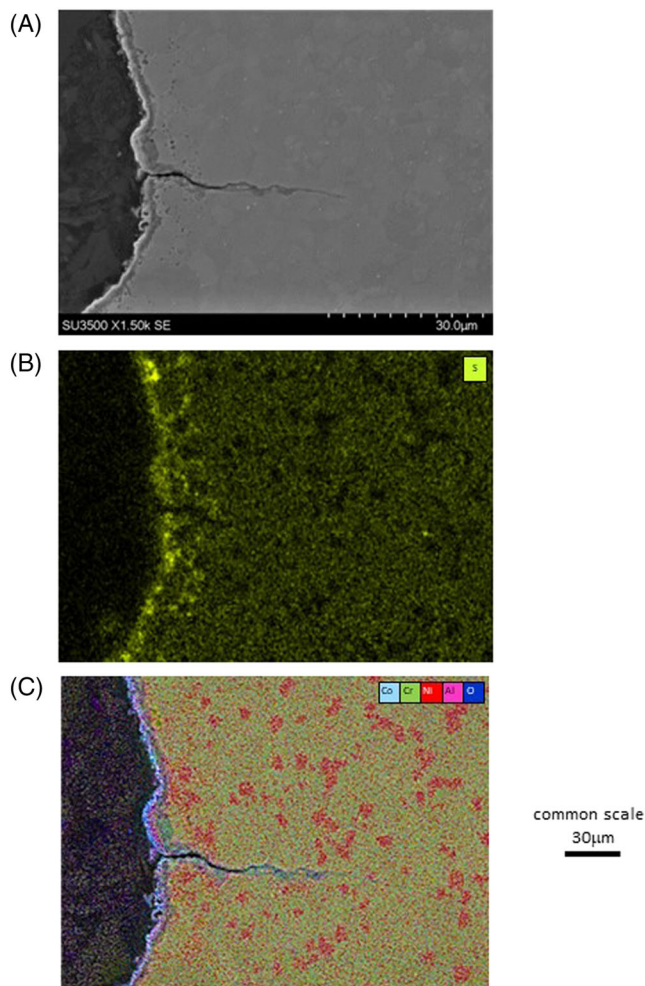
FIGURE 7 (A) Metallographic section through a corrosion pit with secondary cracking (from a pre-corroded SYS specimen); (B) EDS map of subsurface sulphides; (C) EDS map of oxidation associated with the crack wake [Colour figure can be viewed at wileyonlinelibrary.com]

Selected specimens were also subjected to sectioning on a plane parallel to the longitudinal test piece axis to intersect corrosion pits and expose the subsurface microstructure and chemical distribution (Figure 7). This specific example illustrates a relatively wide pit (i.e., depth to

width ratio $a/c \sim 3$). However, the pit profiles were highly variable (ranging between $\infty \leq a/c \leq 1$) and sensitive to the precise local microstructure and grain dropout. Cracking selectively focussed on sites of surface breaking grain boundaries exposed around the pit periphery. These boundaries, orientated near orthogonal to the tensile stress axis, promoted the ingress of SO_2 under the application of cyclic stress. These polished sections at higher magnification helped to identify the presence of grain boundary sulphides below the base of the pits. It was also common for such sectioning to reveal multiple secondary cracks emanating from the pit periphery. However, sulphides were not detected along the extended crack wake.

Multiple crack initiation was also prevalent among all classes of pre-corroded specimens, irrespective of cleaning between the static hot corrosion and fatigue testing phases. However, crack growth initiated from a greater number of individual pits in the corroded specimens, with eventual failure occurring through the coalescence of adjacent cracks on a common plane (Figure 5). It appears that under the preliminary static corrosion treatment, a significant number of pits had exceeded the critical defect size ($a > a_{pc}$) such that many sites supported local crack growth once fatigue loading commenced. It is pertinent that the combined 400 h spent under static corrosion exceeded the test duration experienced by any of the baseline test specimens while exposed to cyclic stress and SO_2 gas. Once again, crack initiation was intimately related to intergranular sulphide embrittlement at the base of the pits (Figure 7A), but with no further ingress of sulphur associated with the developing long crack (Figure 7B). In contrast, oxidation was detected along the entire length of the crack flanks via EDS and optical imaging (Figure 7C). The predominant transgranular, long crack fracture mode detected

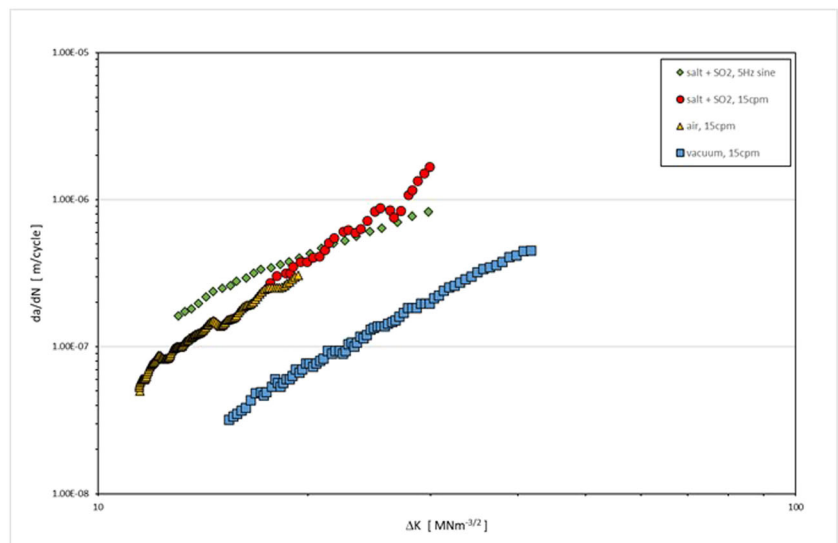
FIGURE 8 Stage II “Paris” fatigue crack growth data measured in vacuum, air, and SO₂ gas environments at 700°C [Colour figure can be viewed at wileyonlinelibrary.com]

Stage II fatigue crack growth data measured at 700°C are presented in Figure 8. Comparing the data under hard vacuum to tests performed in oxidizing environments (air or SO_2) demonstrates a fundamental increase

in growth rates through the presence of oxygen, but notably, no accelerated growth was detected in the hot corrosion SO_2 environment.

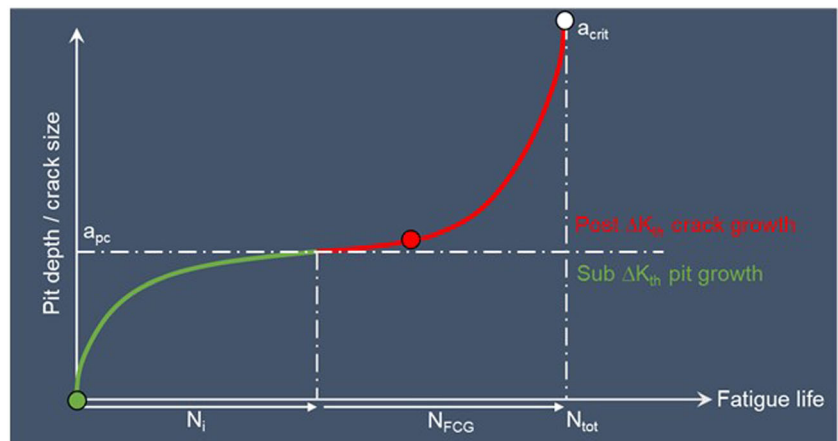
FIGURE 10 Schematic model to define sub and post threshold corrosion pit to crack transition nomenclature [Colour figure can be viewed at wileyonlinelibrary.com]

That same exercise also accentuated the philosophical argument concerning the retrospective definition of the projected length of any surface crack. The continual process of surface recession and the disappearance of the original metal/atmosphere interface acting as a measurement reference, progressive thickening of the corrosion scale, and whether this scale acts as an effective load-bearing element all have implications for crack size measurements. The highly complex interaction between the chemical processes active at the surface and the time-dependent nature of the fatigue cycle has also been considered by a concurrent study.¹⁷ The component lifing philosophies offered by Chan et al essentially concur with the present research while reiterating that the description of pit to crack transition illustrated in Figure 10 may be

Referring again to Figure 10, all pre-corroded LCF specimens would be associated with “post-threshold” behavior. It is reasonable to assume that the pre-existing pitting minimized or even eliminated the initiation life of the pre-corroded specimens, with “long” crack growth encouraged from the very earliest loading cycles, effectively bypassing any short crack phenomena proposed to describe corrosion fatigue mechanisms.²⁴ Schematically, the scale of any pre-existing defect is represented by an arbitrary point superimposed on the growth curve in Figure 10.

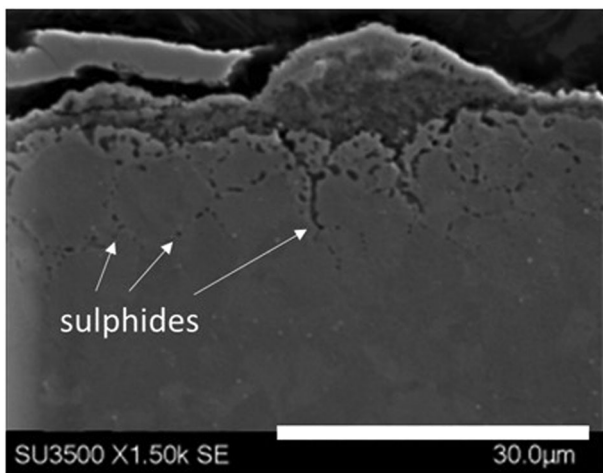
FIGURE 11 Intergranular sulphides decorating grain boundaries and responsible for progressive surface grain dropout

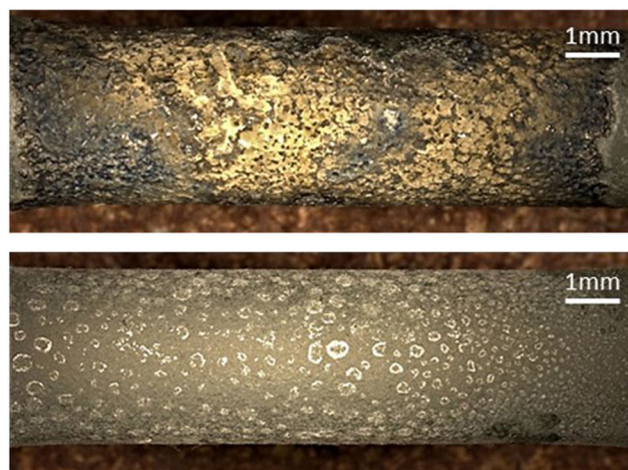
FIGURE 12 Variable hot corrosion response demonstrated in two specimens prior to LCF testing, both subjected to the SYS pre-corrosion scenario. (Top) Corrosion pitting exposed due to the spallation of surface oxide scale (typical of most specimens). (Bottom) Continuous oxide scale retained and lack of pitting [Colour figure can be viewed at wileyonlinelibrary.com]

individually. It is impossible to provide a definitive retrospective explanation but factors that could be responsible include differences in machining process, shot peening anomalies, surface residual stress state, specimen handling, variance of salting concentration/distribution, or any combination of these parameters. Whatever the reason, the absence of stress raising corrosion pits naturally appeared to improve fatigue strength.
