Geophysical Characterisation and Monitoring of Earth Embankment Dams

MSc by Research

Swansea University
Prifysgol Abertawe

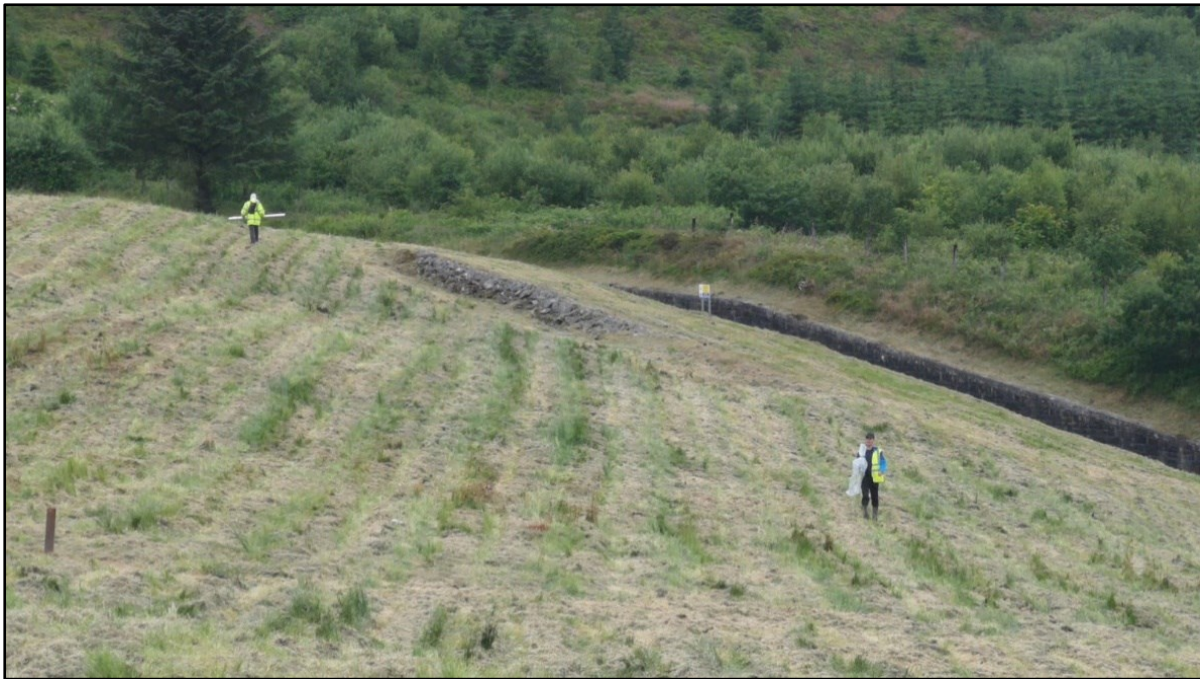
Figure 1.2: Photograph of ground conductivity (left) and magnetic data acquisition (right).

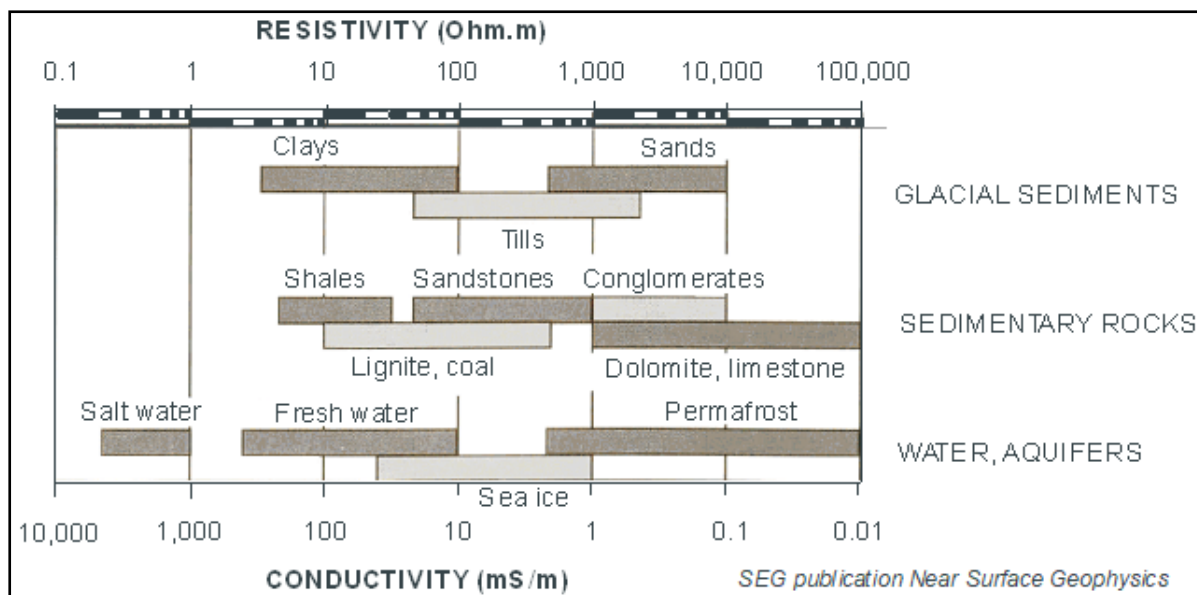
Figure 1.3: Ranges of resistivity and conductivity values of typical sedimentary materials (SEG, 2022).

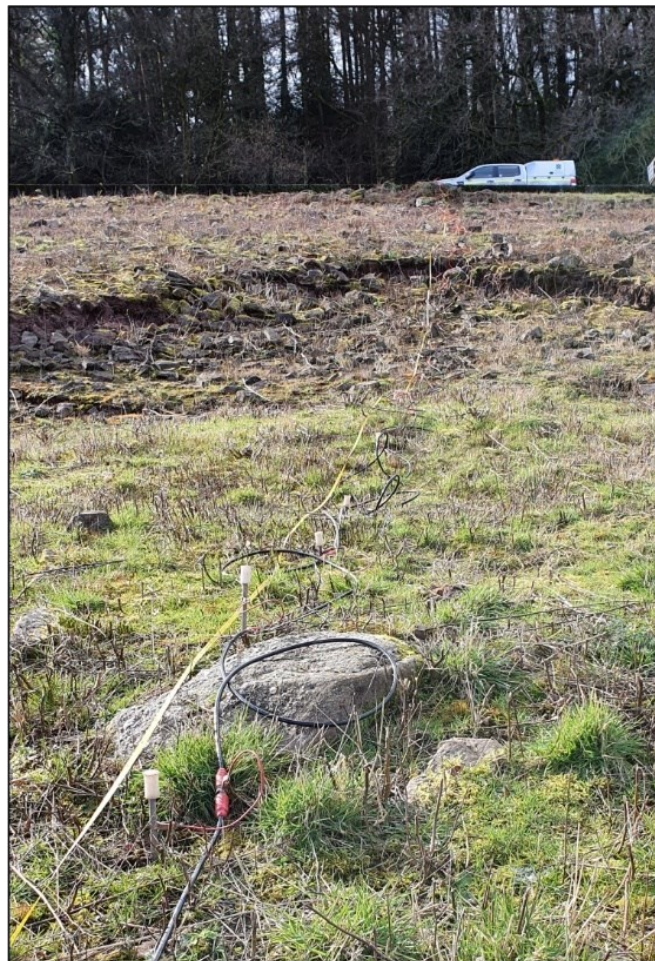
Figure 1.5: Acquisition of ERT and IP data using an Iris SYSCAL resistivity system (library photo from TerraDat UK Ltd.).

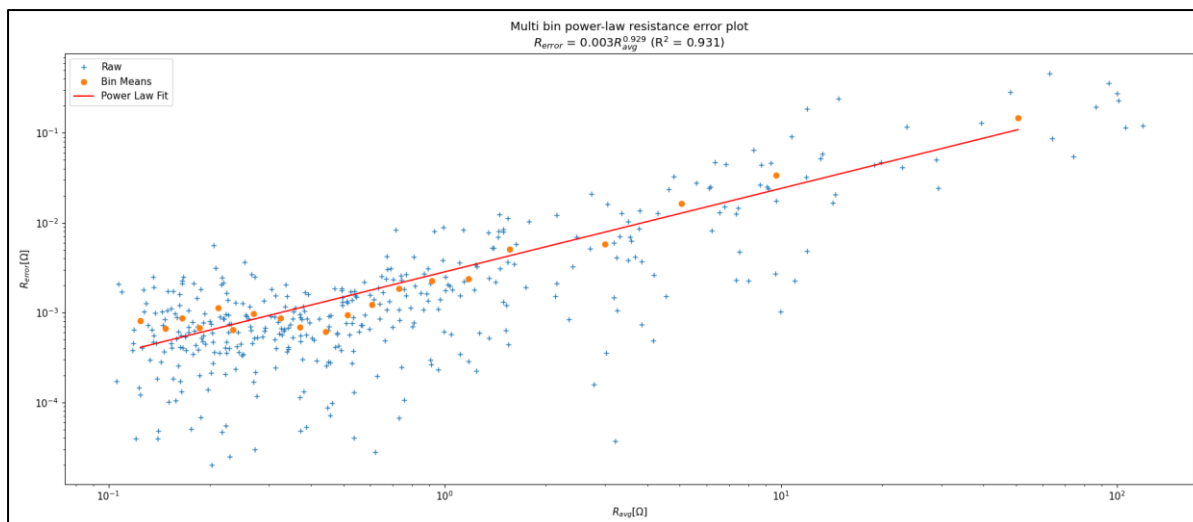
Figure 1.6: Results of multi-bin power-law resistance error model. Power law fit equation used to model error values for all ERT datasets.

This model was used to estimate the error for all other ERT datasets. Values of resistance were made the subject of the power-law function, producing a corresponding error value. This approach strikes a balance between statistical valid error modelling and practical application.

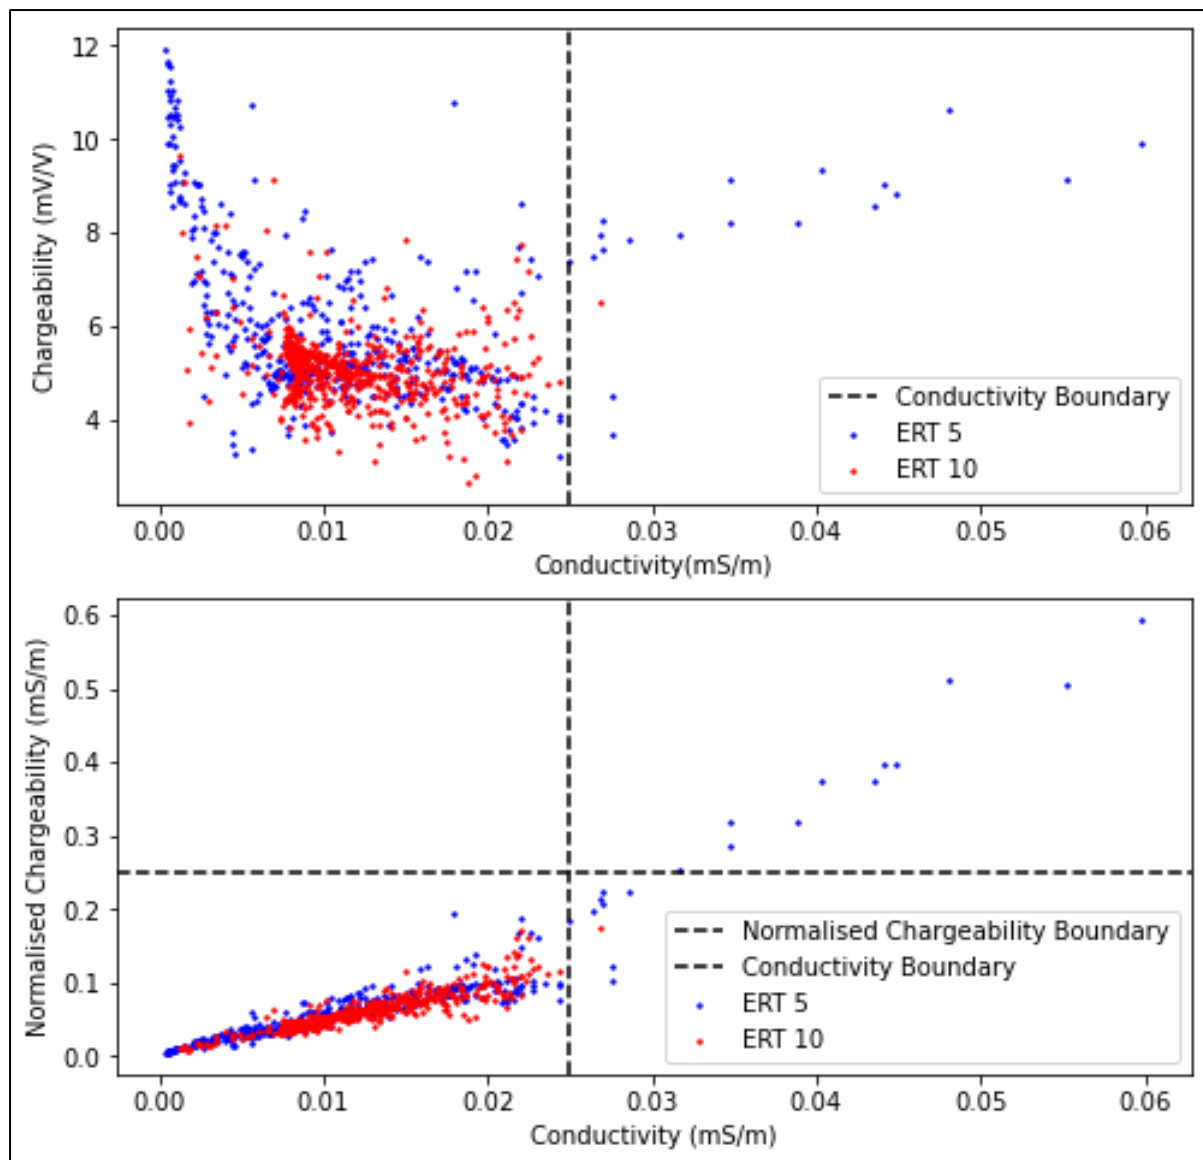
Figure 1.7: Top: Plot of chargeability against conductivity for ERT 5 and ERT 10. **Bottom:** Plot of normalised chargeability against conductivity for ERT 5 and ERT 10. Values on either side of the conductivity boundary are distinguished by calculating the normalised chargeability. The normalised chargeability boundary was determined following Slater and Lesmes (2002).

A plot of normalised chargeability against quadrature conductivity was used to set binary values to indicate the spatial distribution of clay rich and clay deficient material (Figure 1.7). Normalised chargeability values greater than 0.25 mS/m are considered clay-rich, and values less than 0.25 mS/m are considered clay-deficient. These thresholds were taken from Slater and Lesmes (2002).

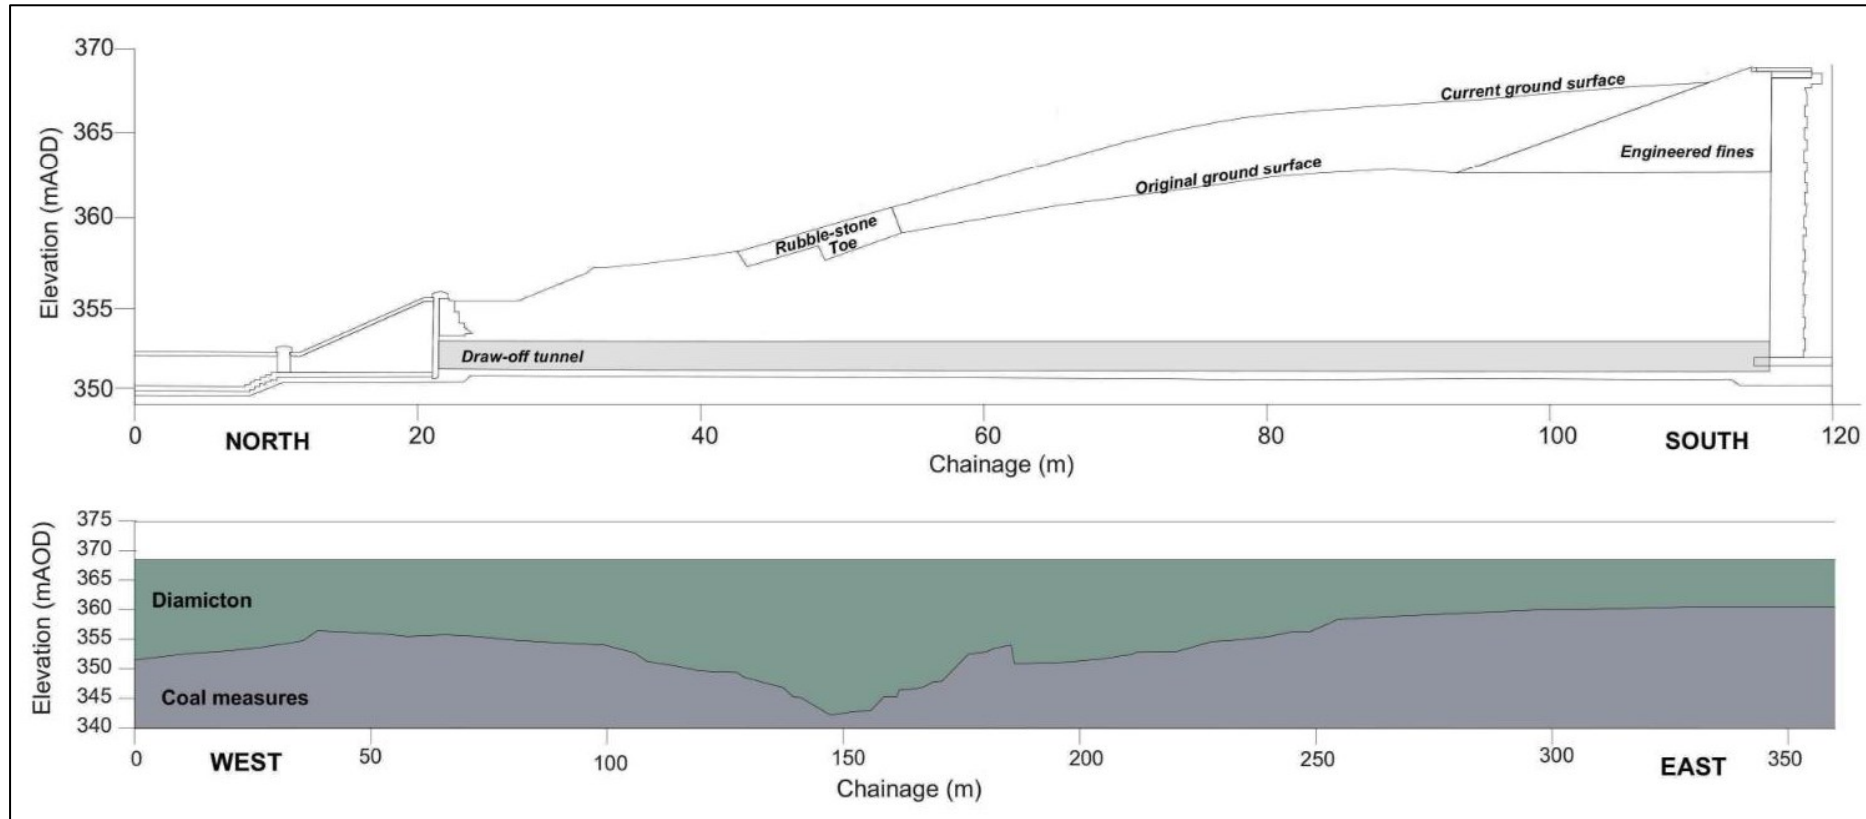
Figure 3.5: *Top: Initial conceptual cross section perpendicular cross section to the crest of the dam. Bottom: Indicative cross section along the crest of the dam, taken from historical drawings at the time the dams construction.*

Figure 3.5 shows two schematic cross-sections digitised from a series of historical drawings. It should be noted that the georeferencing and scaling of these cross-sections can only be estimated and are thought to be correct within ± 5 m on the x-axis and ± 2.5 m on the y-axis

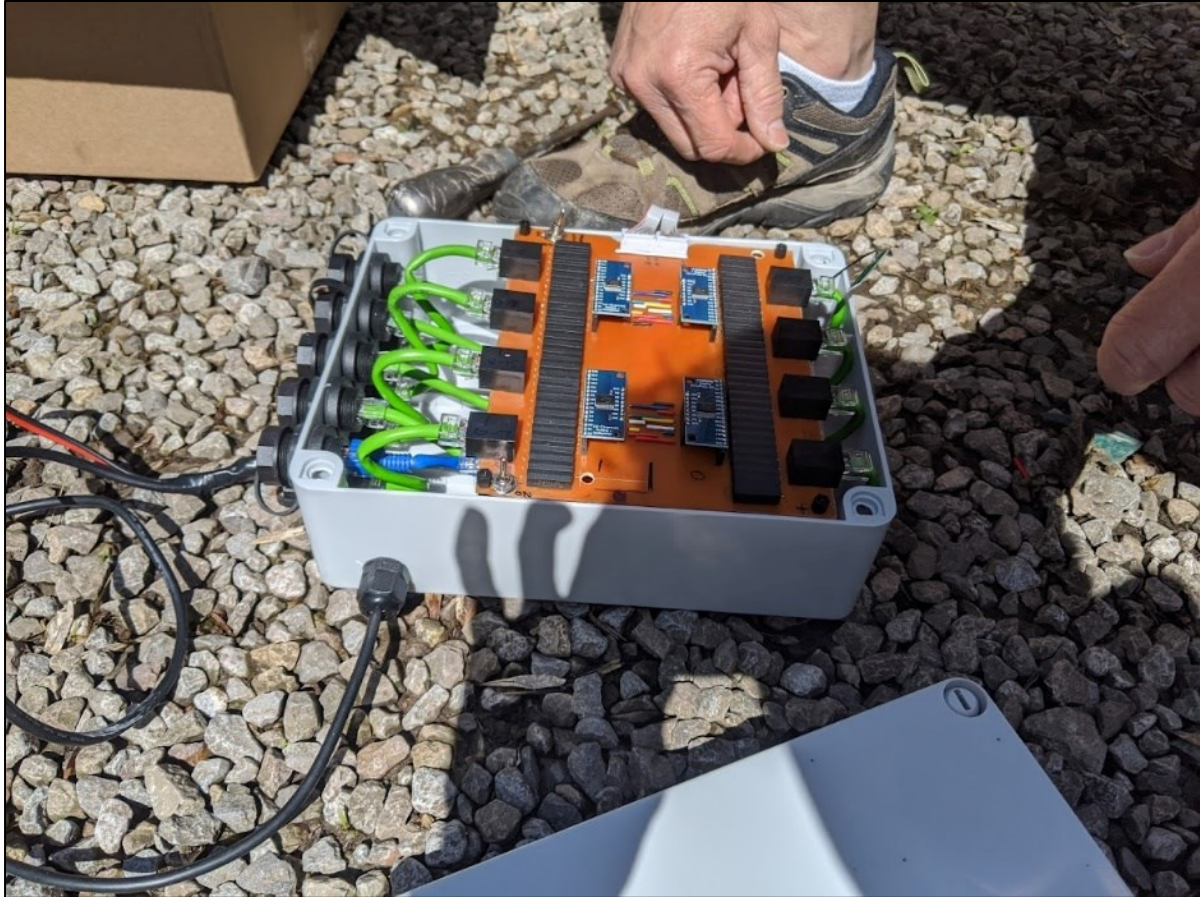
Figure 4.1: Photograph of inside the SPiVolt Hub.

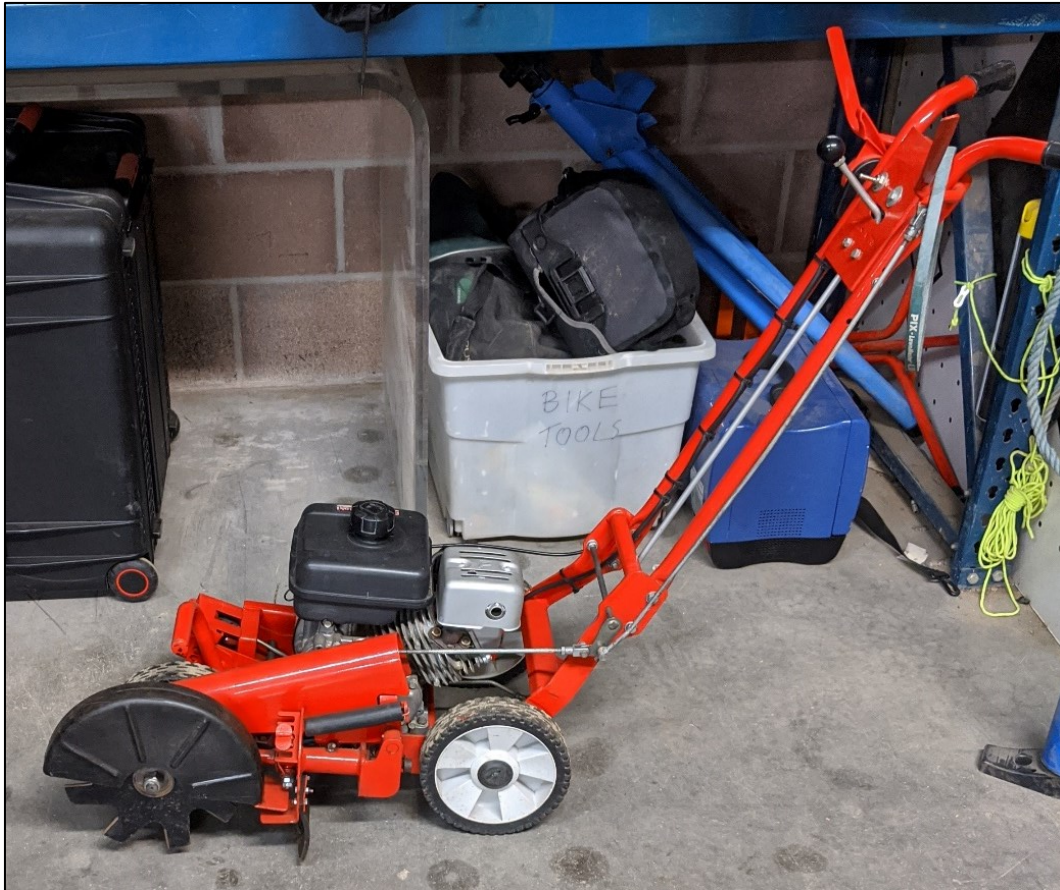
Figure 4.5: Photograph of adapted lawn edger used for cutting trenches at the study site.

It was important that the cables were buried to avoid being eaten by fauna or being tampered with by members of the public. Burying these cables purely by hand would be extremely labour intensive and take a very long time. To make this process more efficient, a “lawn edger” was re-purposed for cutting a small narrow trench in the ground which the cables could be fed into (Figure 4.5). Normally, these machines are used to trim the edges of lawns for residential properties. They consist of a small two-stroke petrol engine which is connected via a belt drive to a cutting blade. The cutting blade was adapted by installing two sharpened cutting blades separated by a ~ 3 cm washer to enable the edger to break through matted roots and create a narrow trench. The result of this process is shown in Figure 4.6.

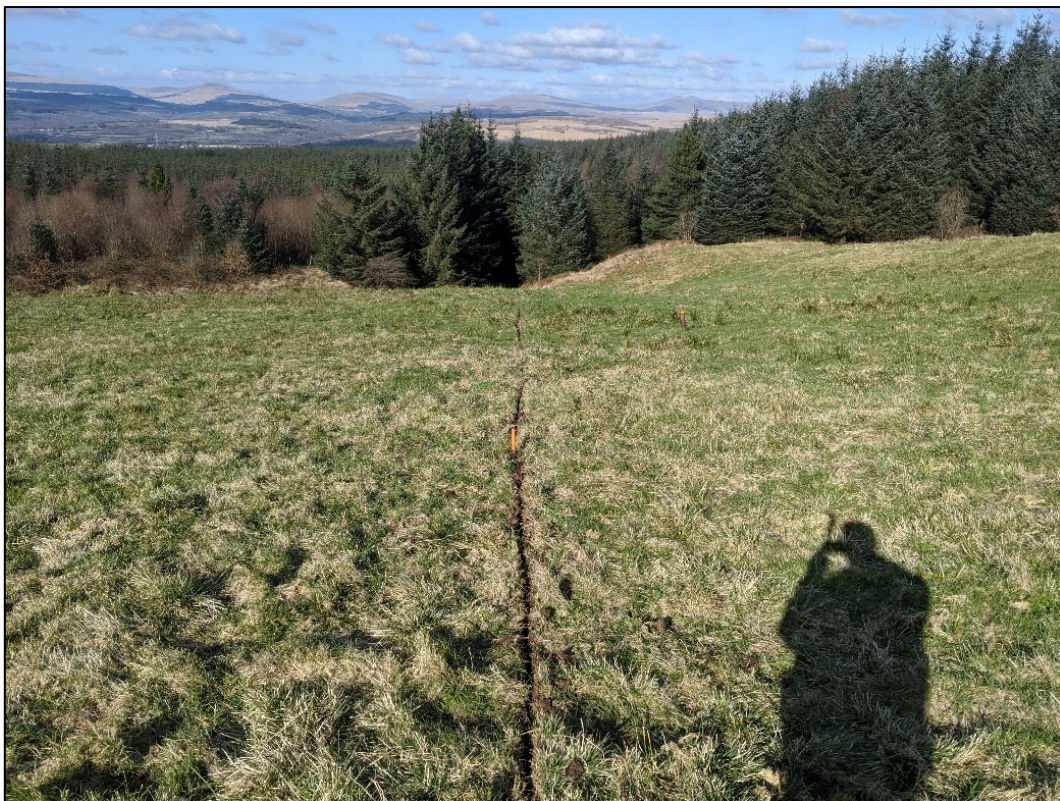
Figure 4.6: Photograph of trench cut using adapted lawn edger.

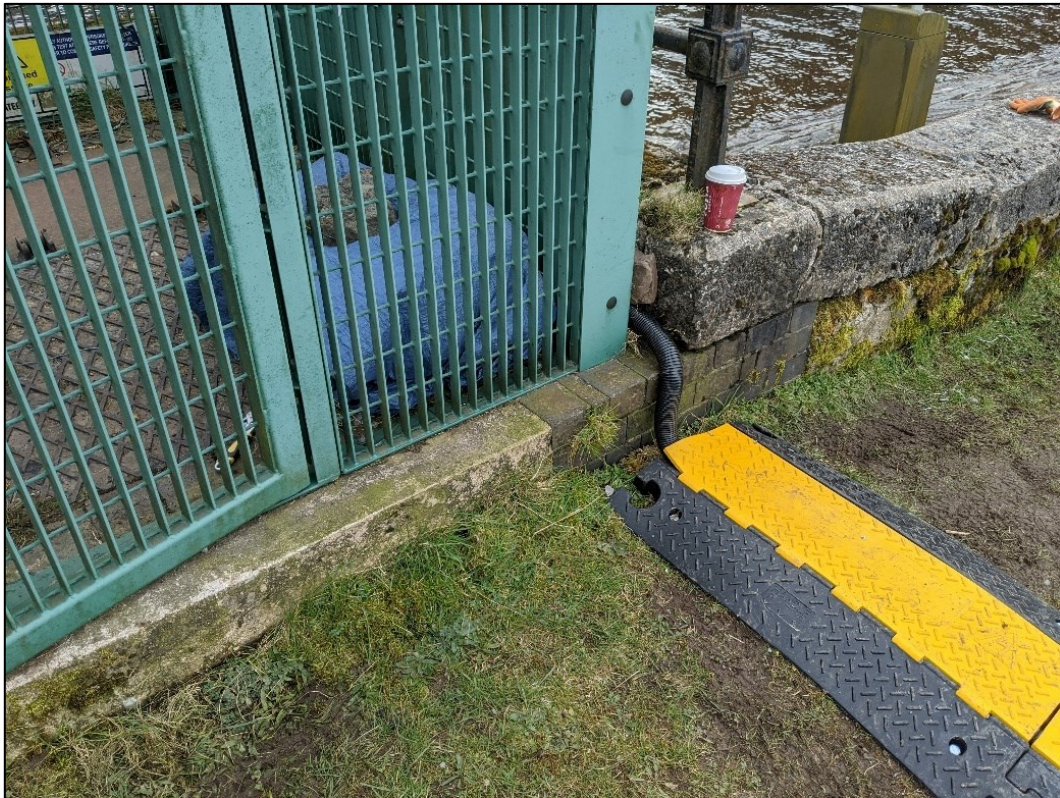
Figure 4.7: Photograph showing SPiVolt cables feeding through speed bump and plastic tubing into valve cage.

All electrodes were connected back to the SPiVolt Hub through a secure cable management speed bump, which was drilled into the hardstanding track at the crest of the embankment to prevent damage from vehicles. These cables were then fed through a section of plastic tubing into the secure valve cage to prevent damage from members of the public (Figure 4.7). These cables were then colour coded and connected to the SPiVolt Hub to allow for easy maintenance in the future. The SPiVolt Hub, and its power supply, were sealed within a modified weatherproof case and wrapped in a tarpaulin (Figure 4.8). The SPiVolt system was then programmed to take a full set of measurements at 17-minute intervals and upload this data to a server every hour.

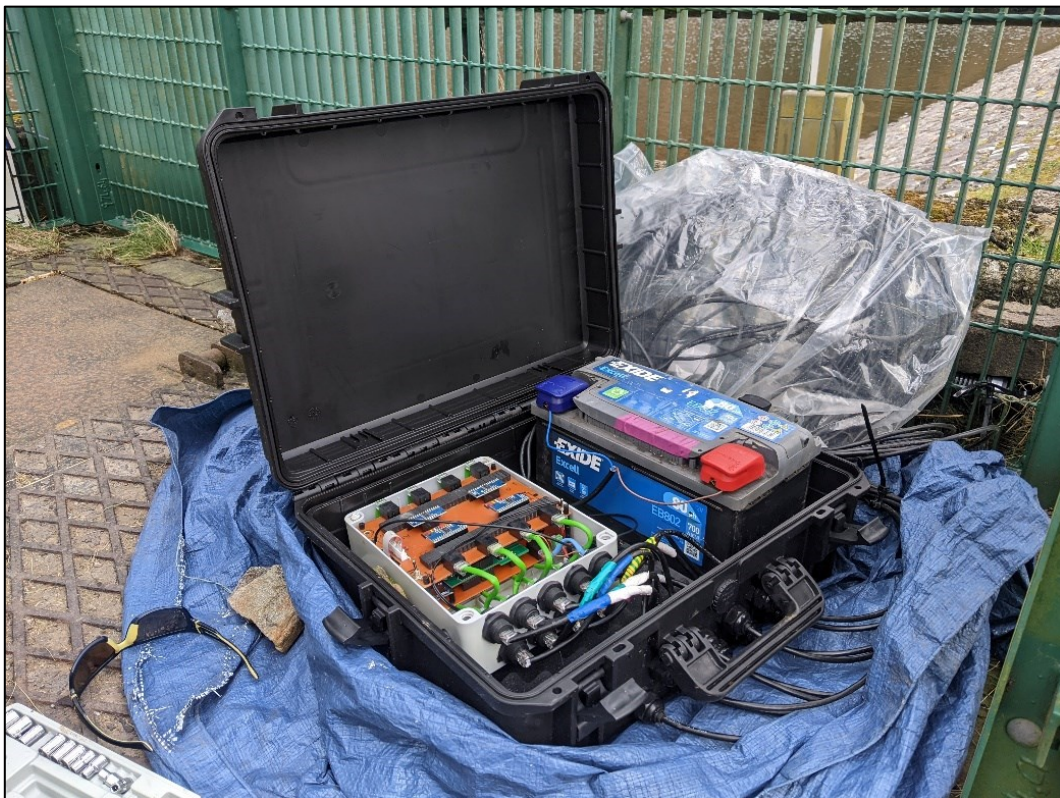
Figure 4.8: Photograph of SPiVolt Hub, power supply and cables secure in weatherproof case with valve cage.

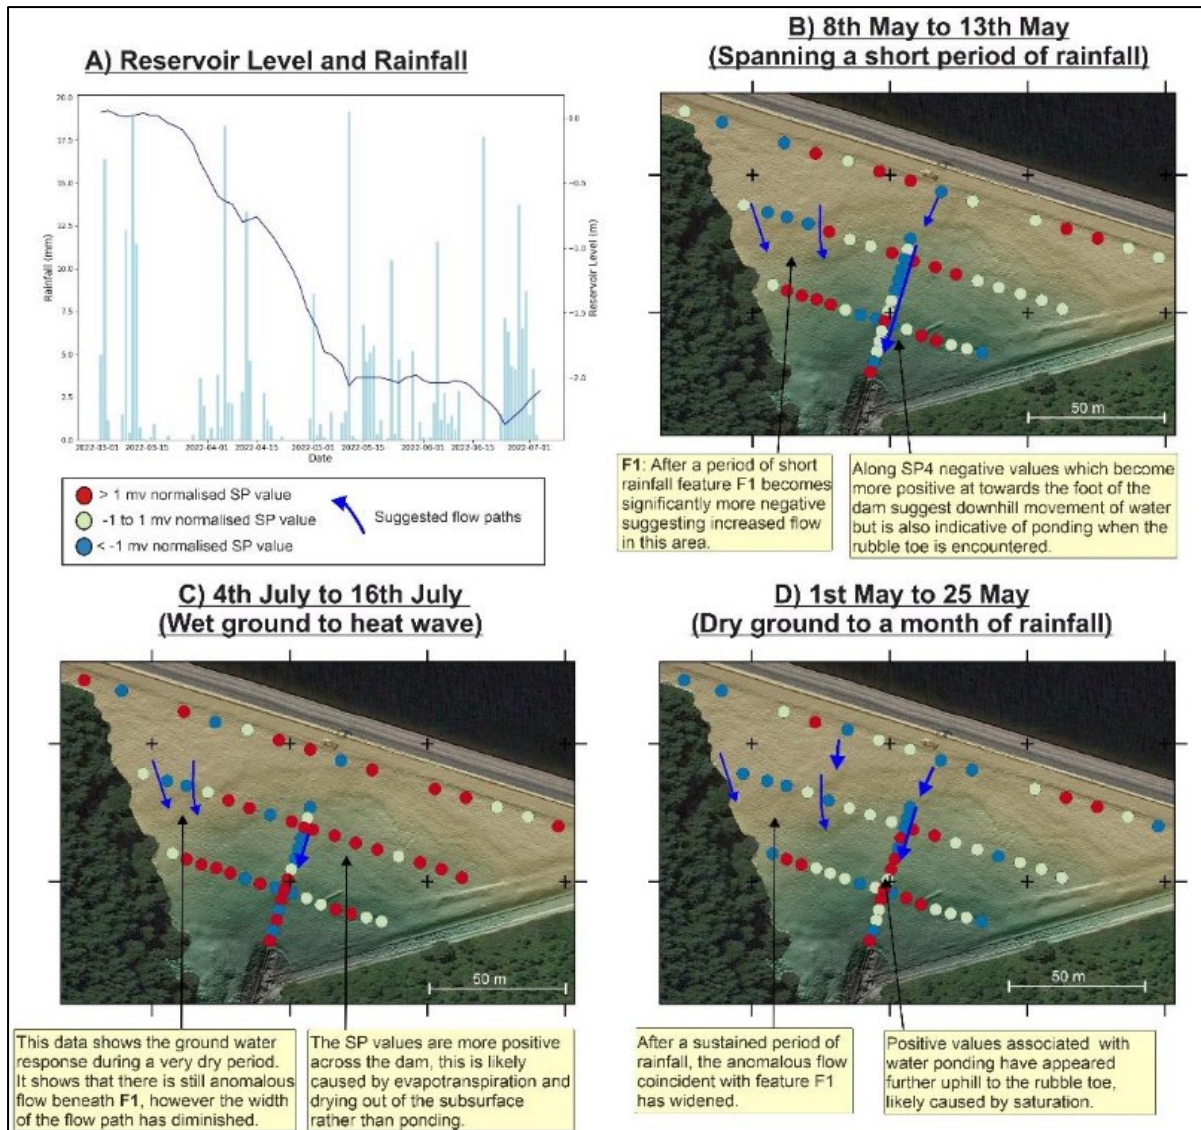
Figure 5.8: A: Reservoir level and rainfall data. B-D: Maps of normalised SP response following dry and wet periods. Electrodes which record normalised negative values (shown in blue) indicate localised increased water flow, electrodes that record positive values (shown in red) indicate water ponding or drying of the subsurface, electrodes with values around 0 (+/- 1 mV) suggest no significant localised effects from rainwater. Suggested flow paths are indicated by blue arrows. Taken from Hamlyn et al. (2022).

<p>Wet ground into heat wave (04/07/2022 – 16/07/2022).</p>	<ol style="list-style-type: none"> 1. Across the dam, SP response is generally more positive. 2. Feature F1 becomes narrower. 	<ol style="list-style-type: none"> 1. Likely caused by evapotranspiration and ‘drying out’ rather than ponding water. 2. Feature F1 still remains and active flow path, just narrower.
<p>Dry ground to a month of rainfall (01/05/2022 – 25/05/2022).</p>	<ol style="list-style-type: none"> 1. Positive SP values along SP 4 moved further upslope. 2. Feature F1 becomes wider. 	<ol style="list-style-type: none"> 1. Possibly caused by water saturation immediately upslope of the rubble-stone toe. 2. Increased water flow through flow path associated with F1.

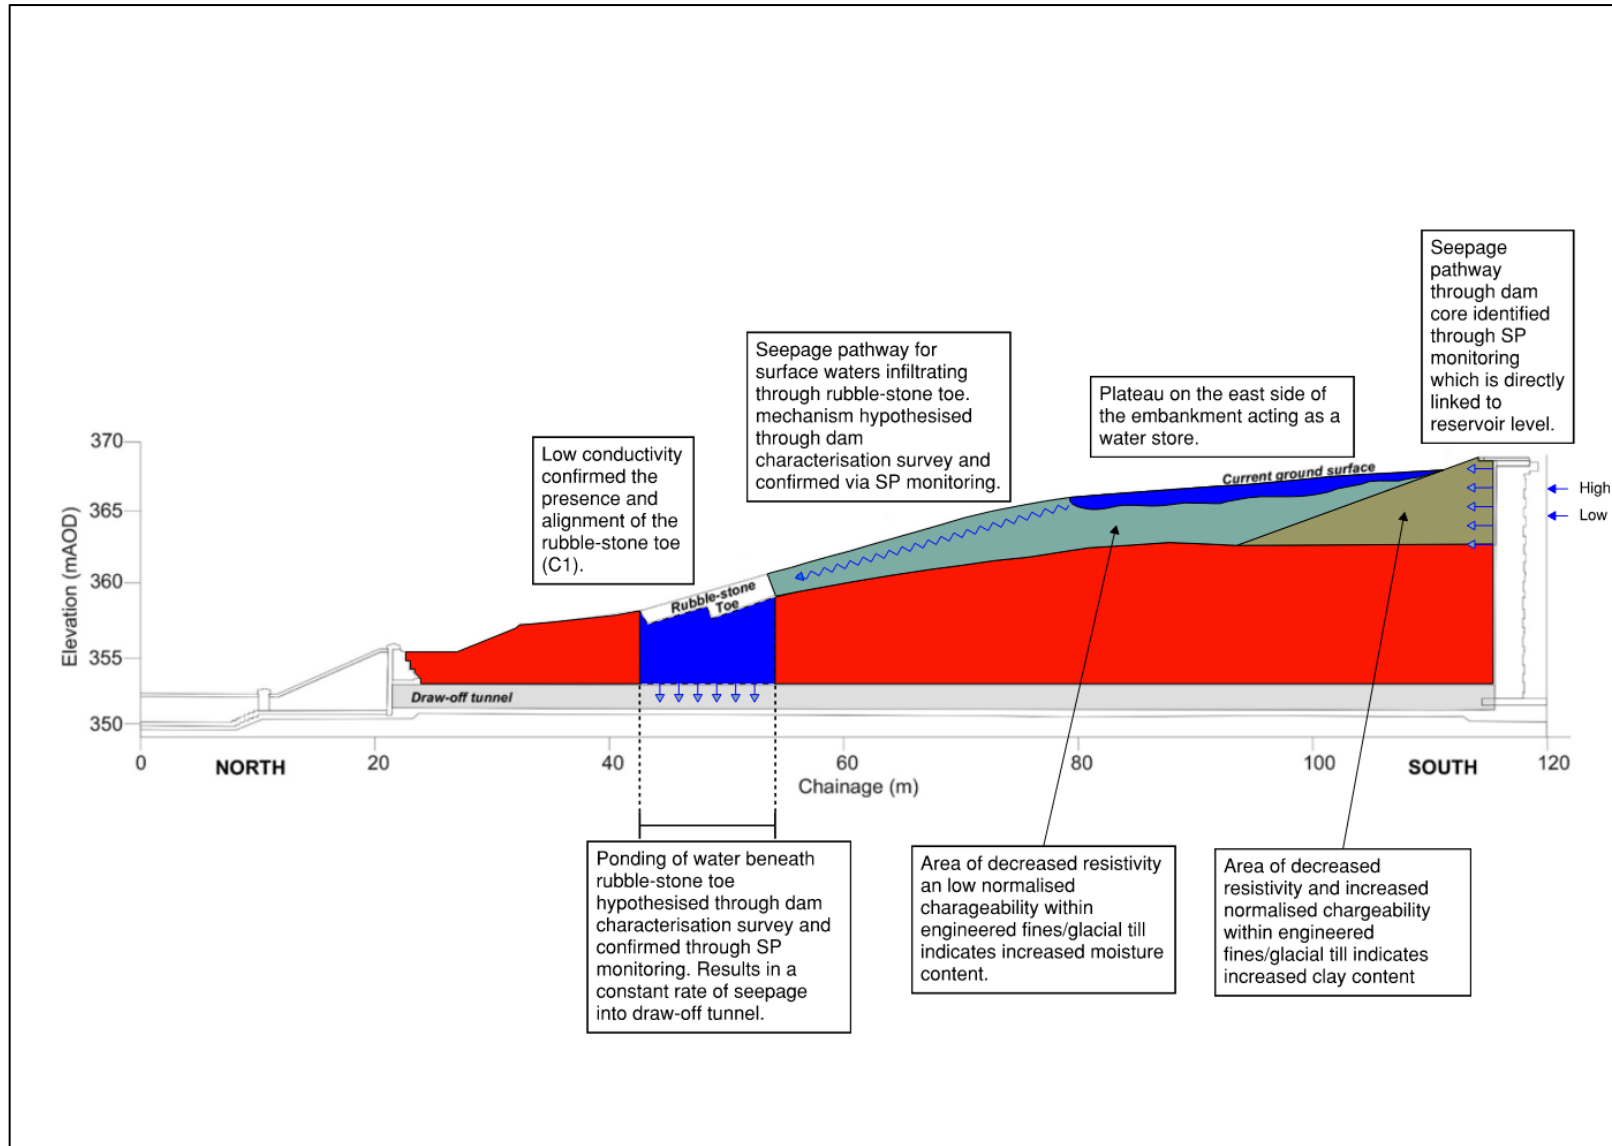
Figure 6.1: Revised conceptual site model.

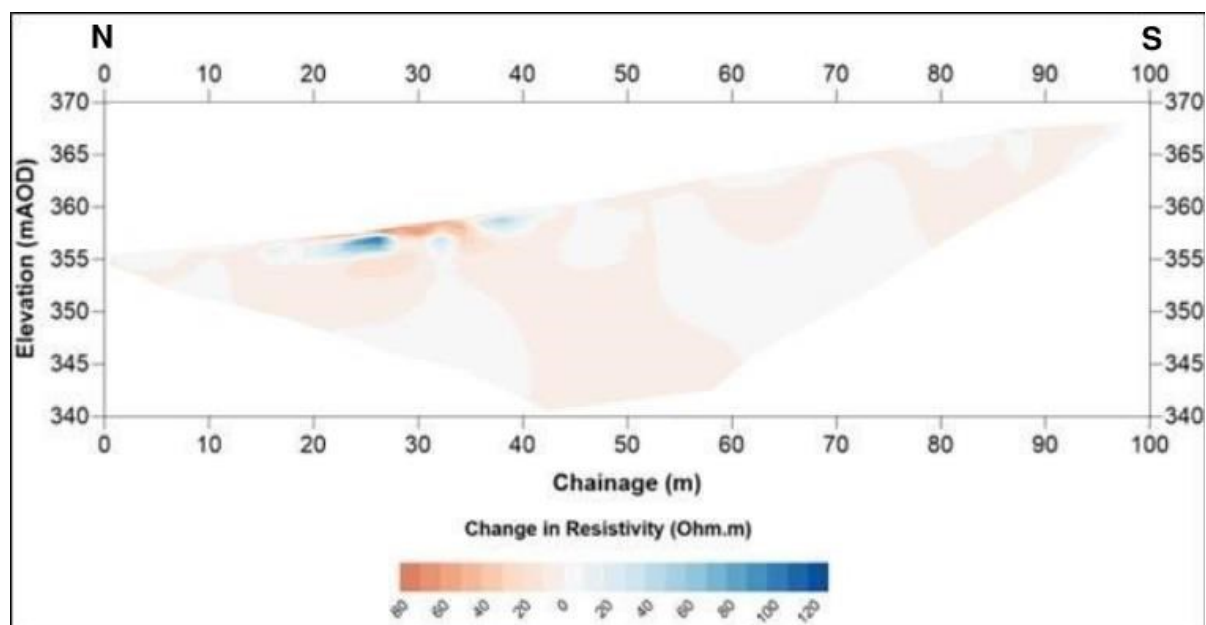
Figure 6.2: Differential plot of raw data from ERT 5 between modelled resistivity by applying the reciprocal error model and using traditional error statistics (i.e., repeatability) within Res2DInv.

Acquiring reciprocal ERT data doubled the time taken to acquire data in the field. Figure 6.2 shows a differential plot of ERT data acquired for ERT 5. The plot shows the difference in modelled resistivity between applying the reciprocal error model and using traditional error statistics (i.e., repeatability) within Res2DInv. Most of the modelled data points did not change within 10 Ωm . The maximum difference were observed at high resistivity values ($> 100 \Omega\text{m}$), which is to be expected. The differences in resistivity between the two models did not affect the interpretation of the ERT data. Therefore, it can be concluded that applying this method of ERT error analysis (acquiring one reciprocal data set and applying it to the rest of the ERT data sets) is a commercially valid option. The data does not suggest that acquiring reciprocal measurements for all ERT profiles is commercially viable, i.e., doubling the survey time to acquire this data is not justified in this instance.

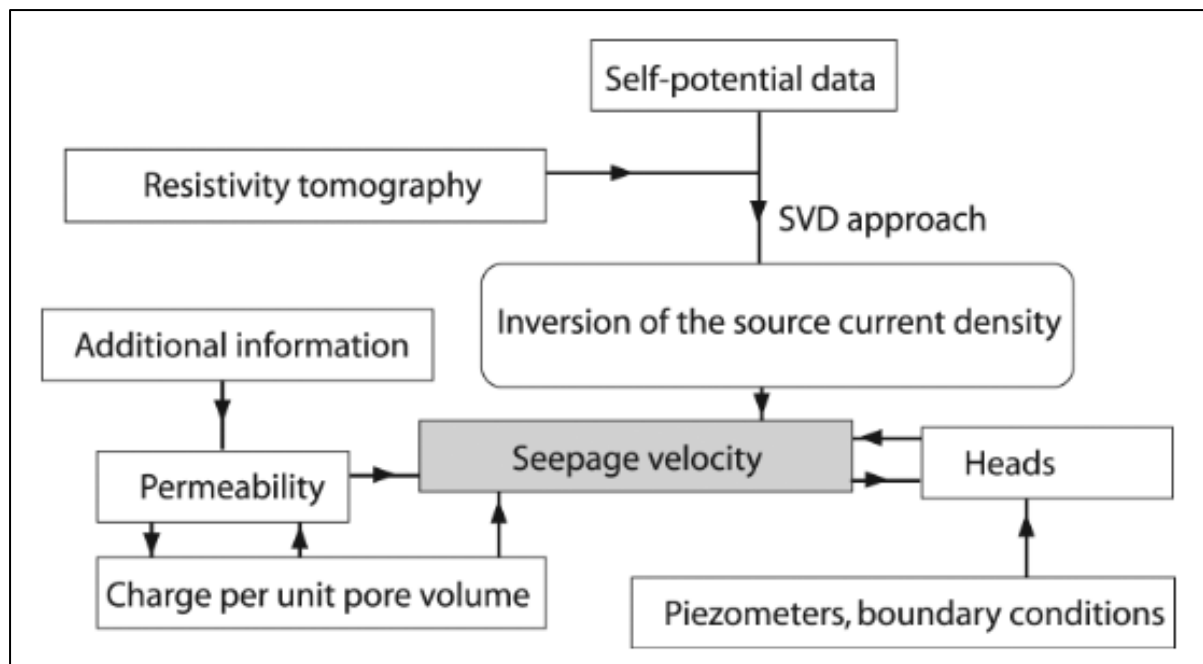
Figure 6.3: Process to obtain seepage velocities from SP Tomography taken from Bolève et al. (2009).
