Cite this: *J. Mater. Chem. C*,
2024, 12, 9401

Infiltration issues in printed mesoporous carbon perovskite solar cells: a troubleshooting guide

C. A. Worsley,^{id}* T. Dunlop,^{id} S. J. Potts,^{id} R. Bolton, E. Jewell and
T. M. Watson^{id}*

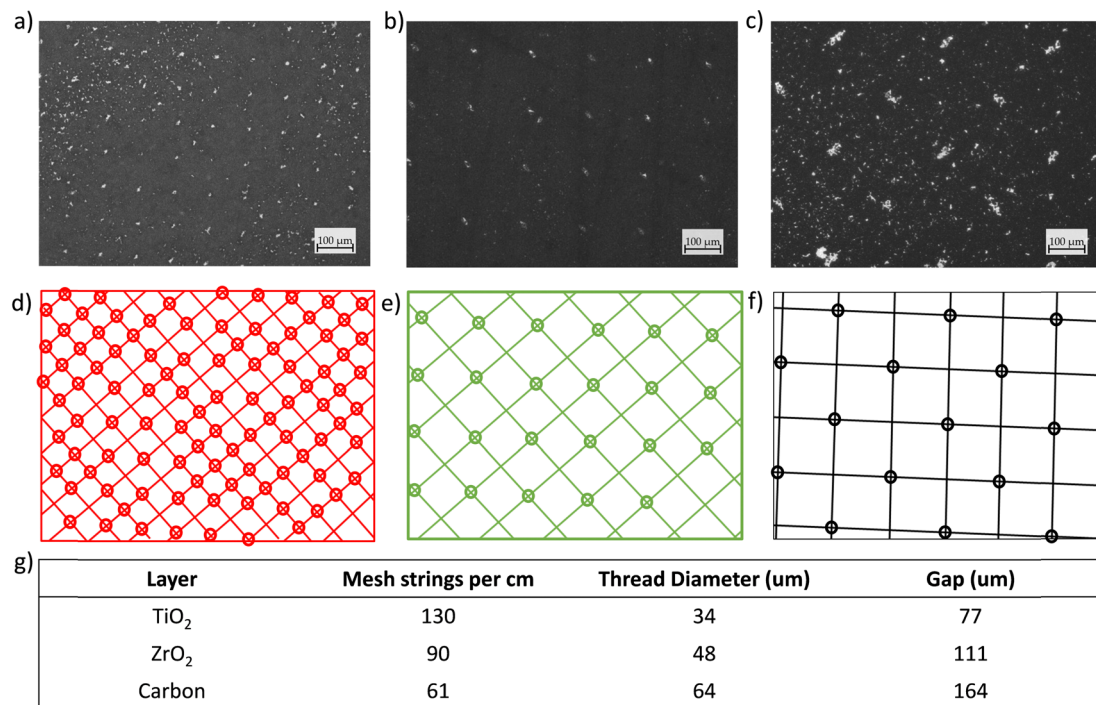
Fig. 3 Optical images of infiltrated TiO₂ in devices showing mesh mark defects from (a) TiO₂, (b) ZrO₂, and (c) carbon screens. (d)–(f) Show diagrams of mesh dimensions of TiO₂, ZrO₂ and carbon screens respectively, with circles representing cross sections where an infiltration issue is present in the device. (g) Shows mesh types and calculated gap size for each layer.

Perhaps the most characteristic defects are those caused by mesh marks; troughs or peaks at the surface of a screen printed layer. Mesh marks occur due to ink filaments forming at mesh crossover sections as the screen separates from the substrate during printing. This produces round, evenly spaced infiltration defects in the finished device. Usually present across a large area, these features are obvious when examining the infiltrated TiO_2 layer with an optical microscope (Fig. 3a–c). Critically, mesh marks in the ZrO_2 or carbon print can cause infiltration defects at the base of the TiO_2 . (Fig. 3a–c) shows optical microscopy images of infiltrated TiO_2 layers from three devices, which respectively show evidence of TiO_2 , ZrO_2 and carbon related mesh mark infiltration defects.

As presented in Fig. 3, observed infiltration defects will correspond with the mesh dimensions of the relevant screen. Therefore, if different screens have been used for TiO_2 , ZrO_2 and carbon, defect spacing can be measured to conclude in which layer the problematic marks reside. For example, the small defects in Fig. 3a must correspond with those from the TiO_2 layer, as this was the only deposition where a fine mesh was used (Fig. 3c). Note that defects may only appear (or be more severe) at alternate cross sections, as is the case in Fig. 3b and c. If similar mesh screens are used for different layers, the problematic layer can be identified using WLI (white light interferometry) of any remaining uninfiltrated devices single prints (Fig. 3b).

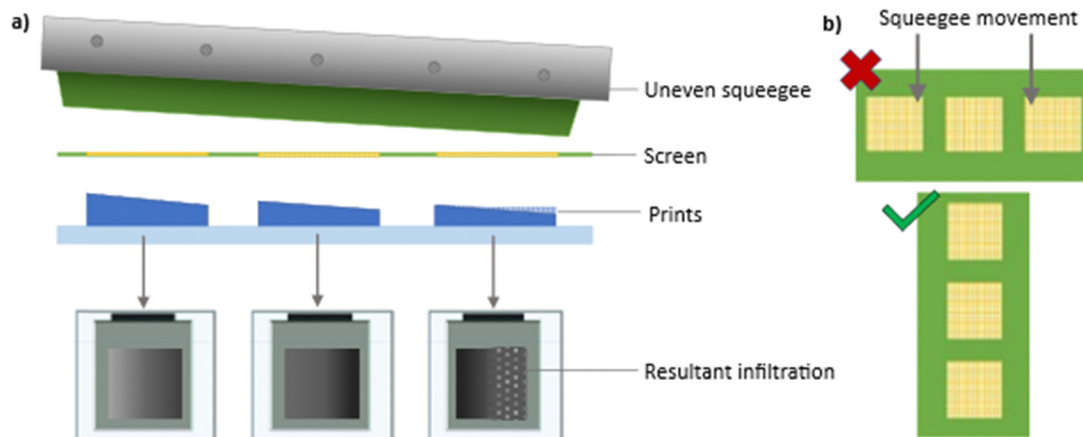
Fig. 4 (a) Diagrammatic representation of the consequences of uneven squeegee pressure and its resultant impact on device infiltration. Note that mesh marking defects in real samples will only be visible via optical microscopy. (b) Screen alignment to limit horizontal print variations.

Careful setup and pressure monitoring can help prevent squeegee related issues. Changing screen designs to limit the horizontal print width (depicted in Fig. 4b) can also improve uniformity and batch variation. In the case of glass warping, ramped heating and cooling steps for blocking layer spraying and each high temperature anneal can help minimise these issues.

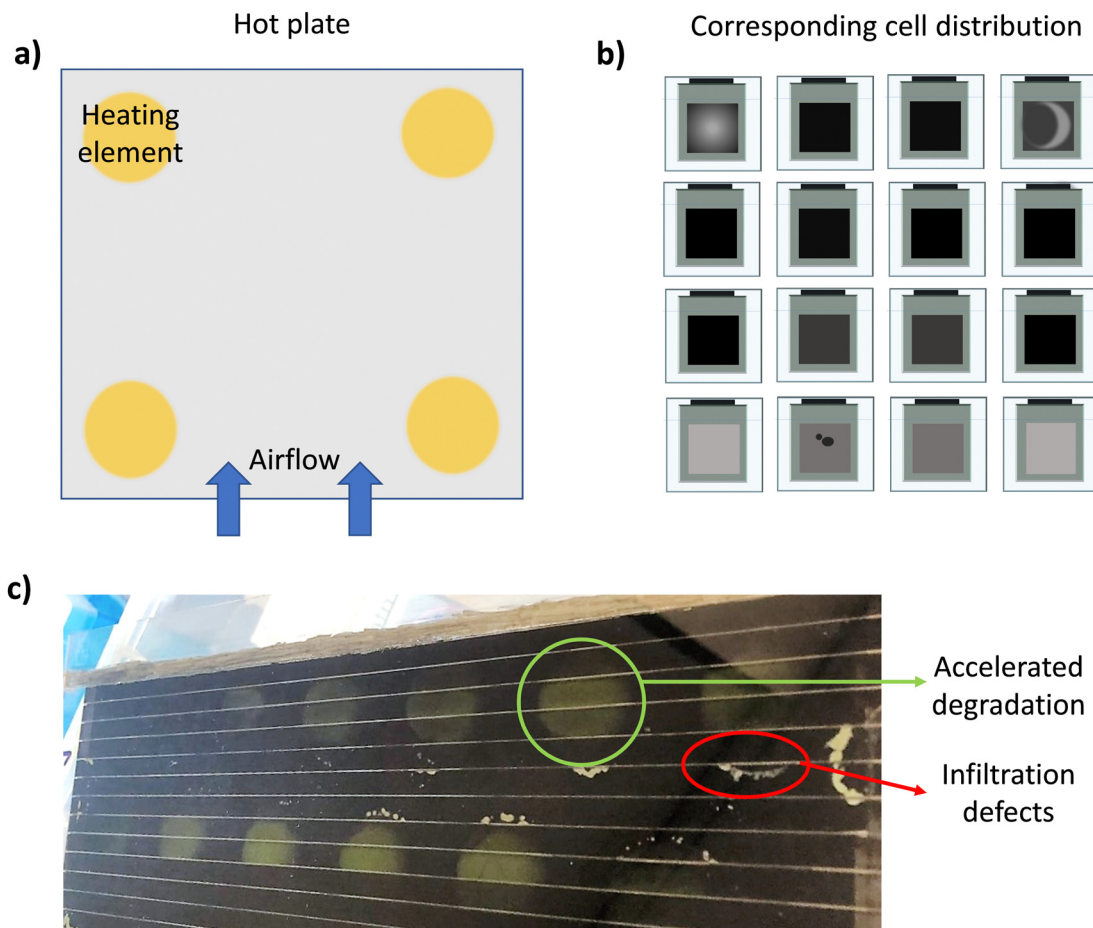
Fig. 5 Diagrammatic representation of (a) an unevenly heating hot plate and (b) resultant impact on device infiltration. Depicted in (c) is a photograph of damage on a $30 \times 30 \text{ cm}^2$ module caused by heating elements and airflow during perovskite annealing.

This issue can occur at multiple scales and using different equipment setup. For example, Fig. 5c shows a $30 \times 30 \text{ cm}^2$ module annealed on a conveyor dryer. Through the glass substrate, greyish white and yellow defects can be seen, impacting multiple cells. The grey or white perovskite free voids indicate an infiltration issue caused by fast crystallisation and high airflow, whereas the yellow areas show accelerated degradation due to uneven heating. On examination of equipment, the yellow defects corresponded with overhead heating elements in the dryer and the white and grey with areas of high airflow.

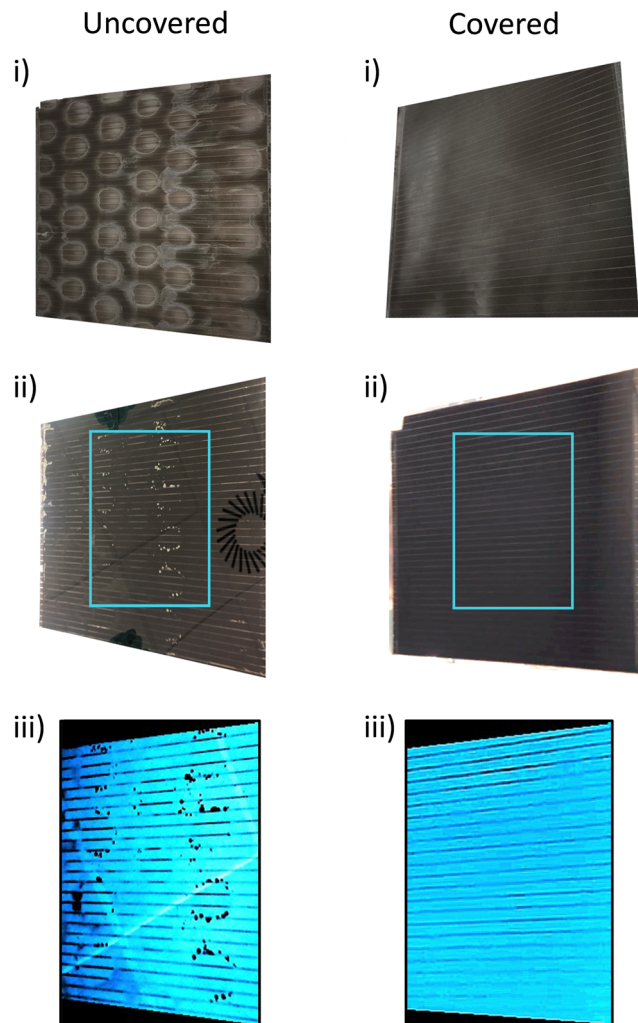
Fig. 6 Photographs of 519 cm² active area modules with (RHS) and without (LHS) a cover during perovskite annealing. (i) Back electrode, (ii) through glass substrate, (iii) magnified with applied colour filter to highlight infiltration problems.

A simple partial cover was thus applied, to protect the module surface while allowing sufficient solvent removal. This completely eliminated the defects, as shown in Fig. 6.
