Cite this article: Arora H, Kelly M, Worley A, Del Linz P, Fergusson A, Hooper PA, Dear JP. 2014 Compressive strength after blast of sandwich composite materials. *Phil. Trans. R. Soc. A* **372**: 20130212.
<http://dx.doi.org/10.1098/rsta.2013.0212>

Compressive strength after blast of sandwich composite materials

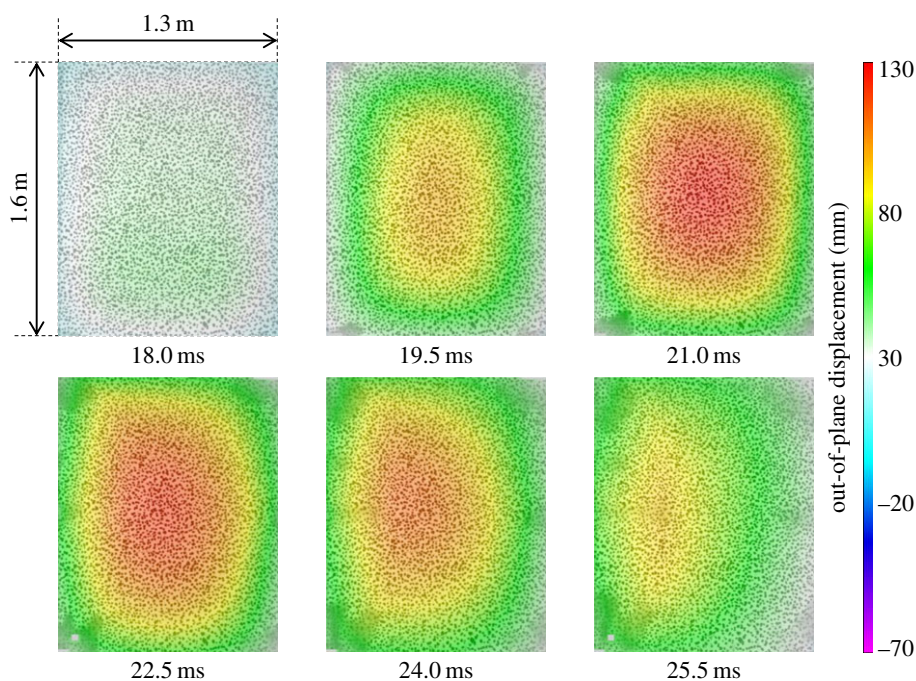
The glass-fibre-skinned panel, GL1, deformed symmetrically until the point of maximum *z*-displacement. By this point, front-face and core damage had already occurred and affected the return response of the panel, causing a non-uniform rebound response at 20 ms about the peak out-of-plane displacement (see graphic in figure 5). This asymmetry caused by the damaged core is highlighted in the out-of-plane displacement contour plots in figure 6.

Figure 6. DIC analysis of blast on GL1 featuring contour plots of out-of-plane displacement. (Online version in colour.)

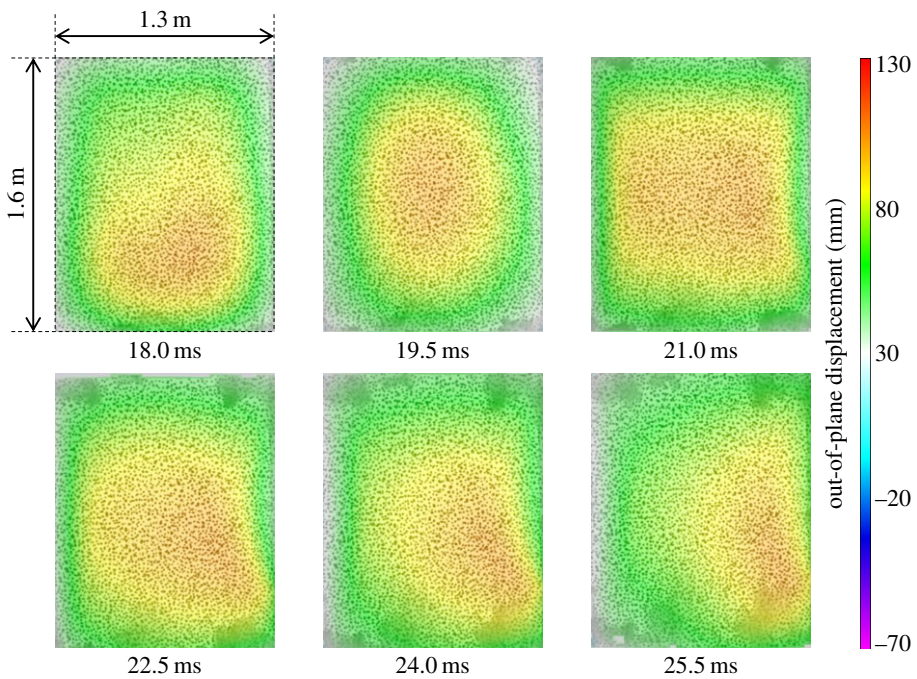
as shown previously in figure 4. The damage to the panel also led to a reduced stiffness, which caused an increase in the time for the return response. This was seen in the carbon-fibre panel as an elongated return from maximum displacement in figure 5 and the relatively flat-looking contour plot in figure 8. It took 1 ms longer for the carbon-fibre panel to return to its original position than the glass-fibre panel owing to the difference in core crack distribution observed in the carbon-fibre-skinned panels compared with the glass-fibre-skinned panels and other effects.

Figure 8. DIC analysis of blast on CA1 featuring contour plots of out-of-plane displacement. (Online version in colour.)

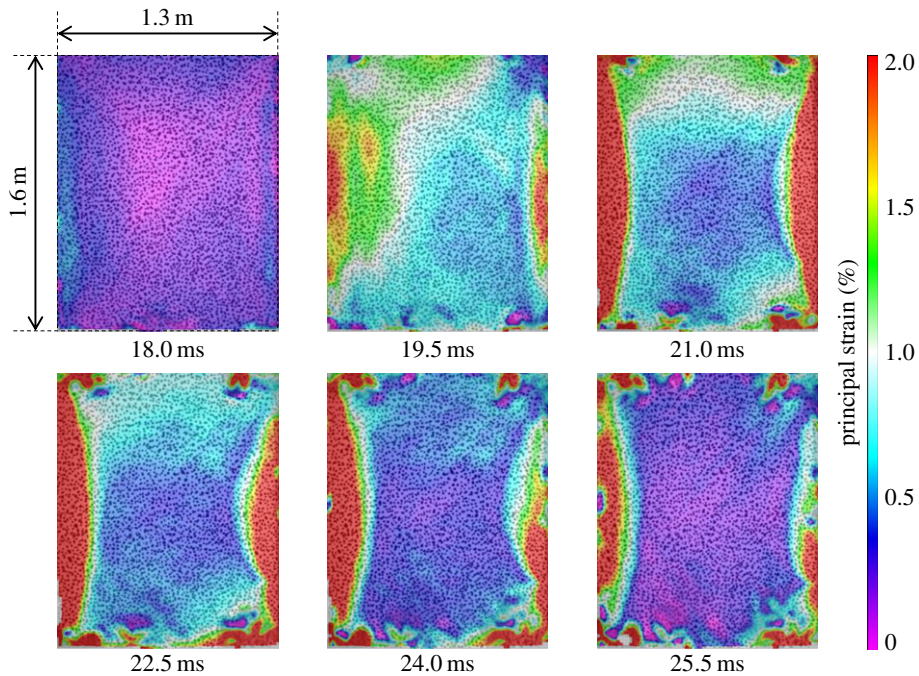
CA1 was seen to have strain concentrating around the edges of the panel in figure 9, with the central region relatively unstrained, complementing the displacement observations in figure 8. Similarly, the edges of the GL1 were relatively highly strained between 18.0 and 21.0 ms; however, this strain progressed to concentrate around a region that suffered complete failure along an edge (figure 7). This coincided with the time at which a front-face failure was observed in figure 3.

Figure 9. DIC analysis of blast on CA1 featuring contour plots of maximum principal strain. (Online version in colour.)

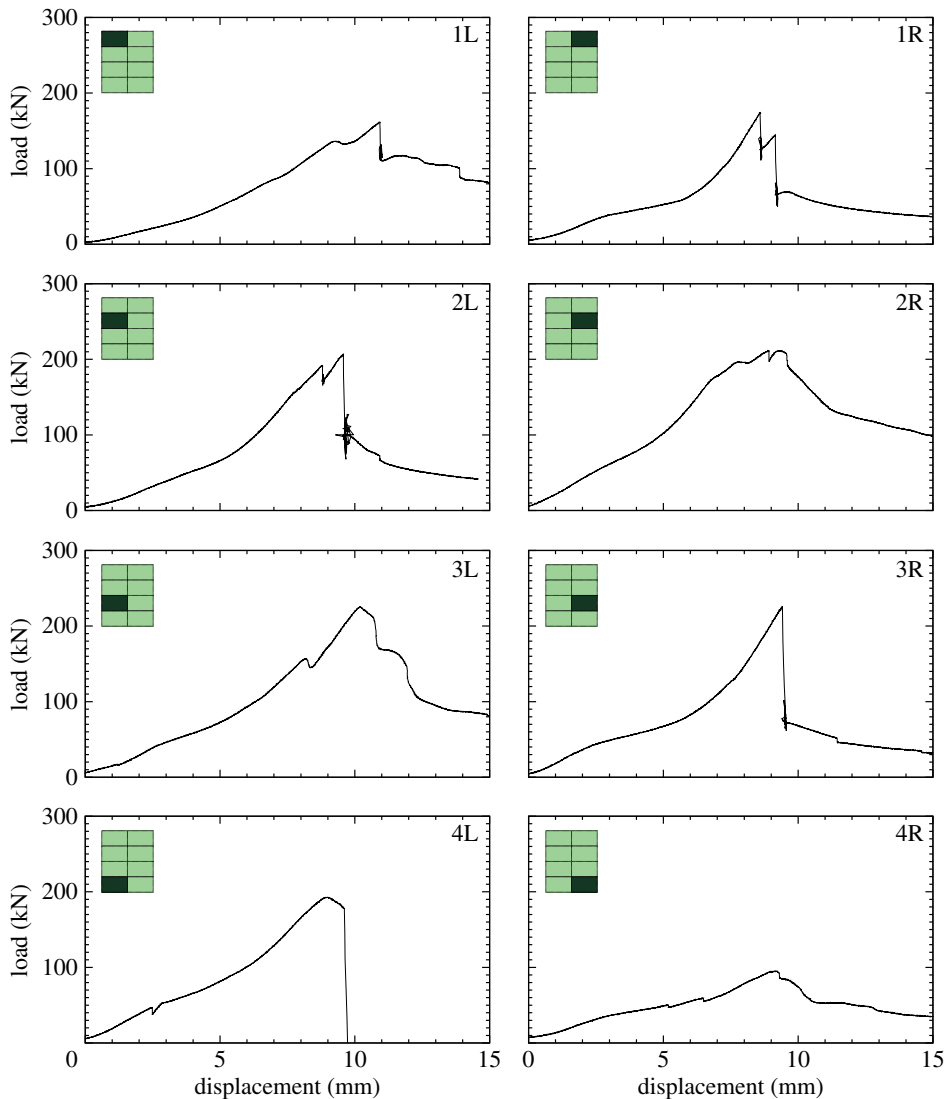
Figure 15. Force–time data for each sample in GL1. Data for each subpanel are shown in the position of where it lay in the global blast panel as viewed from rear of panel. The inset shows the location of the subpanel within the GFRP panel. (Online version in colour.)

Figure 15 shows a summary of all the load–displacement plots taken for each subpanel of GL1 tested, with each location of the subpanel within the global blasted panel labelled. It was observed in the glass specimens that the ultimate compressive load was greater for those panels which were situated in positions 2 and 3. The damage here was observed to be less severe than the bottom of the panels. The damage in the centre panels was also noted to be predominantly at the top and bottom, and the DIC data from the blast test (figures 16 and 17) suggested that core cracks travelled vertically, in line with the direction of the compressive load. It can be seen in figure 18 that higher ultimate loads were withstood by the panels in positions 2 and 3, and that, particularly in position 4R, a much lower load was attained before ultimate failure. These panels demonstrated

cracks travelling across the loading direction, and 4R showed the most damage of any of the glass-fibre panels.

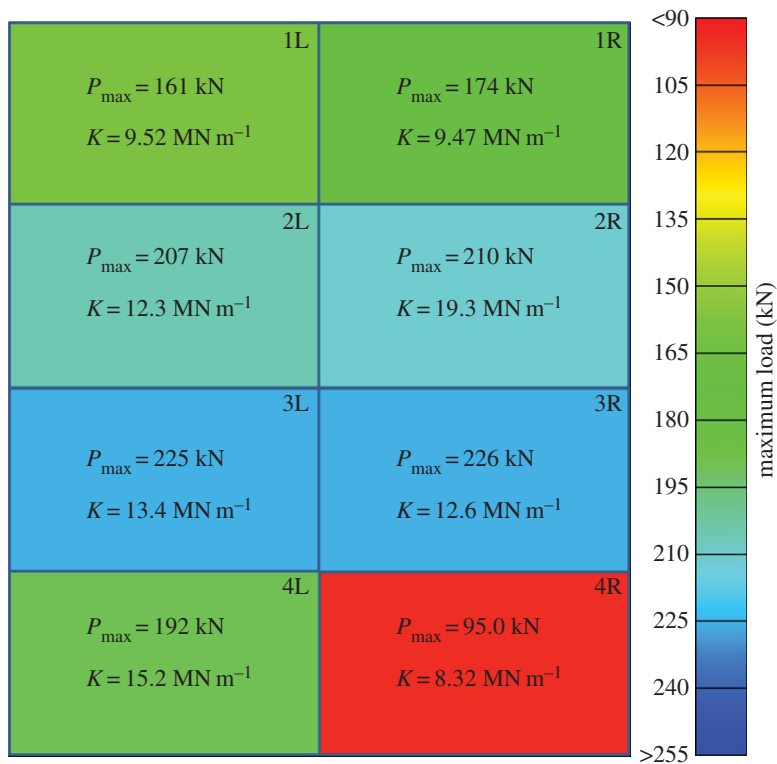
Figure 18. Graphic showing, as a greyscale (colour) plot, how ultimate load-bearing capacity varied with location of subpanel on the global GFRP blast panel as viewed from rear. (Online version in colour.)

relative to the whole target, which is also being loaded by the blast. There is a period of build-up during the loading phase, particularly on a non-infinitely rigid surface. The surface waves travelling along the panel are transmitted along the lengths towards other regions of the target, i.e. opposite corners. The faster wave speed in the CFRP targets allows the waves to propagate to the other boundaries quicker than in the GFRP targets. Therefore, damage builds up greatly in the CFRP targets away from the centre. However, in the GFRP targets, the magnitude of the blast wave is sufficient to breach the failure strain of the fibres (especially once support from the core is lost due to shear failures), and so energy dissipation to remote areas from peak-loaded ones is minimized. Energy is lost due to other failure mechanisms in the GFRP sandwich panels such as gross skin failure, rather than simply core damage. Therefore, the more significantly damaged area is focused in the GFRP targets to where the most force is expected to be applied and not necessarily focused in the CFRP targets. This concept is shown in figures 18 and 22.

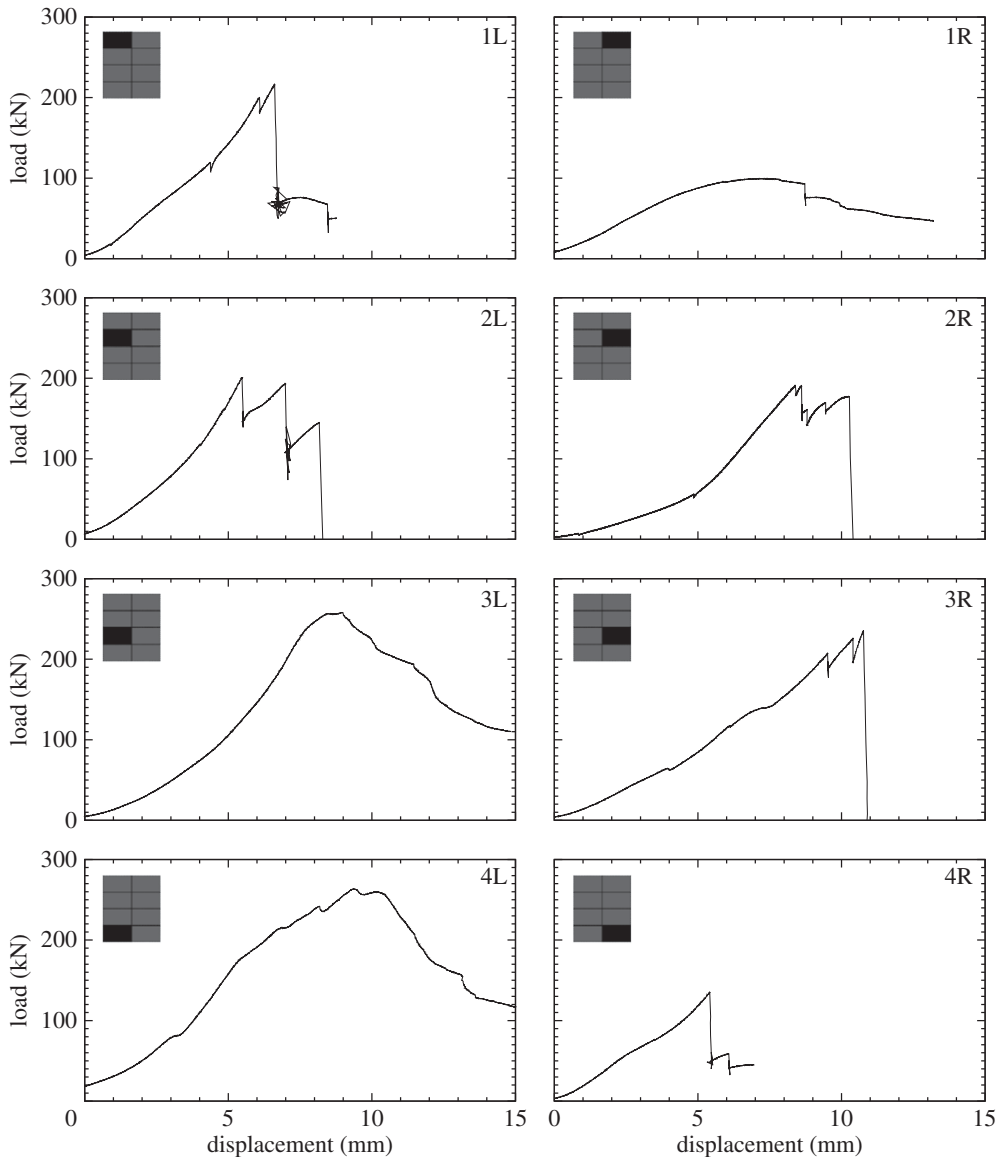
Figure 19 shows a summary of the load–displacement plots for the subpanels of CA1 tested. Figures 20 and 21 show the DIC for out-of-plane displacement in the CA1 subpanels 1R and 4R, respectively. The point during each test where the plots have been extracted are marked in terms of compressive displacement relating to the plots in figure 19. Similar to those figures produced for the GFRP subpanels, each compressive stage shows DIC images to illustrate the variation of out-of-plane motion and ε_y along the height of the panel front. The carbon skins suffered minimal damage during blast testing, which can be seen from the even displacements in the DIC images. However, core cracking and debonding were present in these test samples. In CA1-4R, this can be seen by the high out-of-plane deflection and relatively uniform strain plots on the right-hand edge, which corresponds to the core cracking damage.

Figure 19. Force–time data for each sample in CA1. Data for each subpanel are shown in the position of where it lay in the global blast panel as viewed from rear. The inset shows the location of the subpanel within the CFRP panel.

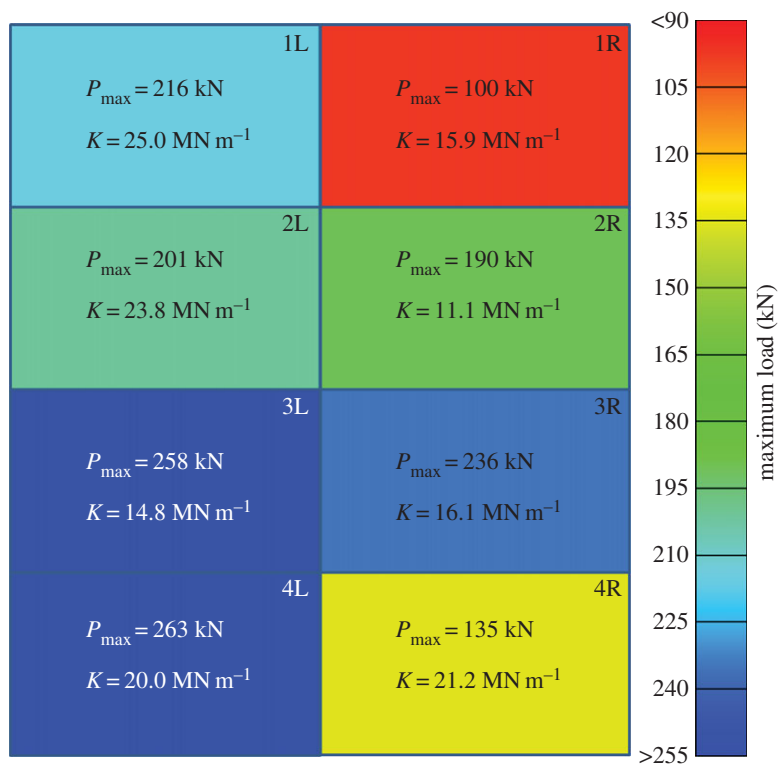
Ultimate load-bearing capacity data are presented for the CFRP panels in figure 22. It can be seen again that the residual strength of the panels corresponds to the damage severity and orientation observed from the edges of the panels and interpreted from the DIC blast data. In this case, it can be noted that panel 4L demonstrates a very high ultimate compressive strength, and that the corresponding corner, 1R, demonstrates a very low compressive strength. This

corresponds to the amount of visible damage to the panels, and is indicative of the unequal loading shown in the DIC blast data due to the constraint of the panel. Otherwise, a reasonably high compressive strength was still observed at the centre of the carbon-fibre panel, and locations of lower strength were observed at the upper and lower positions.

Figure 22. Graphic showing, as a greyscale (colour) plot, how ultimate load-bearing capacity varied with location of subpanel on the global GFRP blast panel as viewed from rear. (Online version in colour.)

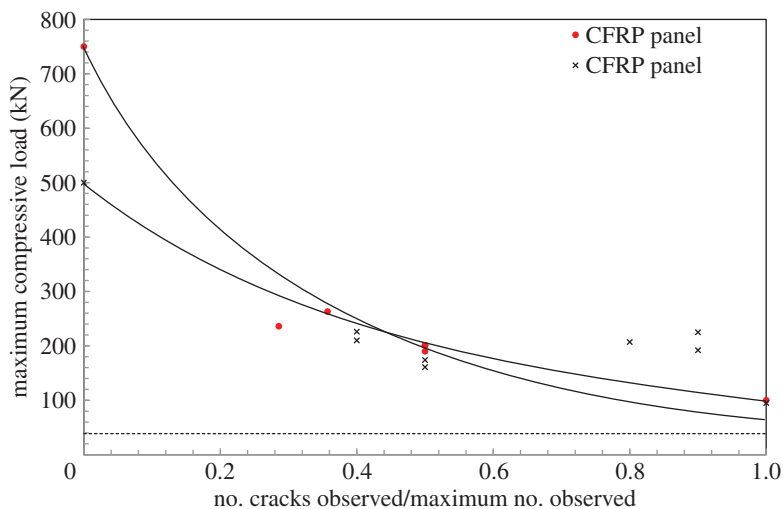
A number of trends and hypotheses can be drawn from the raw data. However, the importance of core cracking, particularly those normal to the loading direction, can lead to significant reduction in stiffness and load-bearing capacity. The graph shown in figure 23 plots the normalized number of cracks, i.e. the total number of cracks observed visually from each edge of the subpanel divided by the greatest number observed, all plotted against the peak compressive load. The peak values of compressive load were obtained from testing non-blasted materials.

Figure 23. Plot showing compressive load against normalized number of cracks recorded prior to compression testing. Dashed line represents the theoretical minimum compressive load to crush the core and buckle the skins. (Online version in colour.)

Referring to figure 23, it is seen that the CFRP targets have a much higher initial maximum load-bearing capacity (which is taken to be the buckling load) than the GFRP targets. However, based on the stiffer fibres in CFRP and the improved blast resistance, resulting in greater degree of blast energy absorption, the relative reduction in load-bearing capacity was greater for the CFRP targets compared with the GFRP targets. Furthermore, a stiffer material experiences a higher load (or resistance to impact); therefore the apparent damage induced in the core and interfaces is understandable compared with a more compliant material such as GFRP.
