Analysis of a Centreline Failure of a Lead Alloy Anode used in the Copper Electro-Winning Process

A. Elrefaey, Y. Gu, J.D. James, C. Kneen, I. Crabbe, J. Sienz

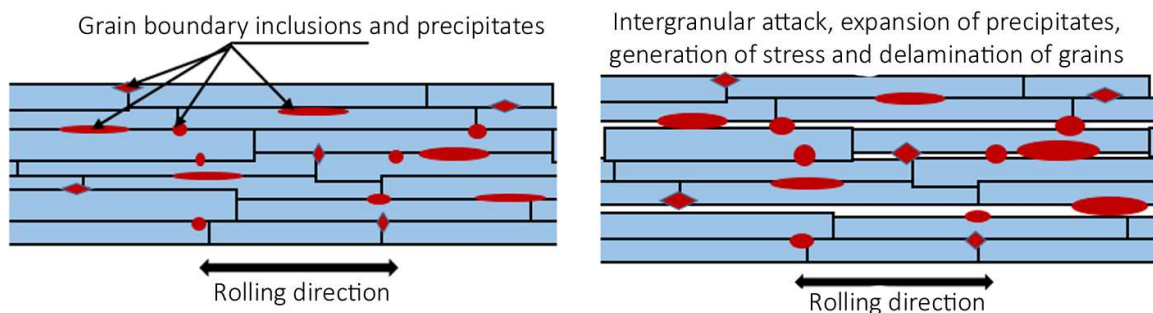
Fig. 9 Schematic illustration of exfoliation corrosion.

The investigation into the failed split anode indicates that exfoliation corrosion appears to be the main cause of failure. The corrosion attack through the stretched grains, especially at the anode centreline, causes the grains to be pushed apart as corrosion products have a greater volume than the original un-corroded alloy. This creates stresses and forces that in turn cause leafing action of the grains, and an exfoliated sheet starts to appear as schematically illustrated in Fig. 9.

Although, as mentioned previously, anodes are rolled during their manufacturing process to improve their mechanical strength and corrosion resistance, the rolling processes of the plate increase the deformation and grain thinning toward the centre of the plate, which makes its microstructure more susceptible to exfoliation corrosion. Strains build up slowly in the grains with a high aspect ratio, and when the strains exceed the fracture strength of the materials, the grains start to break open and exfoliation starts [29].
