Pedrazzini, S., Child, D., Aarholt, T., Ball, C., Dowd, M., Girling, A., Cockings, H., Perkins, K., Hardy, M., et al. (2018). On the Effect of Environmental Exposure on Dwell Fatigue Performance of a Fine-Grained Nickel-Based Superalloy. *Metallurgical and Materials Transactions A*, 49(9), 3908-3922.

On the Effect of Environmental Exposure on Dwell Fatigue Performance of a Fine-Grained Nickel-Based Superalloy

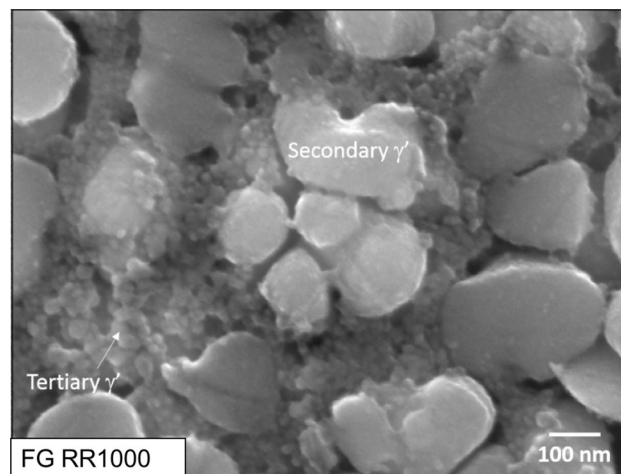
Fig. 1—Secondary electron micrograph of the etched sample (whereby the γ matrix was dissolved) showing the distribution of secondary and tertiary γ' particles.

Figure 1 shows an SEM micrograph performed on the etched sample with the purpose of revealing the γ' distributions. A bimodal distribution of spheroidal, large secondary γ' particles is shown, surrounded by tertiary γ' particles. Secondary γ' particles had a mean planar diameter between 250 and 350 nm and tertiary particles between 7 and 50 nm.

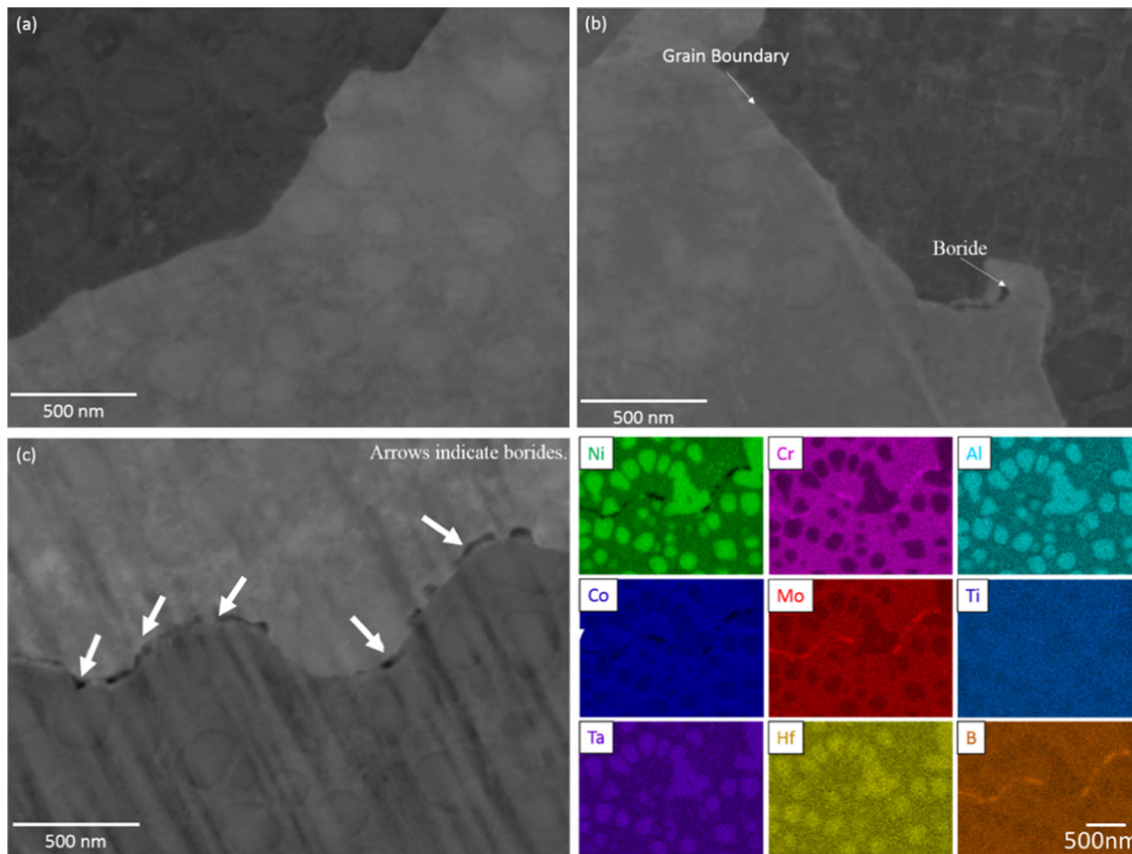
Fig. 2—SEM backscattered electron images of the unetched sample showing (a) a planar grain boundary that is precipitate free and representative of the majority of grain boundaries in the sample, (b) a rare grain boundary boride accompanied by a serration, and (c) the only grain boundary found in the sample that was fully serrated and decorated with Mo-Cr-borides with the accompanying EDX maps.

The grain boundary character and grain boundary serrations were analyzed through backscattered electron imaging on the unetched sample, and SEM micrographs and associated EDX maps are shown in Figure 2. The planar grain boundaries shown in Figure 2(a) were characterized in this same sample as part of a previous study and were found by APT to be enriched in Mo and B in solid solution.^[10] These were the main, representative examples of grain boundary morphology present in the sample. In some rare occurrences, grain boundary serrations were observed and associated with the presence of localized, ellipsoidal < 20-nm wide and 100- to 200-nm-long Mo-Cr borides, an example of which is shown in Figure 2(b). Few such examples were

observed within the sample. One exceptional case was found, in which a grain boundary decorated with a semicontinuous series of borides exhibited a fully serrated morphology, with serrations of amplitude ~ 500 nm. Two current separate investigations were carried out on the effect of boron on grain boundary character,^[11] grain boundary serrations,^[12] and their role in improving ductility and creep lifetime in a polycrystalline nickel-based superalloy, which is beyond the scope of the present work. For the present investigation, it is important to note that prior to mechanical testing and thermal exposure to 700 °C, most grain boundaries were planar, enriched in Mo and B in solid solution, and precipitate free, with a few rare exceptions in which Mo-Cr borides were observed. The occasional presence of Ta-rich MC carbides and larger intragranular Mo-Cr borides was also observed in this sample and documented in a previous characterization study, where the borides were shown by APT to be of M_5B_3 type.^[10]

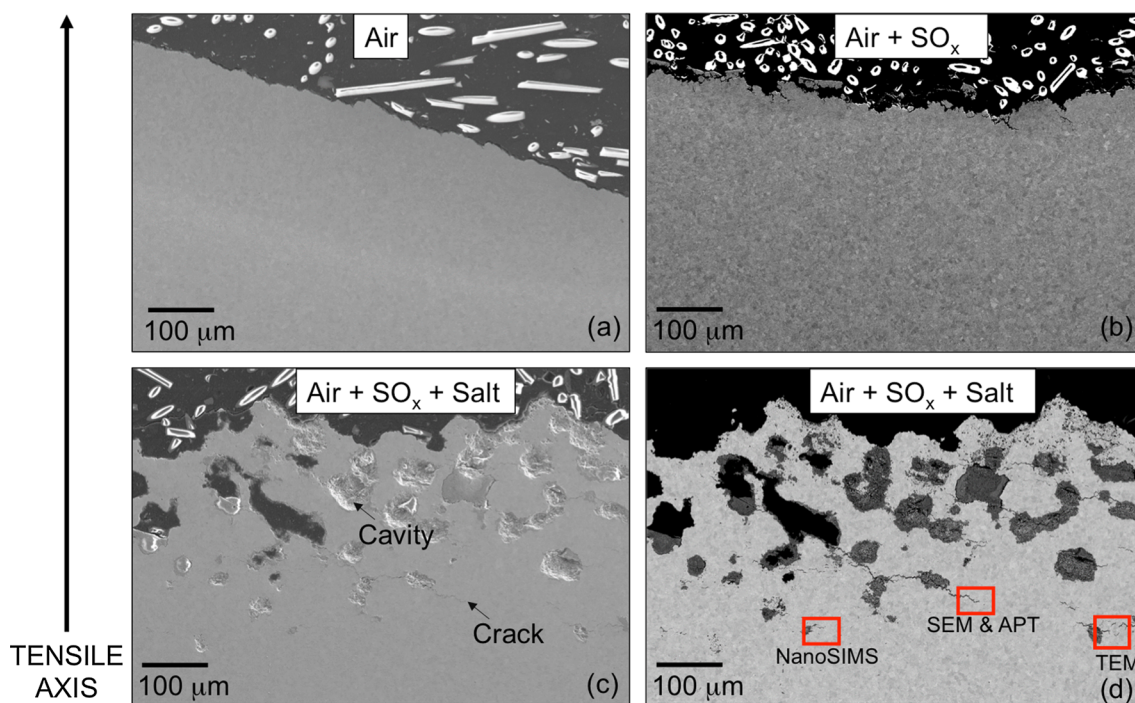
Fig. 3—SEM secondary electron micrographs of the fracture surfaces of dwell fatigue samples exposed to (a) air, (b) air + 300 ppm SO_x, and (c) air + 300 ppm SO_x + salt. (d) Backscattered electron micrograph of the sample shown in (c). The exact locations of the cracks analyzed using APT, TEM, and NanoSIMS in Figs. 4 through 10 are highlighted by the red boxes (Color figure online).

SEM micrographs of the fracture surfaces of each of the test samples, which were tested to failure, are shown in Figure 3. Samples 1 and 2 (air and air + 300 ppm SO_x), shown in Figures 3(a) and (b), failed at 90 deg from the tensile axis in a uniaxial tensile mode. Fracture appears intergranular in all samples. The fact that crack growth in air is intergranular (in RR1000 dwelt fatigue samples tested at 750 °C) was also previously observed by Li *et al.*^[13] Sample 3, which was exposed to salt, is different, however. The fracture surface, shown in the secondary electron micrograph in Figure 3(c) and in the backscattered electron micrograph in Figure 3(d), is also at 90 deg from the tensile axis. These images show evidence of internal cracking and oxidation/corrosion effects. The secondary electron image shown in Figure 3(c) shows internal cracks extending approximately 300 μm below the surface that are decorated by cavities and block-shaped phases. These phases are revealed by the backscattered electron image in Figure 3(d), appearing darker than the matrix; therefore, they are made of lighter elements, possibly oxides. Internal cracks can also be observed in this micrograph, extending at 45 deg from the fracture surface.

The fracture surfaces shown in Figure 3 reveal that the addition of 300 ppm of SO_x to the testing atmosphere was sufficient to alter the crack propagation behavior in RR1000 under dwell fatigue conditions at 700 °C when compared to air exposure alone. Fracture of the prenotched samples occurred at 90 deg from the tensile axis and, ultimately, failure occurred intergranularly in a uniaxial tensile mode for all samples. Intergranular fracture was expected to be the main failure mode based on a study published by Li *et al.*^[13] on the same RR1000 alloy, though their samples were studied following a supersolvus heat treatment, which created a coarse-grained microstructure. Their study analyzed samples that had been subjected to different cooling rates after heat treatments and found that dwell fatigue crack propagation behavior was sensitive to the distribution of γ' precipitates (mainly tertiary). Their study also found that, at 700 °C, grain boundary embrittlement was the main mechanism responsible for accelerated failure when samples were exposed to air rather than kept under vacuum. The present results allow us the opportunity to extend their argument to sulfur exposure and to shed insight into grain boundary oxidation and sulfidation ahead of the crack tip.

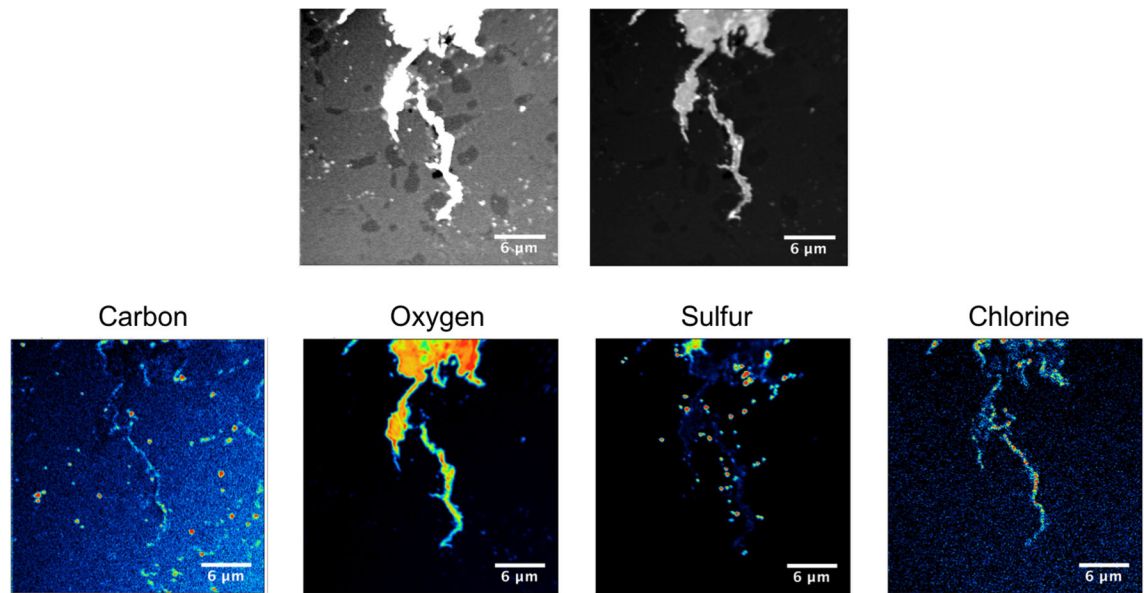
Fig. 5—Secondary electron micrographs (top) with different contrast to show different phases around the crack and within the oxide, and element concentration maps determined using NanoSIMS (bottom) showing the C, O, S, and Cl locations within and around the crack tips.

Due to the difficulties encountered when attempting to identify the location of lighter elements, such as S, O, C, and Cl, by EDX, NanoSIMS analysis was performed, the results of which are shown in Figure 5. The carbon map indicates the presence of carbides, which are distributed along the crack path and intragranularly within adjacent grains. These are likely to be the MC carbides also shown in Figure 6. Oxygen was identified by the peak at 16 amu and is found inside the crack. Sulfur is at 32 amu, which could have overlapped with O₂, but the mass resolution of the nanoSIMS was sufficient to detect two peaks at 31.82

and 31.84 amu, one of which overlapped with the peak at 16 (oxygen) and one which did not (sulfur). Sulfur was detected in distinct particles ahead of and around the crack tip. Chlorine is identified by the peak at 35 amu. The sulfur, therefore, was confirmed to segregate to specific particles ahead of and around the crack tip, and not within the oxide. Chlorine (also introduced in as contamination due to the exposure to salt, though only as 2 pct of the solution) was, unlike sulfur, detected within the crack. NanoSIMS is an unsuitable technique for the analysis of heavier metallic ions due to its ability to detect only ions that can be charged negatively and the limitation of characterizing a maximum of five elements at a time.

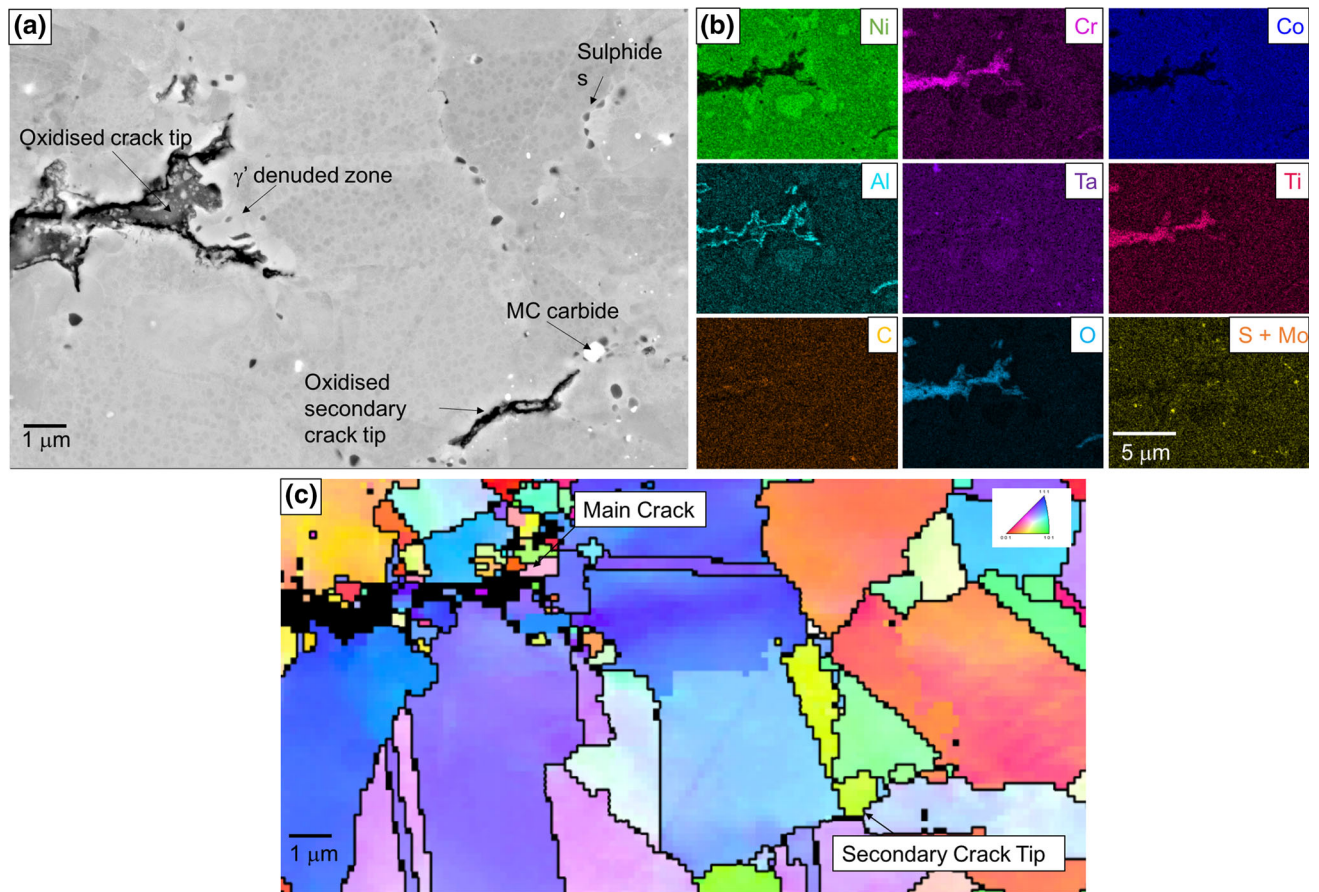
Fig. 6—(a) SEM backscattered micrograph showing a closeup of the crack tip, (b) EBSD map of the same region showing the intergranular nature of the crack and some of the particles, and (c) EDX elemental concentration maps for each element.

Figure 6(a) shows a close-up backscattered electron micrograph of the crack tip, which gives an insight into the type of oxides present within. In the EDX maps shown in Figure 6(b), the end of the crack appears to contain a Cr-Ti-rich oxide, most likely a form of rutile

(Ti,Cr) O_2 . The outer edges of the rutile are covered by what appears to be a continuous thin film of alumina, which also decorates the secondary crack tip. The main and secondary crack tips and the grain boundaries ahead of the crack tip are decorated with darker particles, which, based on the salt exposure of the sample and the NanoSIMS results shown in Figure 5, may be borides, sulfides, or other grain boundary precipitates. The evidence of the intergranular nature of both the cracking and of the sulfur-rich particles is given by the EBSD in Figure 6(c). In generating Figure 6(c), a filter was applied to the resulting map removing the areas in which the confidence index was less than 20 pct. High-angle grain boundaries (> 15 deg) are shown in black.

The EDX map in Figure 6 shows that the crack is filled with a region enriched in Cr, Ti, and O. Based on EDX measurements alone, this phase could have been mistaken for rutile. However, Figure 8(c) shows an atom probe reconstruction from the oxidized region of the crack tip, whereby the needle itself is made up of several different types of oxides, including spinel NiCr_2O_4 , chromia, rutile, and small amounts of unoxidized, Cr-depleted γ phase. It is interesting to note the presence of Ti in both the NiCr_2O_4 spinel and in the rutile and its complete absence from the chromia.

Comparing Figures 6 and 13, it is clear that secondary crack tips can be analyzed to obtain information about the crack propagation mechanisms, but only if they are carefully selected from specific locations where the mechanisms are active. It is likely that, in the present tests, the crack propagation mechanism was initially driven by the presence of sulfur but switched from being sulfur driven to being oxygen driven, in this case after the crack length exceeded ~ 1.5 mm. It is clear that further work is required to characterize in-depth primary crack tips of tests that are interrupted at various stages in order to fully rationalize the fracture mechanisms.

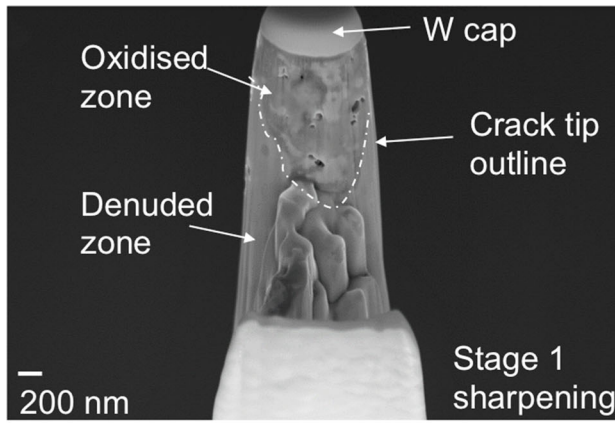
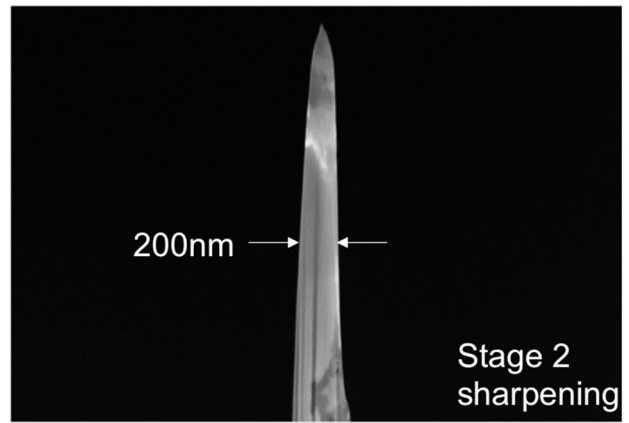
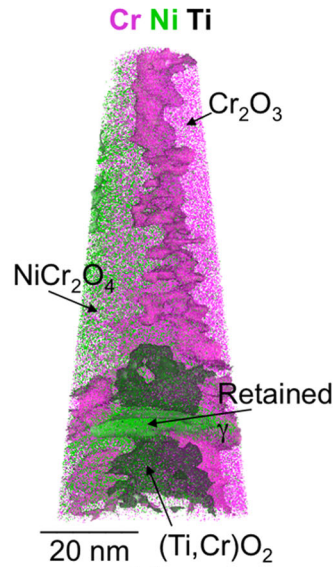
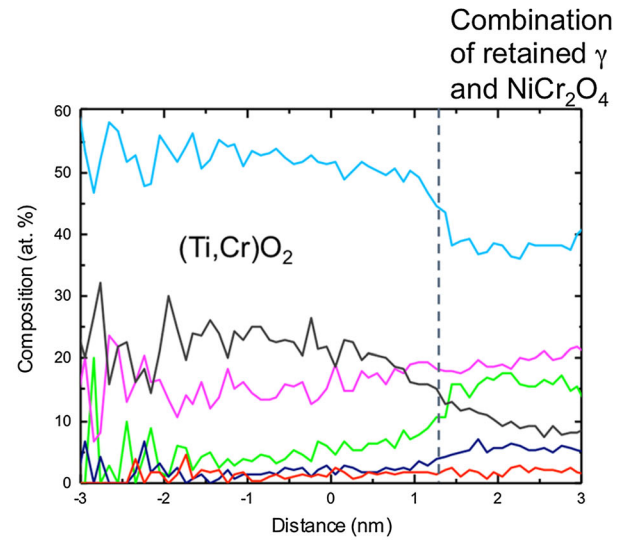
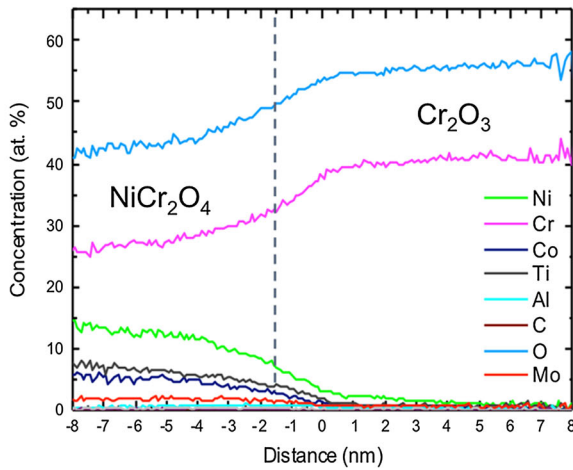
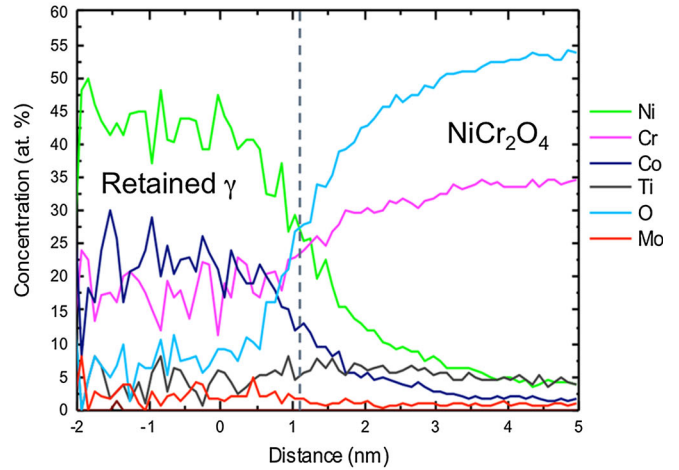
Fig. 8—(a) SEM micrograph showing the section of the cantilever containing oxide buildup and porosity within the crack tip, (b) the final sharp needle that was analyzed in the atom probe, (c) reconstruction of the needle, and (d) through (f) proximity histograms going across the boundaries between the phases shown in the needle.

Atom probe needle 1, as shown in Figure 7(a), was taken from the oxidized region of the crack approximately $3\ \mu\text{m}$ away from the tip. SEM micrographs of the needle during sharpening are shown in Figures 8(a) and (b).

Figure 8 shows the chromia and other oxides that are present at the crack tip. The lack of Ti in solid solution in the chromia is noteworthy because current oxidation theories speculate that Ti increases the oxidation rate by dissolving in the chromia scale in the form of Ti^{4+} ions, which substitute for Cr^{3+} ; therefore, more vacancies are required to keep charge neutrality, which makes diffusion faster.^[16] Kitaguchi *et al.*^[15] performed an atom probe analysis on an oxidized RR1000 dwell fatigue crack tip that was not exposed to sulfur. They saw ~ 5 at. pct Ti in solid solution in the chromia of an oxidized crack tip in RR1000, as well as rutile particles similar to those identified in Figure 8. The main difference between both samples is the sulfur exposure. Therefore, this result is a likely indicator that the sulfur diffuses ahead of the oxide front and forms Ti-Cr sulfides. The titanium forms sulfides and the local reduction of titanium is evident, as it does not form a solid solution in the chromia. As the crack propagates, the sulfides then oxidize, releasing the sulfur and creating the $(Ti,Cr)O_2$ particles we detected. The oxidation of sulfides releasing elemental sulfur on grain boundaries and causing embrittlement was previously shown as a potential mechanism of gas-phase embrittlement,^[29] although based on our observations, the sulfur diffuses ahead of the advancing crack front to form more sulfides under the current testing conditions.

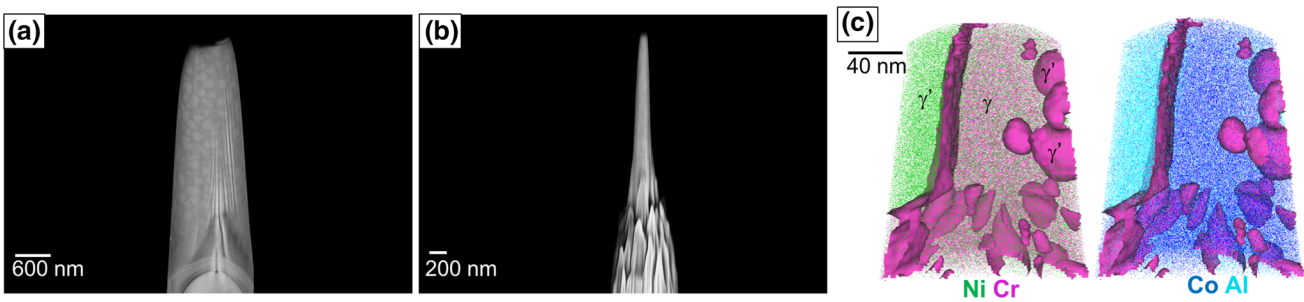
Fig. 10—(a) and (b) Final stages of sample preparation and sharpening of the atom probe needle 3. (c) Reconstruction showing secondary and tertiary γ' from this sample. Elemental concentration maps are shown with isoconcentration surfaces at 12 at. pct Cr.

The third atom probe needle, whose location is also shown in Figure 7(a), contains unoxidized secondary and tertiary γ' particles and is shown in Figure 10. The needle was taken approximately $5\ \mu\text{m}$ ahead of the crack tip. Figures 10(a) and (b) show the final stages of sharpening. Figure 10(a), in particular, shows a uniform distribution of γ' particles within the γ matrix. Figure 10(c) is a reconstruction, where the individual phases are marked and shown with distinctive elemental maps. The interfaces are isoconcentration surfaces at 12 at. pct Cr. Table III contains the elemental compositions of secondary and tertiary γ' phases and of the γ matrix that were obtained from the reconstruction in Figure 10(c).

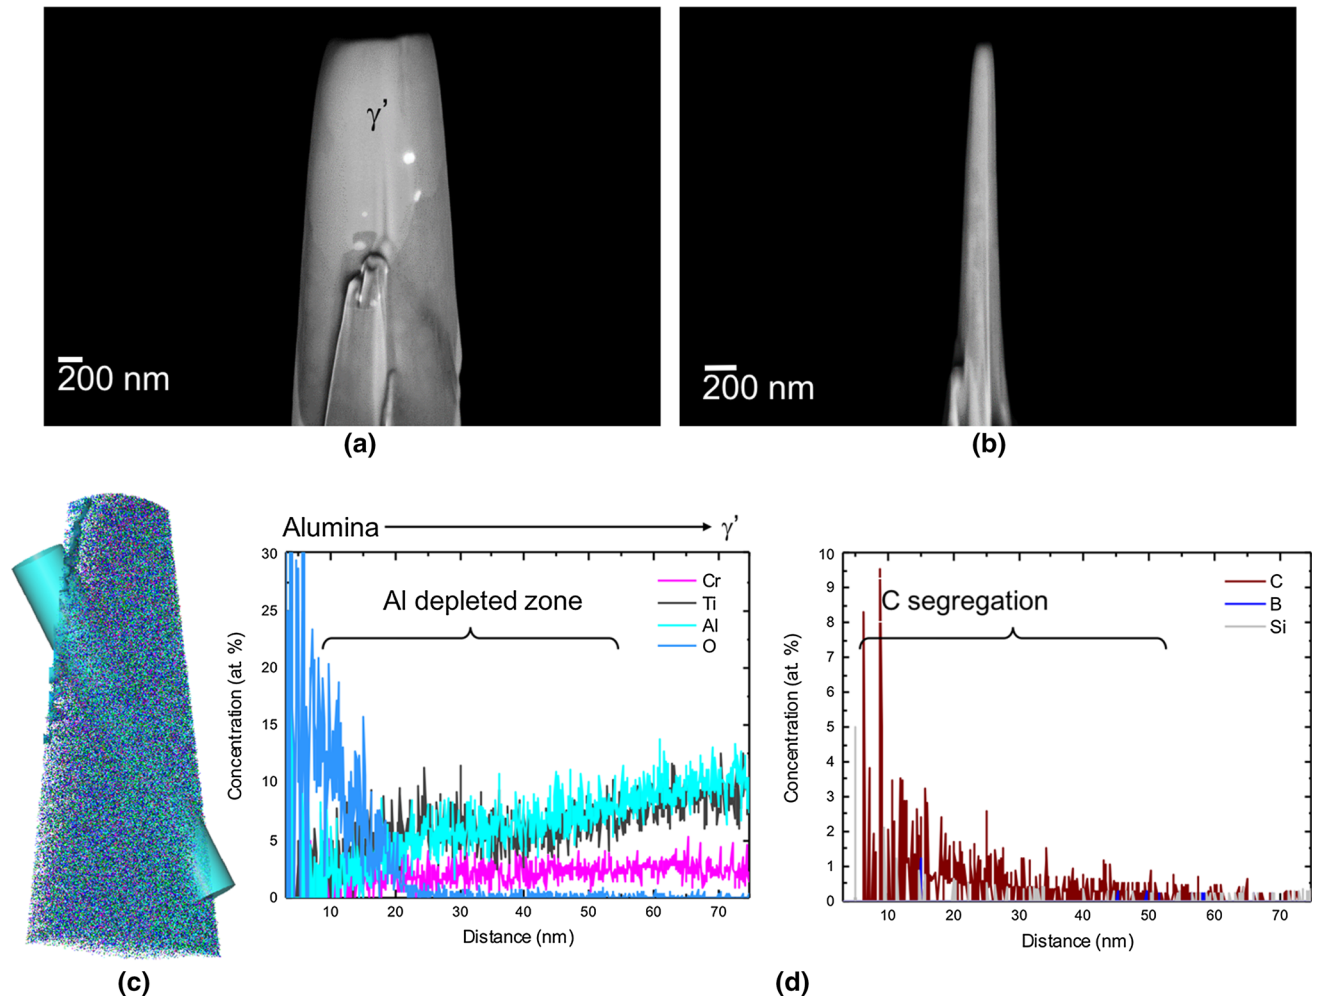
Fig. 11—(a) and (b) SEM micrographs of the samples during sharpening, showing a γ' particle in the tip of the needle, with a part of the oxide-metal interface close to the tip. (c) Atom probe reconstruction taken from the external alumina envelope surrounding the secondary crack tip. (d) 1-D concentration profiles showing the segregation and partitioning preference of various elements, including Si, C, and O, obtained from the cylindrical volume identified in (c).

A fourth atom probe needle was extracted from the tip of the secondary crack, as identified in Figure 7(a). The oxide-metal interface was targeted, and it was acquired from a region that contains a γ' precipitate being oxidized. The sample in two stages of sharpening and the resultant APT data are shown in Figure 11. The composition of the γ' at the transition point showed an oxygen gradient and an Al- and Ti-depleted zone ahead of the oxidizing interface. Silicon was seen to segregate to the alumina, while carbon was rejected ahead of the oxide-metal interface. No evidence of S was observed. The lack of sulfur is noteworthy, as it is consistent with the nanoSIMS results and shows that sulfur diffused through the grain boundary, though it all appears to be contained within well-defined particles and not present as elemental segregation at the crack tip or at the oxide-metal interface.

Previous studies analyzing combined sulfur-oxygen exposures report lower damage rates than sulfur exposure alone, suggesting that preferential oxidation delays sulfur corrosion.^[2] Further studies into this mechanism hypothesize surface oxide formation, followed by sulfur diffusion along the grain boundaries within the oxide. Sulfur would diffuse to the oxide-metal interface, then cause the preferential sulfidation of specific elements that subsequently grow outward toward the surface along the grain boundaries within the oxide.^[20] The diffusion of sulfur to the oxide-metal interface was documented in the case of surface oxide scales,^[21,22] encouraging spallation and causing material loss at an accelerated rate.^[23] This behavior was not observed at crack tips under the current testing conditions, as proved by the atomic resolution microstructural characterization shown in Figure 11.

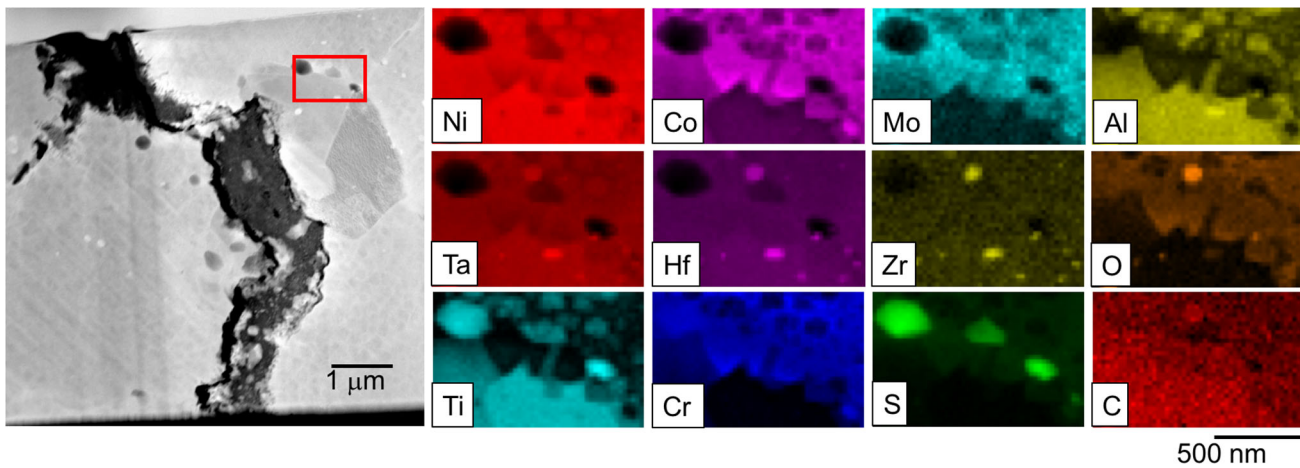
Fig. 12—TEM micrograph of the crack and surrounding particles and STEM-EDX elemental concentration maps taken from the region highlighted by the red box (Color figure online).

Figure 12 shows a bright-field TEM micrograph of the oxidized crack tip, taken from the region shown in Figure 3(d). Some of the grain boundaries around the crack tip contain particles that were analyzed using scanning transmission electron microscopy (STEM)–EDX, which are also shown in Figure 12. The EDX compositional maps elucidate the formation of Ti-Cr sulfides ahead of and around the crack tip, as well as the occurrence of Ta-Hf-Zr oxide particles. This provides further evidence to indicate that grain boundary precipitates, such as the ones around the crack in Figure 6, are, in fact, sulfides. The lack of association between the S, C, Hf, and Zr suggests that the

In the present study, Ta, Zr, and Hf oxidized, forming oxide particles at grain boundaries ahead of the crack tips, as shown in Figure 12. Therefore, these elements have no influence on the sulfur resistance of the alloy. MC carbides in nickel superalloy RR1000 are generally found to be Ta and Ti rich. It is possible that the presence of S could have removed Ti from MC carbides, though further studies are needed to confirm this.

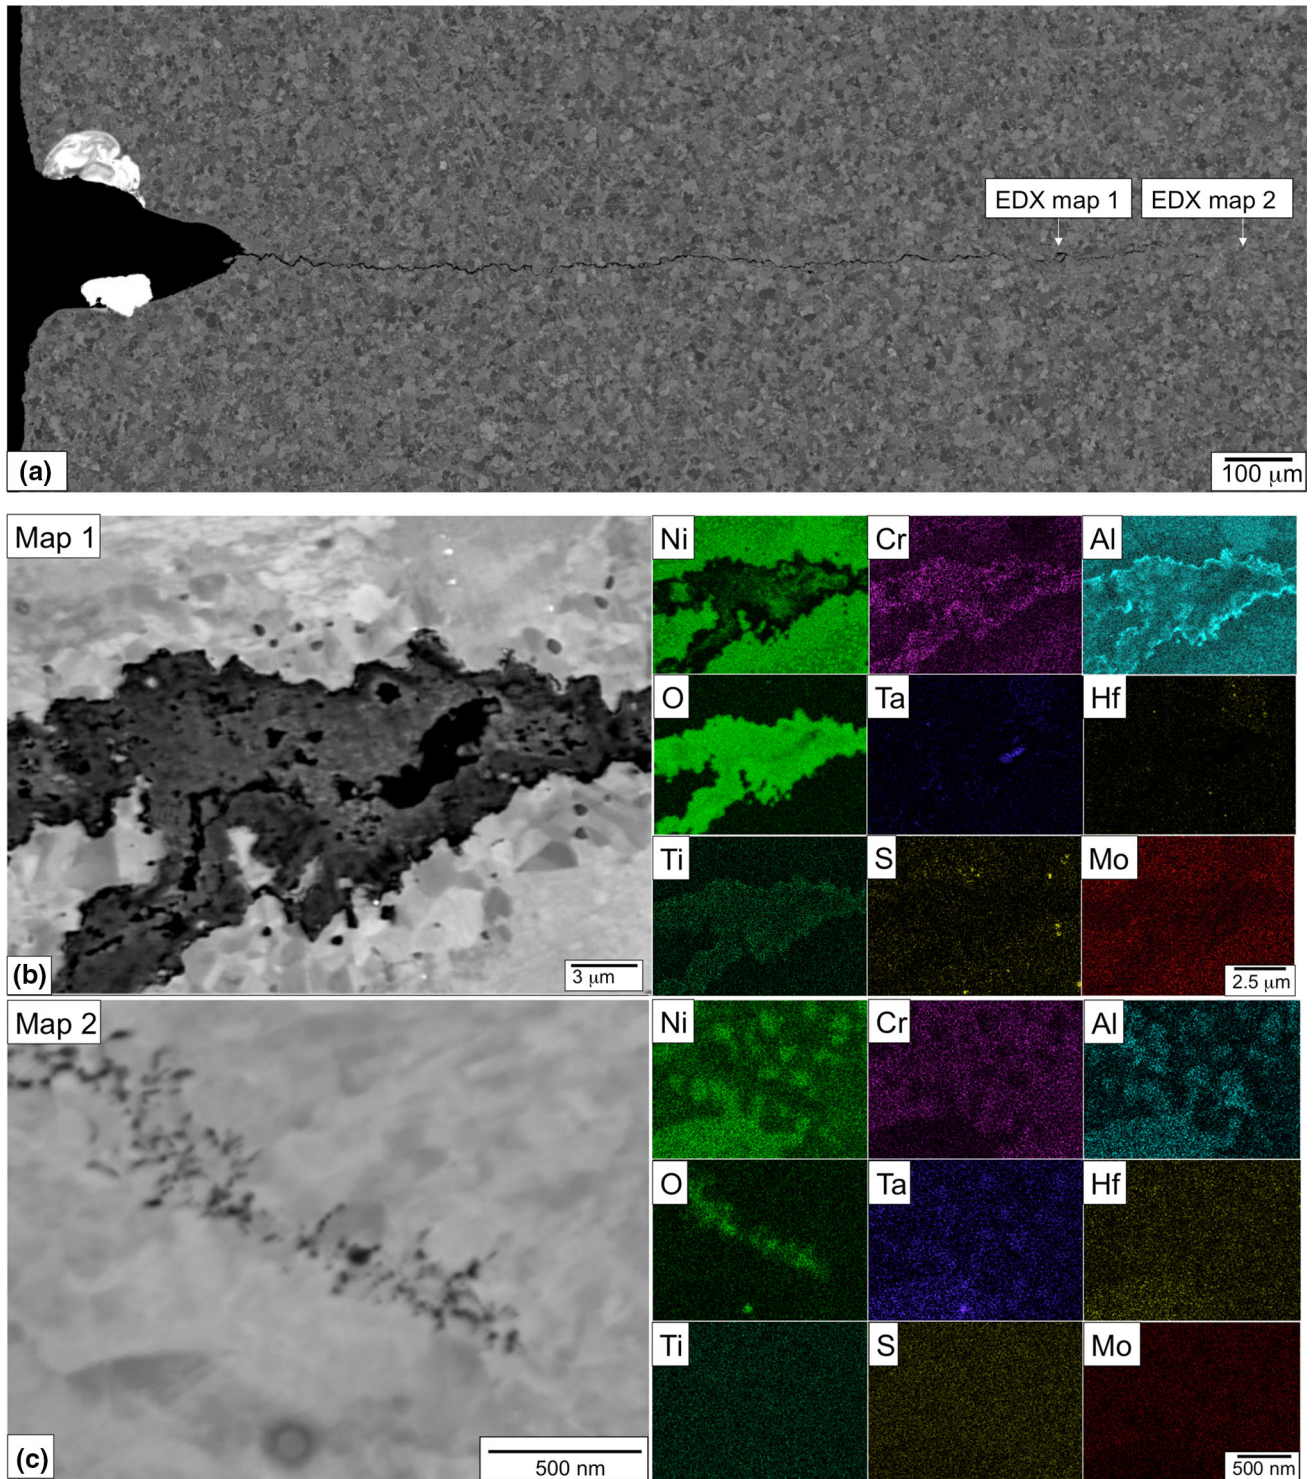
Fig. 13—(a) Backscattered electron micrograph showing the entire crack and the locations from which the EDX maps were acquired. (b) Micrograph showing, in detail, an oxidized portion of the crack and associated EDX compositional maps. (c) Micrograph showing the tip of the crack and EDX elemental composition maps.

An interrupted dwell fatigue test was performed (sample 4) in order to compare the crack propagation mechanism of the primary and secondary cracks. Secondary cracks were analyzed in the present work because the specimens were tested to failure; therefore, the primary crack was no longer present. However, secondary cracks could have been stationary for a substantial portion of the test, therefore having undergone a different environmental and thermal exposure when compared to the primary crack. To ensure the mechanisms described previously while characterizing secondary cracks were representative, the primary crack tip of an interrupted test was used for comparison. Backscattered electron images of the primary crack are shown in Figure 13.

Figure 13(a) shows the entire crack and the locations in which the EDX maps shown in Figures 13(b) and (c) were acquired. Figure 13(b) provides a backscattered electron micrograph and associated EDX compositional maps showing a portion of the crack that appears very similar to the secondary crack observed in Figure 6. In the EDX maps shown, we can observe the internal oxide made primarily of chromia-rutile and surrounded by a continuous layer of alumina. Also visible are the Cr-Ti sulfides

and nanoparticles of hafnia that surround the crack. However, Figure 13(c) shows the very tip of the crack. At this stage, only a discontinuous layer of alumina is present.
